Appendix D: Geotechnical Report

July 15, 2025 Project #: 12541-1 Revised: July 30, 2025

#### PROPOSED DWELLING - GEOHAZARD ASSESSMENT

3139 Otter Point Road - Sooke, BC

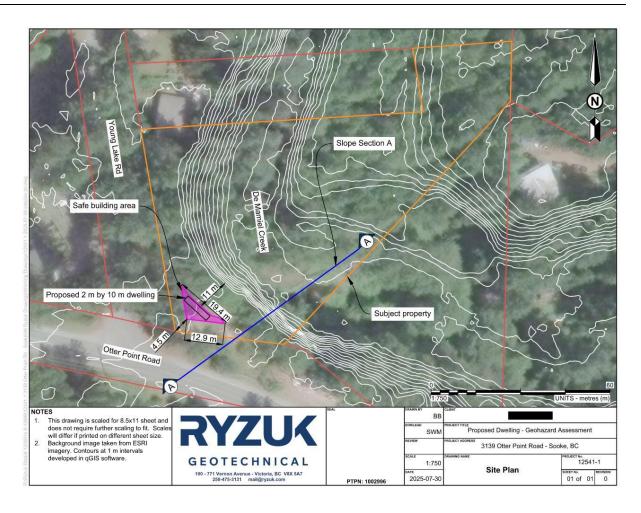
Based on our review of the CRD GIS map satellite imagery and contours and BC LiDAR data (BCGS 092b032, Year: 2019) analyzed in QGIS software, the natural grade on the property significantly varies. The dwelling is proposed on a relatively flat plateau at the southwestern corner of the property that has a geodetic surface elevation between 83 and 84 m. To the northeast of the plateau, the grade steeply slopes down at an angle of 66 degrees a height of 11 m to the base of the western side of De Mamiel Creek. On the northeastern side or inside of the creek where its point bar formation exists, the surface topography gently slopes upwards at a relatively consistent rate to 83 m geodetic elevation at the northeast corner of the property. In the QGIS software, we produced Section A from BC LiDAR data to analyze the slope geometry on the property. The location of Section A can be seen on the attached Site Plan and will be discussed further in the Slope Stability section of the report.

For the purposes of the attached Appendix D: Landslide Assessment Assurance Statement, in accordance with Section 219 of the Land Title Act, we recommend a covenant be registered on title indicating that the steep slope above the creek is subject to geohazard, that the indicated safe building area is considered safe, and that any future building site(s) contemplated closer to the crest of the slope above the creek be assessed by a geotechnical professional to confirm such location is safe for residential construction. Given the above, it is our professional opinion that the proposed safe building area, as indicated on the attached Site Plan, setback 11 m from the slope crest is not subject to risk of geohazard.

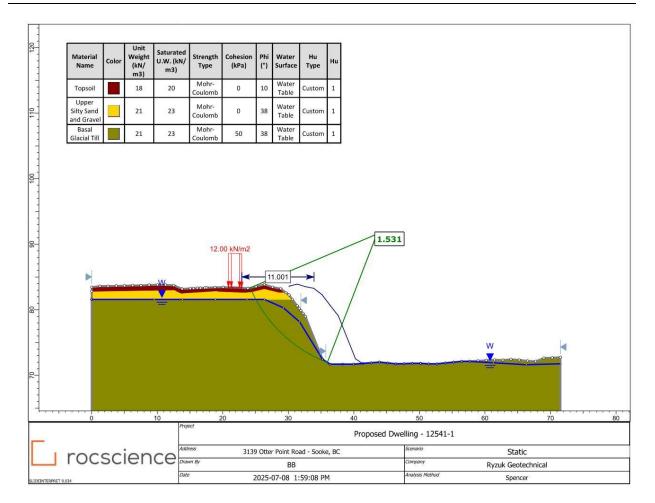
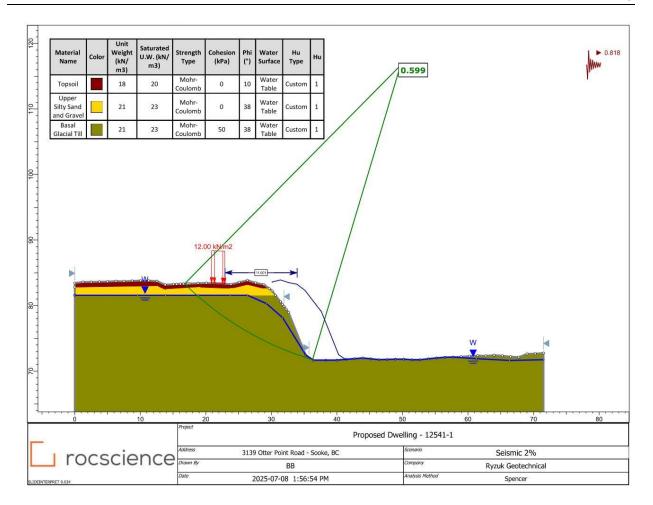
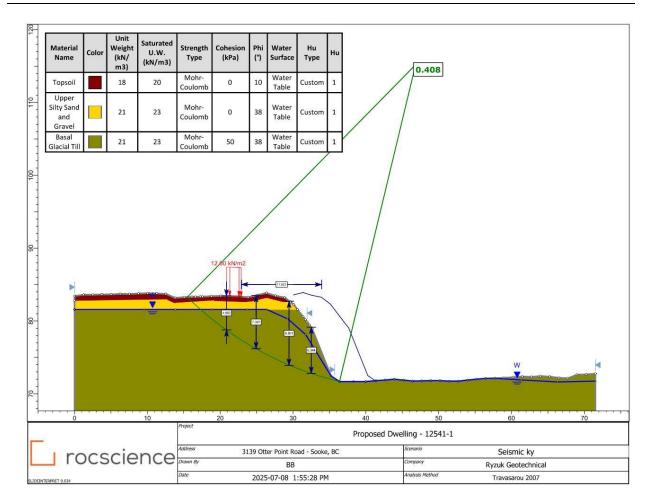
The results of our modelling indicate a minimum Factor of Safety (FS) of 1.53 in static conditions and a minimum FS of 0.60 in seismic conditions. Acceptable values of FS are typically >1.5 in static and >1.0 in seismic, as stated within the EGBC Landslide Guidelines Table B-6: Types of Static and Seismic Slope Stability Analysis. Given the NBCC 2020 seismic Factor of Safety resulted in less than the required threshold, and as per the methodology outlined in the guidelines, we used advanced functionality in the software to determine the critical seismic yield coefficient (k<sub>y</sub>) value (0.408) and used this value in Travasarou's equation to estimate the anticipated permanent displacement resulting from a seismic event. The calculation using Travasarou's "Method 1" (2007) and conservative parameters resulted in a displacement of 12.1 cm, which is within the acceptable maximum limit of 15 cm.

The attached Slope Stability Analysis Results show the stratigraphy, soil parameters, and slip plane in static conditions, seismic 2%, and seismic  $(k_v)$  conditions.
