**REPORT TO SURFSIDE PARK ESTATES WATER SERVICE COMMITTEE  
MEETING OF TUESDAY, FEBRUARY 13, 2024**

**SUBJECT**     **Surfside Park Estates Water System Tank Replacement Options Analysis**

Surfside Park Estate Water System  
Tank Replacement Options Analysis

NOVEMBER 2023

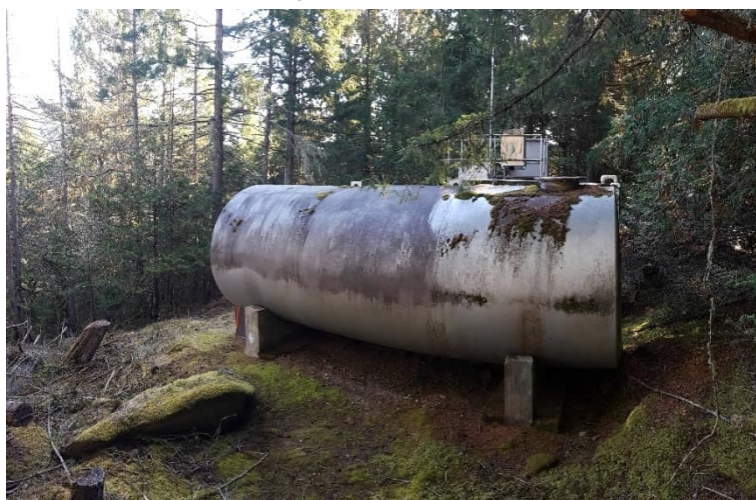
Figure 2-1 Surfside Water Storage Tanks

In general, the available record information for the tanks is poor. The actual volume of the existing tanks is unknown, with recorded capacities between 45 and 57 m<sup>3</sup> per tank, but measurements on site suggesting a nominal capacity slightly over 60 m<sup>3</sup> per tank for a total nominal capacity of more than 120 m<sup>3</sup>. Record drawings show a different foundation system to the one installed.

It is recommended that the CRD pursue siting of replacement tanks within Mount Parke Regional Park. If it is desired to defer this work, upgrades to the coatings and foundations of existing tanks should be considered.

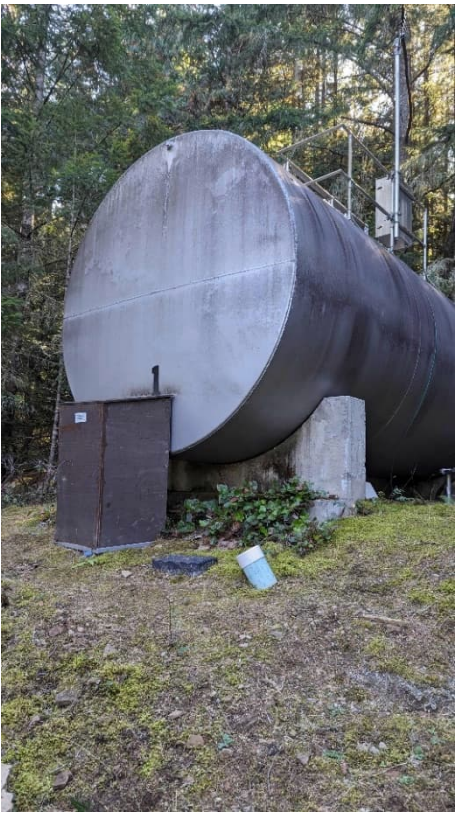
Figure A-5 Existing Reservoir

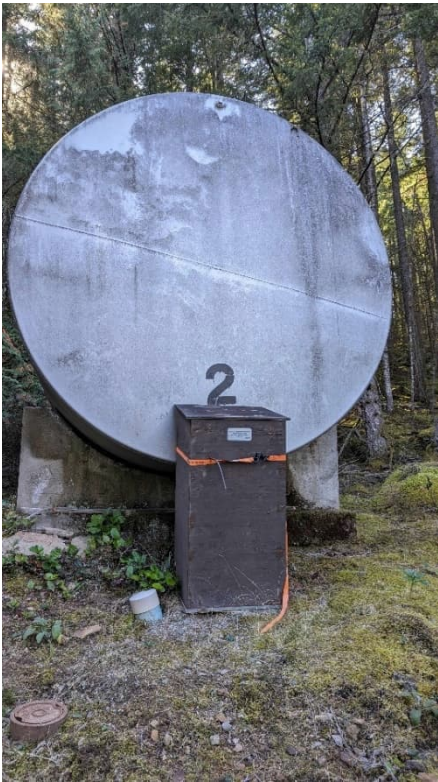
Figure A-9 Existing Reservoir #2

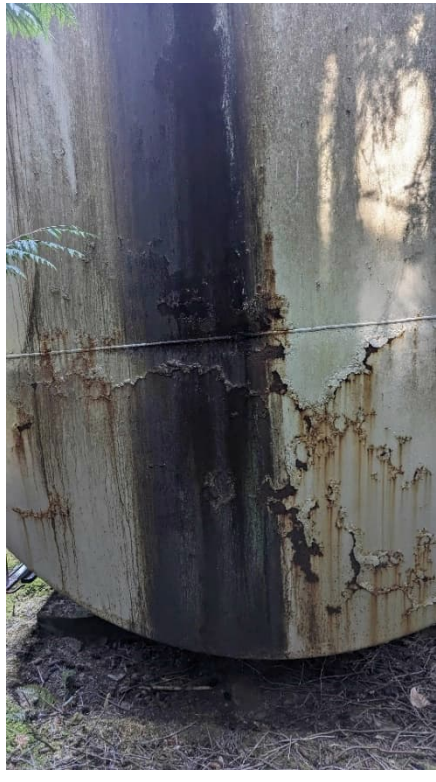
The existing cylindrical horizontal welded steel tanks have been identified as having significant corrosion and poor access for operation, and consideration of options for their replacement is required.

Figure A-31 Reservoir #2 Corrosion

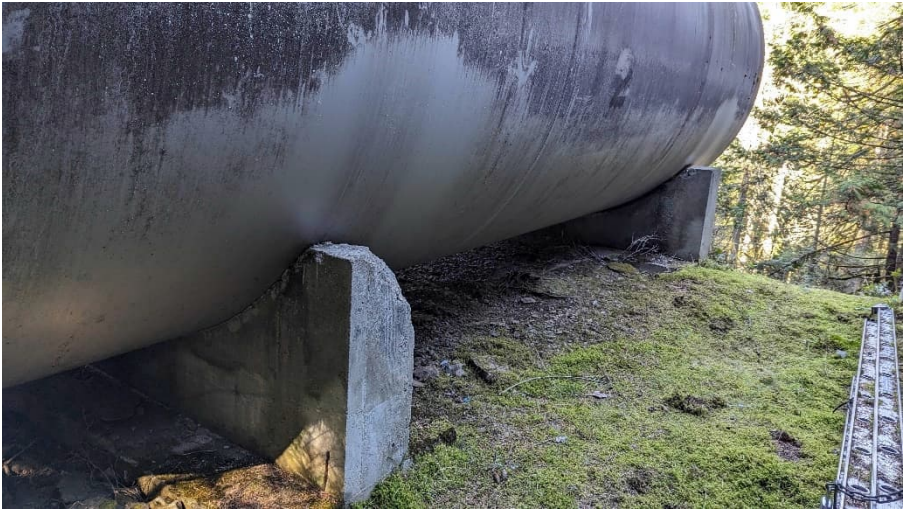
Figure A-13 Existing Reservoir Concrete Saddles
