April 28, 2023

Island View Beach Regional Park - Comparison of 2011 and 2022 Ditch Surveys

Figure 1: Ditch Overview Figure 2, 3: Ditch Profiles

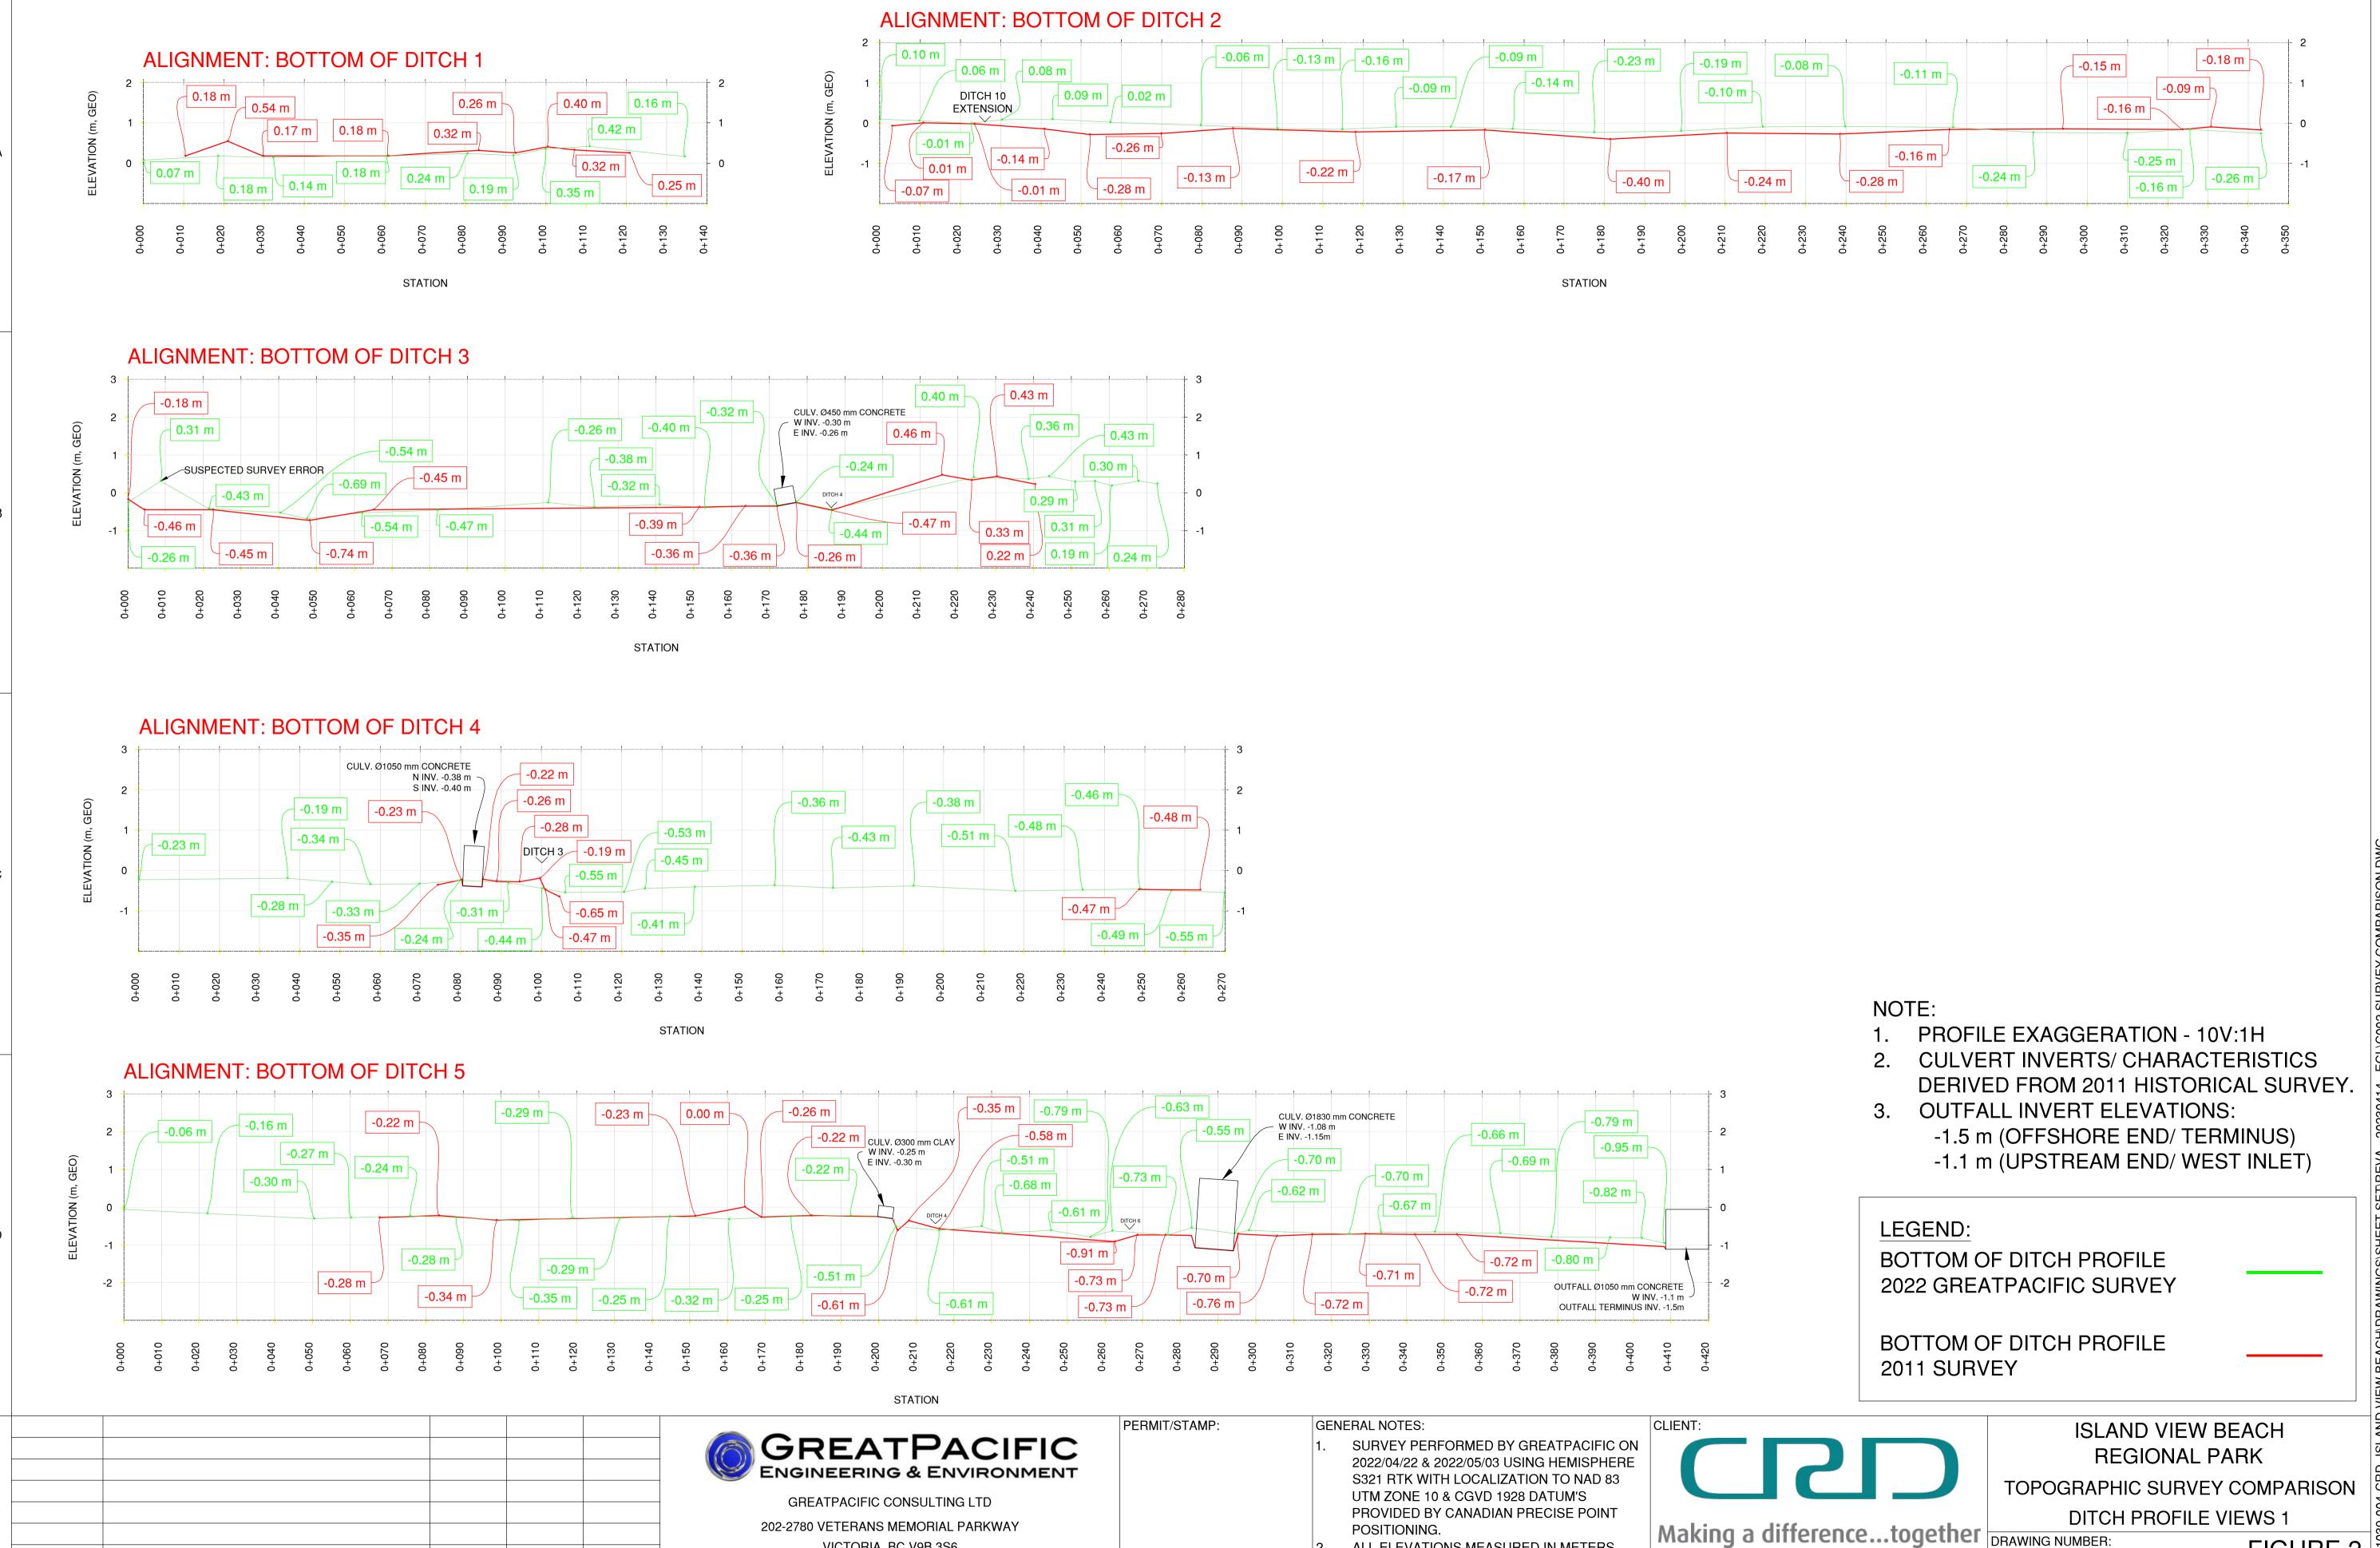
FIGURE 2

It was apparent in both surveys that there were areas of non-positive gradients towards the outfall, meaning there were depressions within the ditch channels. In some cases, depressions were lower than downstream culvert inverts, which are intended to drain the upstream areas. This could result in ponded water behind a culvert, below its pipe invert.
