## TECHNICAL MEMORANDUM

### Capital Regional District Mayne Island

### Skana Water Service Tank Replacement Options Analysis

APRIL 2025

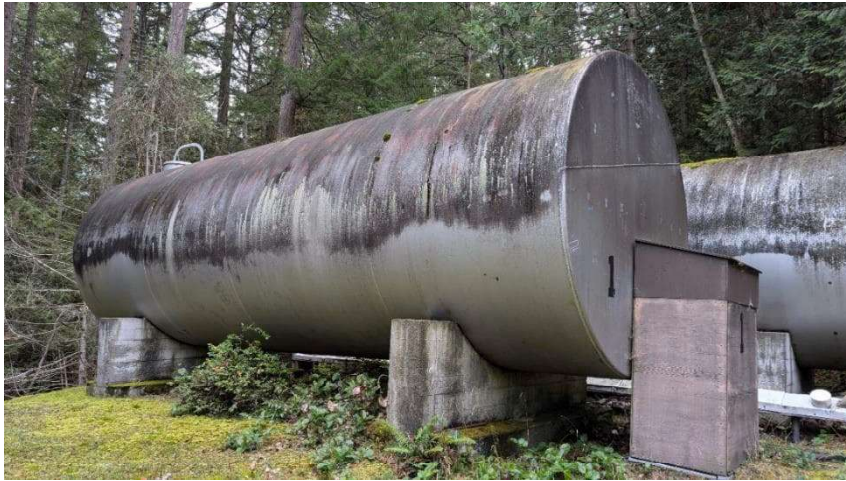
**Figure 2-2 Skana Water Storage Tanks**

Skana water treatment plant feeds a set of two gravity storage tanks which provide water at pressure, via distribution pipe. The existing horizontal cylindrical welded steel tanks have been identified as having significant corrosion. They are at the end of their 40-year lifetime and are not believed to meet post disaster seismic design requirements. Consideration of options for their replacement is required.

The tanks are located at an approximate elevation of 50 m. By gravity, a series of 100 mm PVC pipes supply water at a residual pressure reported to be up to 350 kPa (50 psi), to parcels along Waugh Road, Aya Reach Road, and Sandy Hook Road, at an approximate elevation of 20 m. The location of the existing Skana water system tanks is suitable for gravity storage tanks, and is accessible from Waugh Road, for ease of maintenance and operation requirements. The tanks were constructed in the 1970s and are constructed as horizontal steel cylinders, each supported on two concrete saddles. Tank 1 is shown in **Figure 2-2** with the second tank out of view behind it.

Associated observed the concrete saddles for Tank 1 (closest tank in **Figure 2-2**) to have settled and sitting at an angle 0.4° to 2.7° off of level. The tank walls are understood to be 6 mm thick based on measurements written on the outer tank wall as well as a 2016 assessment report.

The tanks contain low- and high-level float switches, which are used to control the production of water. The level switch wires are routed in the same raceway as the PVC pipe, as illustrated in **Figure 2-2**.

Based on this analysis, it is recommended that the CRD proceed with design and procurement of a pair of 46 m<sup>3</sup> shop-fabricated welded steel tanks with an epoxy coating. This option provides good operational flexibility at reasonable cost with the ability to conduct good quality control in a factory setting and minimize site disruption. Using paired tanks will allow the CRD greater flexibility in terms of ongoing operation and maintenance.

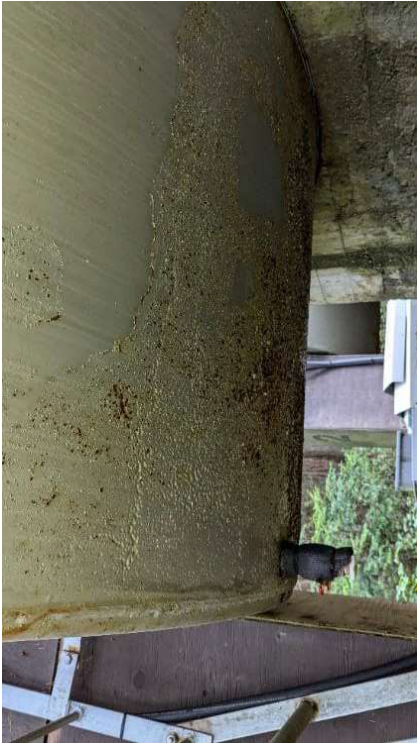
Figure B-2 Exterior Base of Tank 1

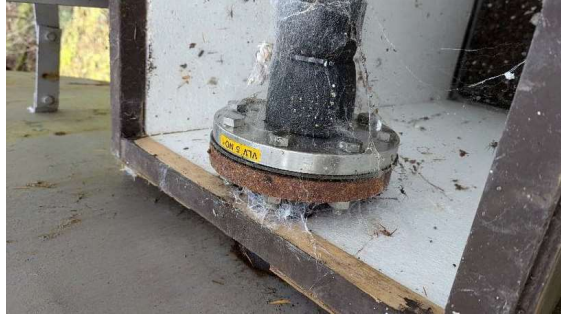
Figure B-4 Flange Connection/Corrosion

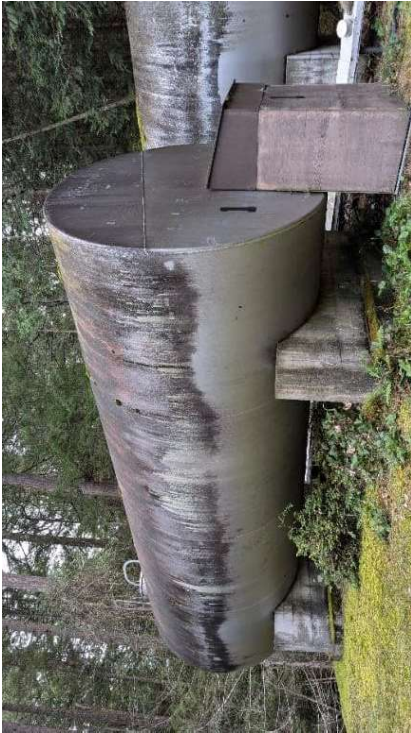
Figure B-1 Tank

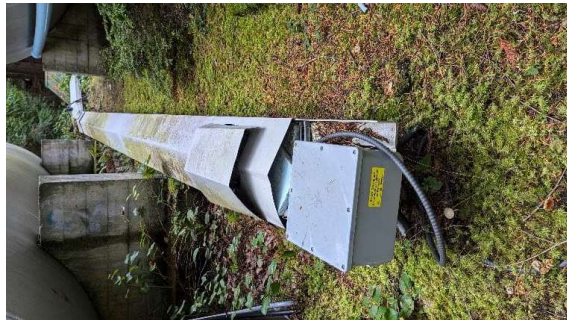
Figure B-3 Raceway Between Tanks

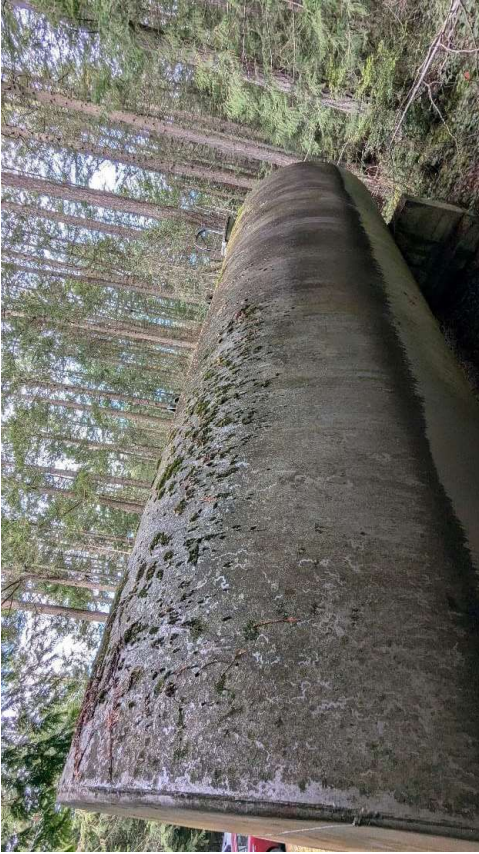
Figure B-6 Exterior Top of Tank

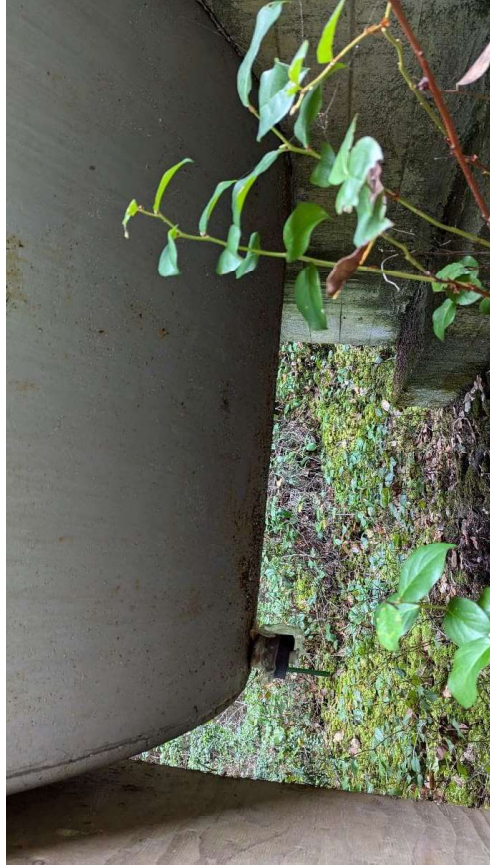
Figure B-8 Exterior Base of Tank 2

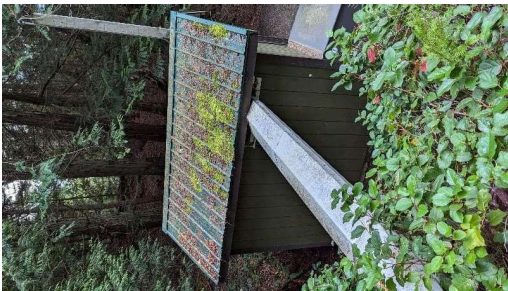
Figure B-5 Raceway to WTP

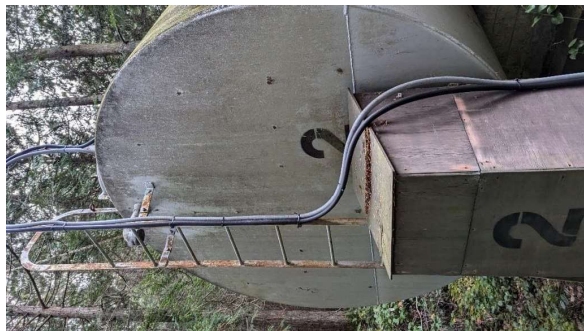
Figure B-7 Front of Tank 2
