**Centennial Park and Grace Point
Boardwalk Structural Assessment**

115602240

March 17, 2021

Capital Regional District
Salt Spring Electoral District

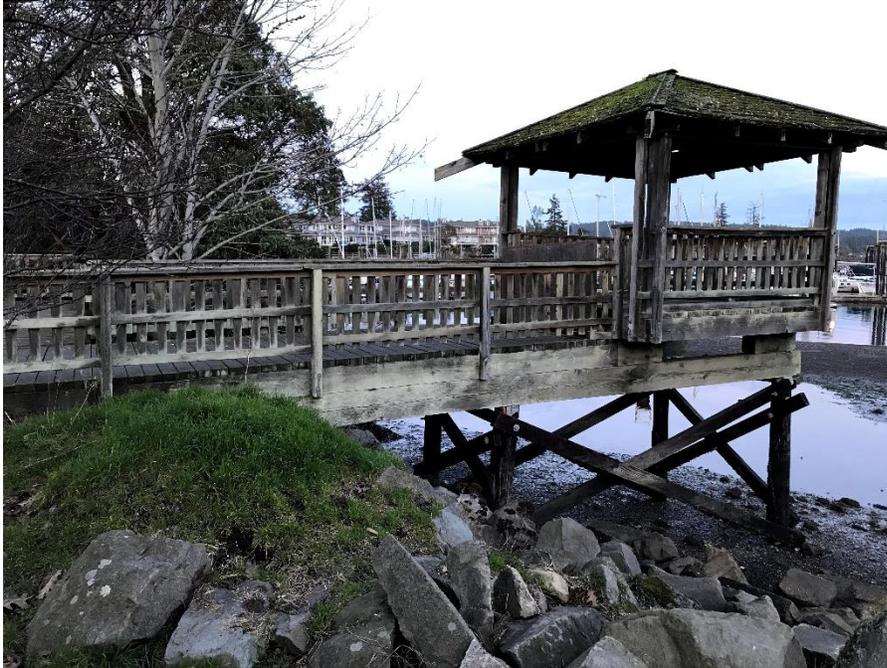
The over water gazebo consists of a cedar shake roof supported by 1x6 strapping at 8" on center. The strapping spans between 2x6 joists spaced at approximately 3' on center. The joists are supported by 4x10 beams spanning approximately 12', supported each end by 4x4 posts. All of the superstructure components appear to be rough sawn, pressure treated timber. The 2x6 ridge members extend past the soffit and are exposed to the weather. This has resulted in accelerated decay as seen in **Image 6 of Appendix A**. It is recommended that the outrigger portion of these ridge members are cut back to reduce any further decay. The cedar shake roof was found to be in poor condition, as seen in **Image 1 of Appendix A** and should be replaced.

Image 1 – Section 1: General view of Boardwalk approach and gazebo

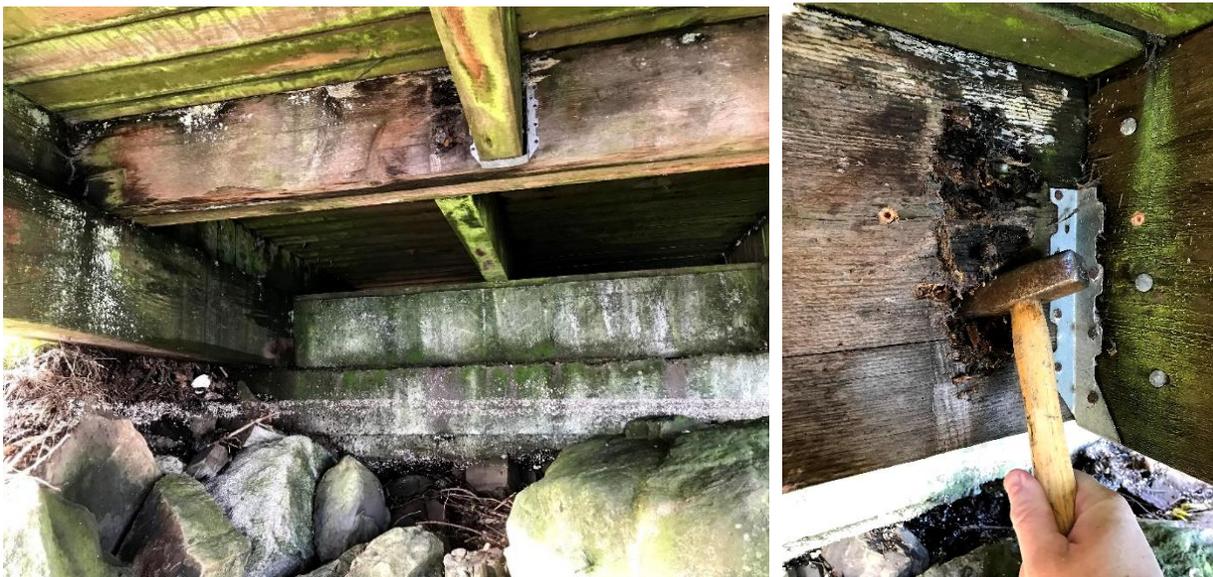
The stringers are typically 4x12 rough sawn, pressure treated members. The outside stringers sit directly parallel on top of the pile caps. The central stringers span approximately 10' supported with joist hangers by perpendicular 4x10 members. Minor organic growth is present on the stringers. Accessible stringers were sounded with a hammer and were found to be in fair condition as seen in **Image 2 of Appendix A**.

A concrete abutment is located at the south end of the approach. The concrete appears to have been cast directly on the existing soil and rock. This foundation has significant undermining as seen in **Image 2 of Appendix A**. This may be a result of wave action, at high tide, eroding the soil from below the footing. It does not appear that any remediations have been attempted for this foundation. Stantec recommends the extent of the concrete foundation is underpinned with cast-in-place, reinforced concrete. If possible, the concrete should be dowelled into the existing underlying rock.

Image 2 – Section 1: (a) Concrete abutment and (b) rotten member

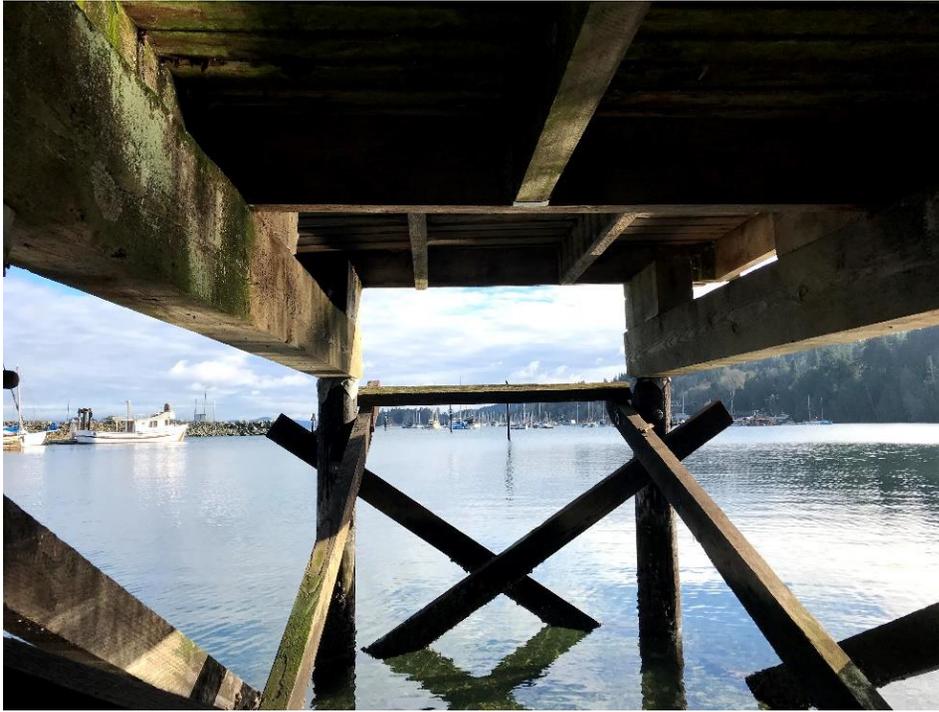
The pile caps are 2-span, 10x16 rough sawn, pressure treated members spanning approximately 16' between the piles and the concrete foundations, as seen in **Image 3 of Appendix A**. The pile caps appear to have been reused from a previous structure. Remnants of old drift pins were visible at the underside of the pile caps. Organic growth is present along the members and rot pockets were found in several locations under the approach section.

Image 3 – Section 1: General view of framing from underside of approach

Stantec recommends that both pile caps and the supported blocks are replaced. It is recommended that this work be completed at the same time as the deck and guard rail replacement to provide access for the replacement. It may be necessary/ cost effective to disassemble the gazebo structure in order to complete this replacement and the end beam replacement recommended in **Section 3.1.1.8**.

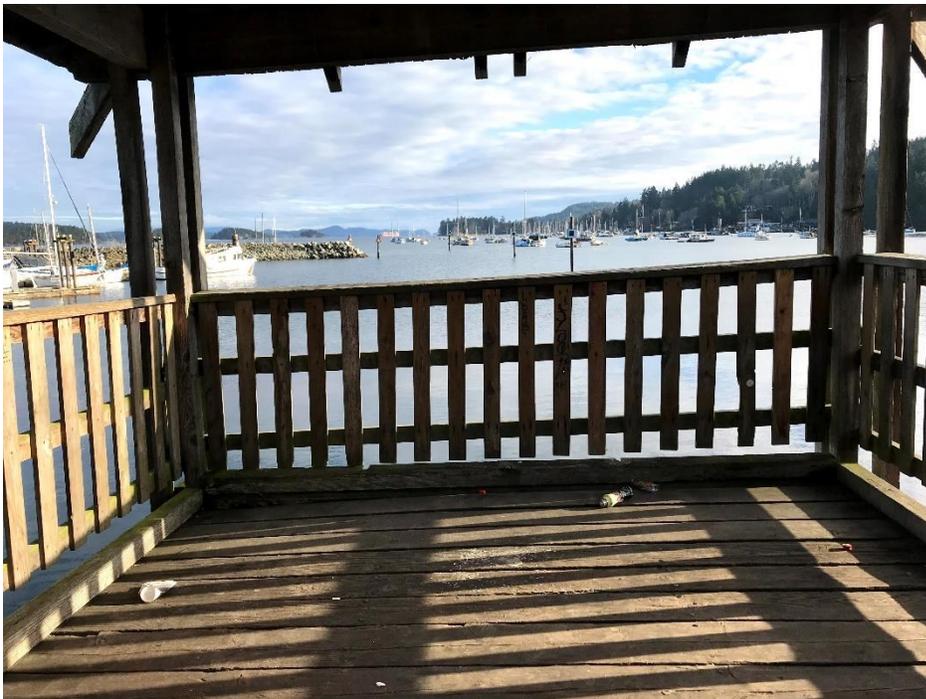
This portion of boardwalk is located furthest to the south-west and is generally open to the public; however, the boardwalk gazebo is currently blocked off due to safety concerns. Ryzuk reviewed this section of the Centennial boardwalk as part of the 2009 assessment but the gazebo superstructure was not included in their review. Currently the gazebo is listing to the north due to a failing member.

Image 4 -Section 1: General view of gazebo structure listing to the left

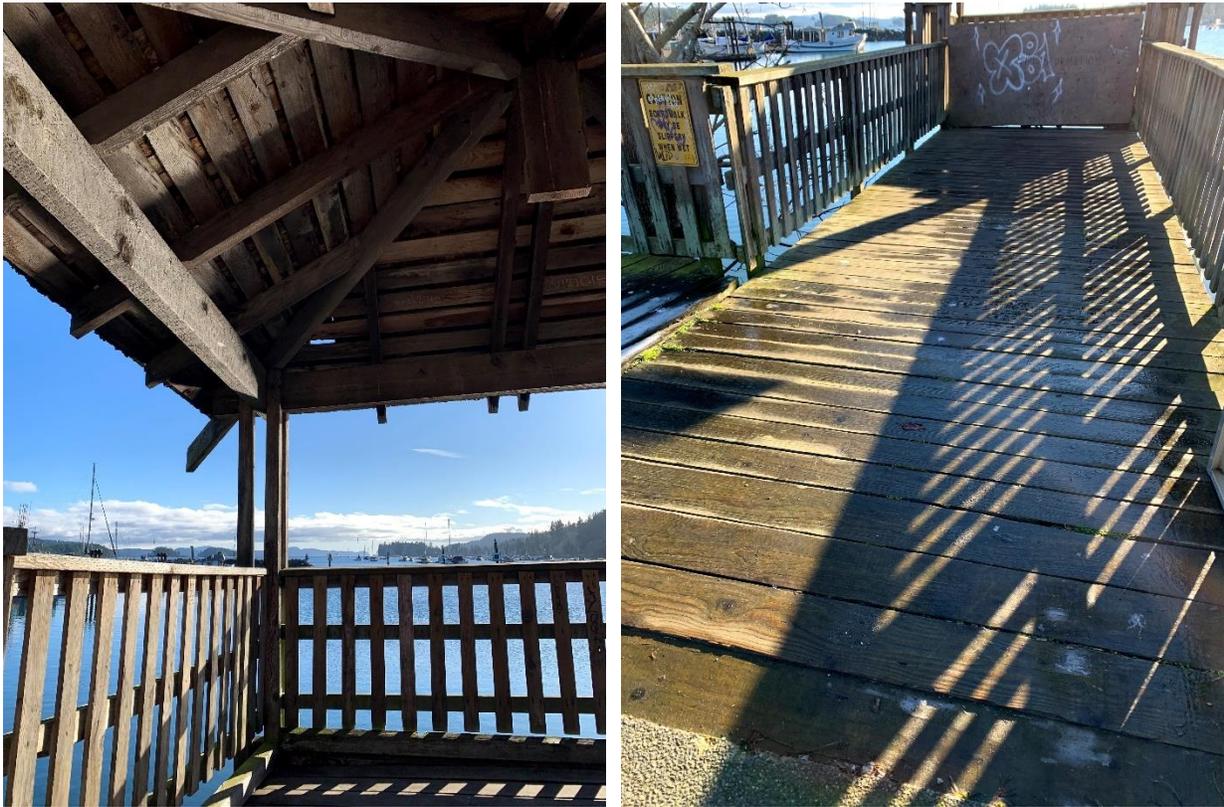
The approach decking is comprised of 3x6 rough sawn, pressure-treated boards, spanning approximately 4', supported by stringers. A considerable amount of the deck was found to have rot pockets and splitting and appeared to be in generally poor to fair condition as seen in **Image 5 of Appendix A**. Based on site observations, the current

Image 5 – Section 1: (a) General view of gazebo superstructure (b) General view of decking and guardrail

decking is approaching end of life; therefore, Stantec recommends that the deck boards be replaced within the next year.

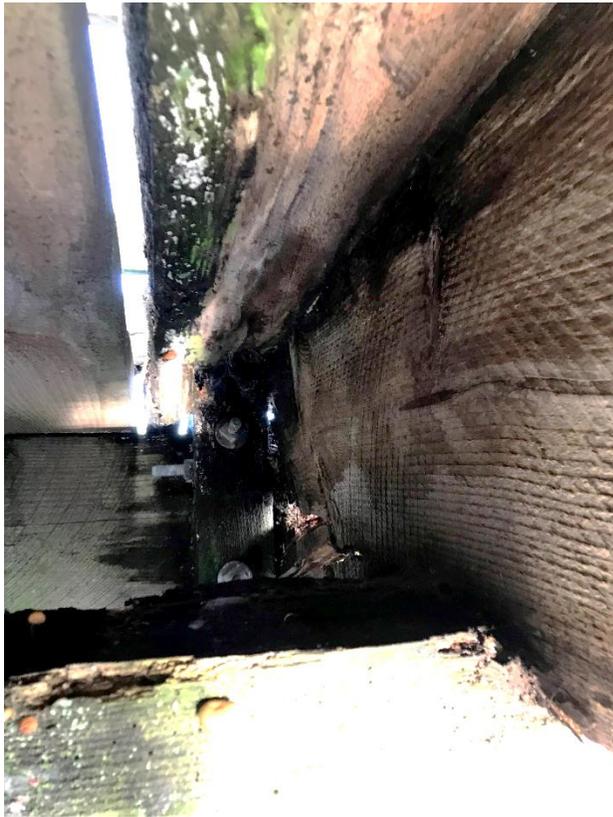
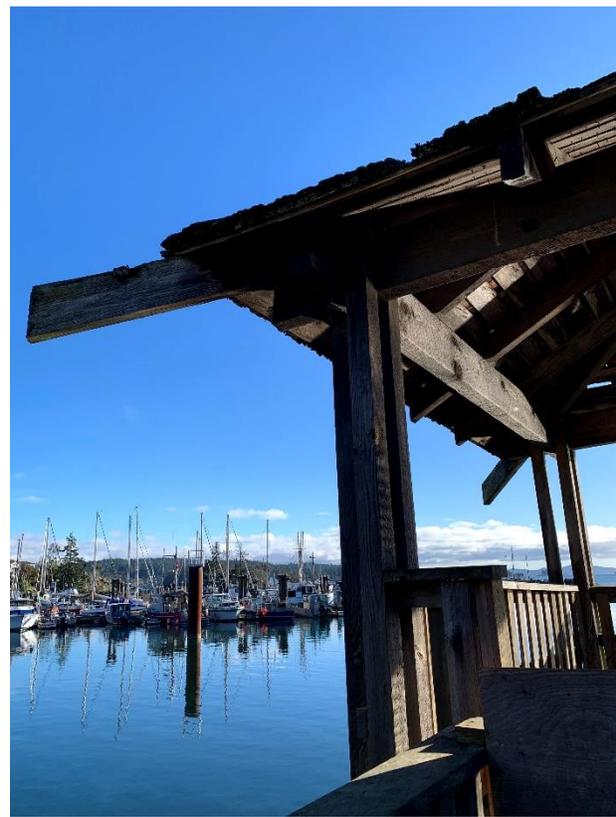
The gazebo floor consists of 3x8 deck boards spanning approximately 4' supported by 4x12 stringers. The stringers are supported by perpendicular 4x12 beams. The stringers appear to be connected to the beams with a minimum of two lag bolts. The beams span approximately 12', supported by 10x16 blocks bearing on the 10x16 pile caps below. All of the substructure components appeared to be rough sawn, pressure treated timber. The beam on the east side is in very poor condition and appears to be severely rotten where it bears on the block below (visible in **Image 6 of Appendix A**). This failing beam has caused the entire gazebo structure to list to the north as seen in **Image 4 of Appendix A**. Due to the construction of the gazebo floor, failure of this beam will likely cause a partial or complete collapse of the gazebo structure. Stantec recommends that this beam be replaced immediately.

Image 6 - Section 1: (a) Failing edge beam in very poor condition (b) General view of 2x6 outrigger in poor condition.

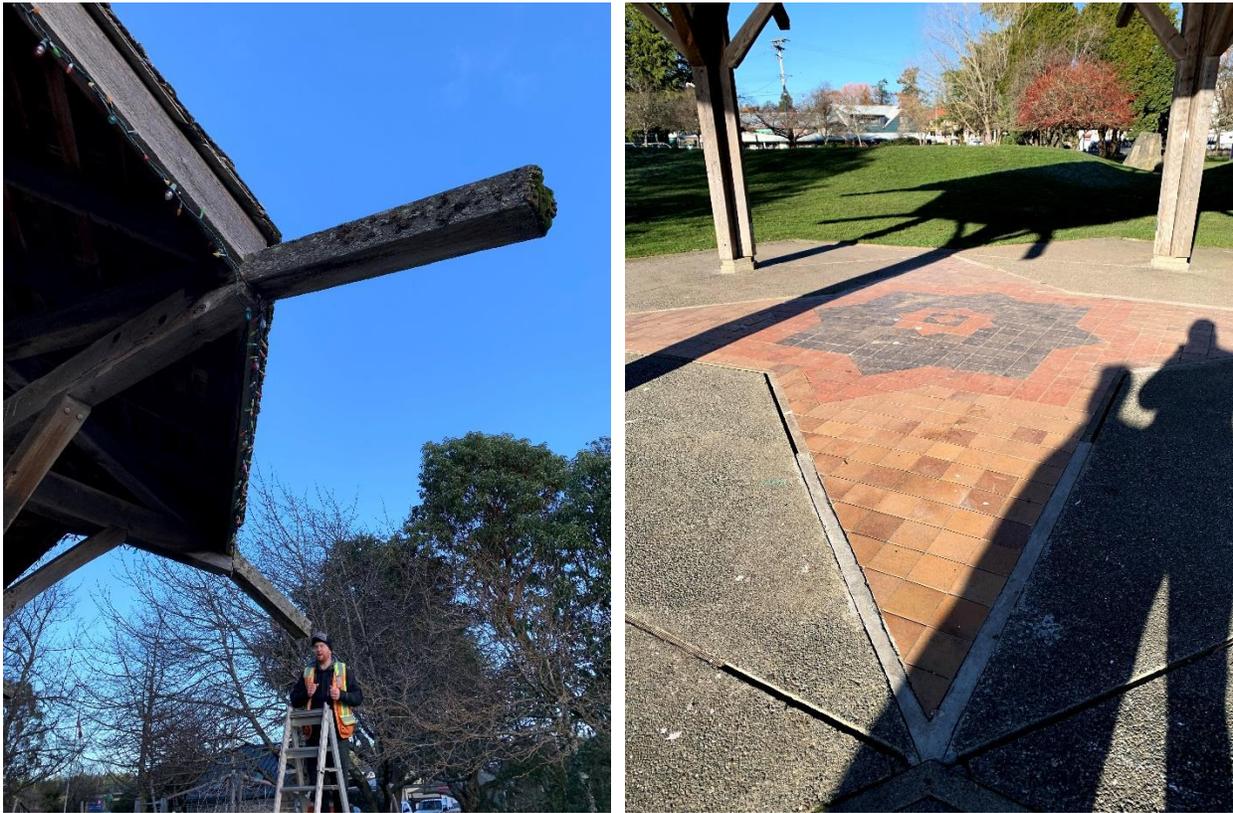
The outriggers are extensions of the 6x6 upper beams and are not supporting any structure. However, during the site review it was found that moisture is being drawn up the beam from the exposed outrigger. If this condition is left to continue the portions of the beams supporting the structure will begin to decay at an accelerated rate. In order to avoid any further deterioration, Stantec recommends that the outriggers be cut back flush with the roof. The ends of the 6x6 beams are recommended to be protected with flashing to avoid any further water damage.

Image 8 - Section 2: (a) General view of outrigger in poor condition (b) General view of concrete slab

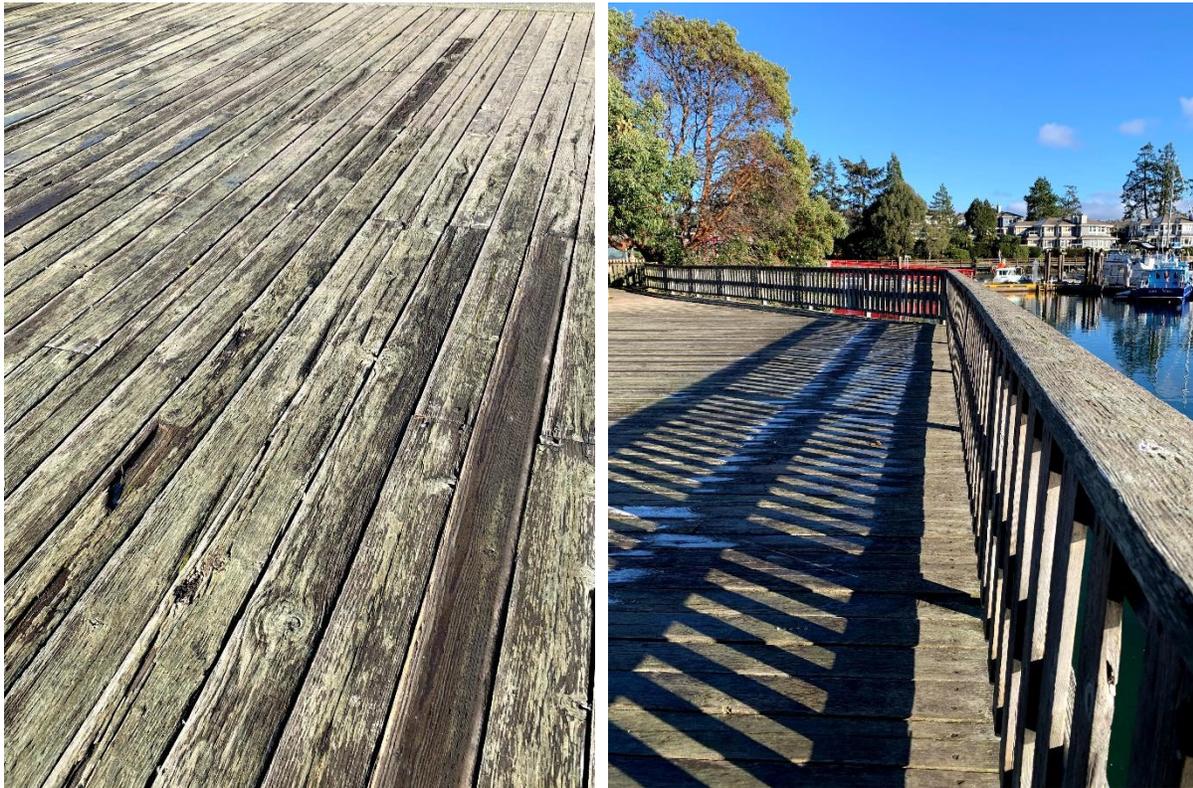
Image 10 - Section 3: (a) Typical condition of boardwalk deck (b) General view of guardrail (note: guardrail leans outwards)

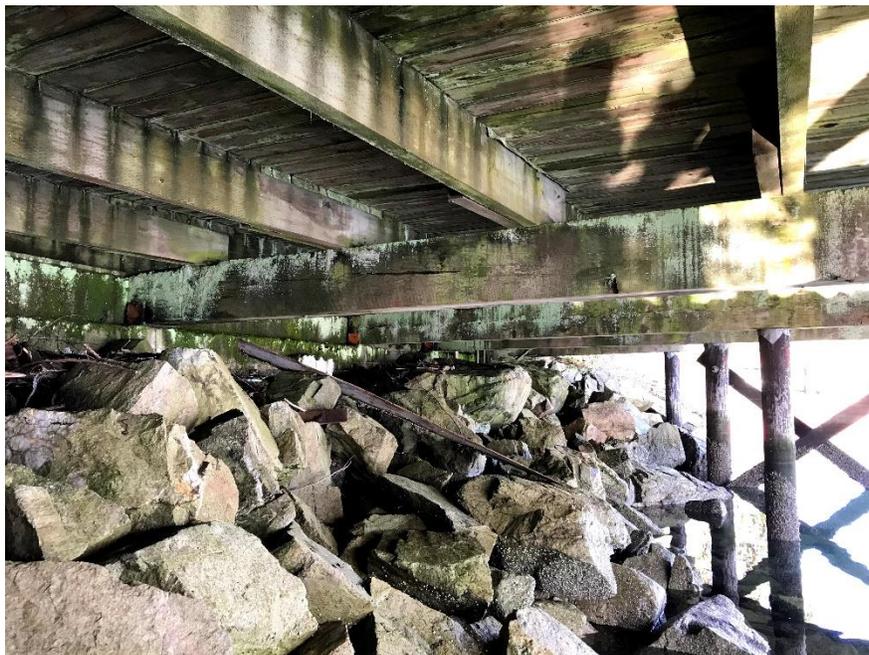
The pile caps are typically rough sawn, pressure treated 10x16 members spanning a maximum of approximately 17' between the piles and concrete strip footings as seen in **Image 11** of **Appendix A**. The pile caps appear to have been reused from a previous structure. Remnants of old drift pins were visible at the underside of the pile caps. There is minor organic growth on the pile caps. In accessible locations, the pile caps were sounded with a hammer and appeared to be in fair condition.

Image 11 - Section 3: General view at underside of pile supported boardwalk

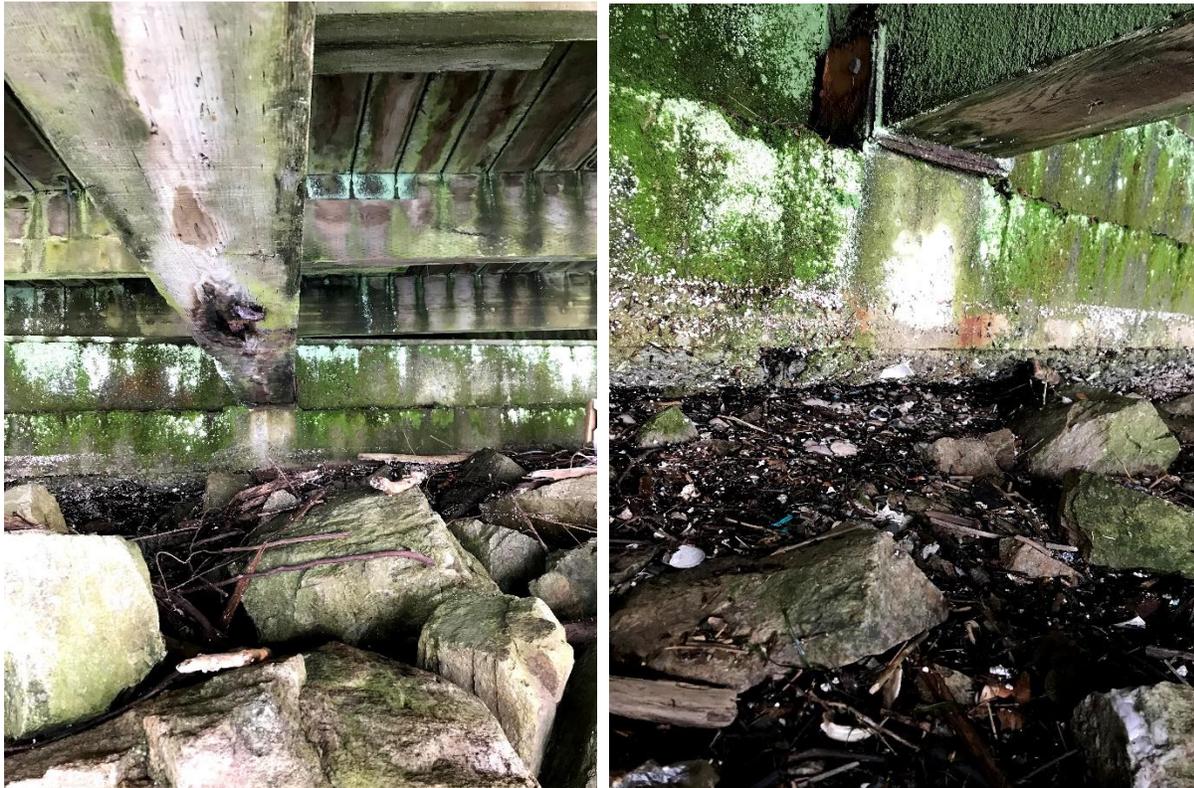
Image 12 - Section 3: (a) View of 10x16 pile cap with areas of rot at underside (b) Typical view of undermined footing

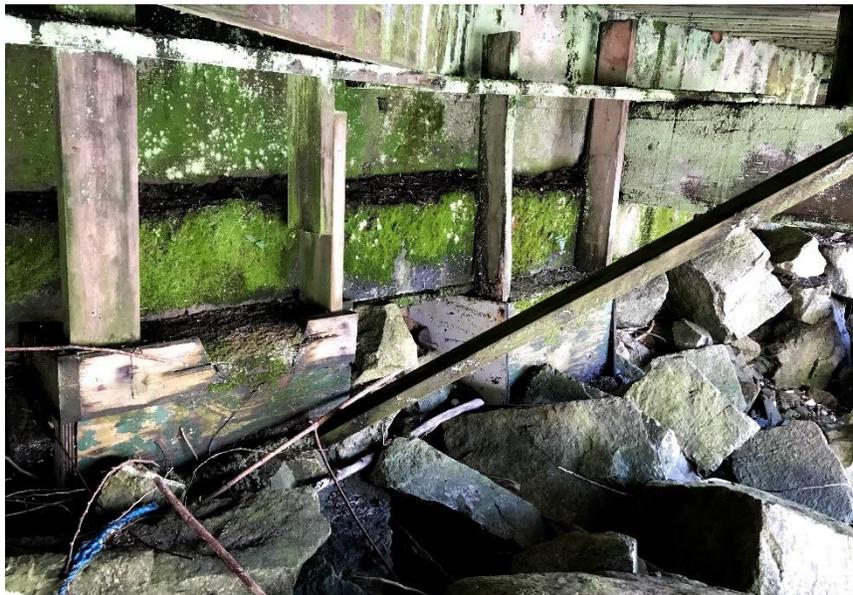
During the review, it was observed that recommended measures to mitigate the undermining were completed since the 2009 Ryzuk review as seen in **Image 13** in **Appendix A**. However, undermining has continued in several locations. Stantec recommends that further underpinning of the foundations be completed by installing cast-in-place, reinforced concrete. If possible, this concrete should be dowelled into the underlying rock. In order to avoid any future undermining, Stantec recommends that additional rip rap be added below the boardwalk structure to reduce wave action against the foundation.

Image 13 - Section 3: General view of previous foundation underpinning and formwork still in place

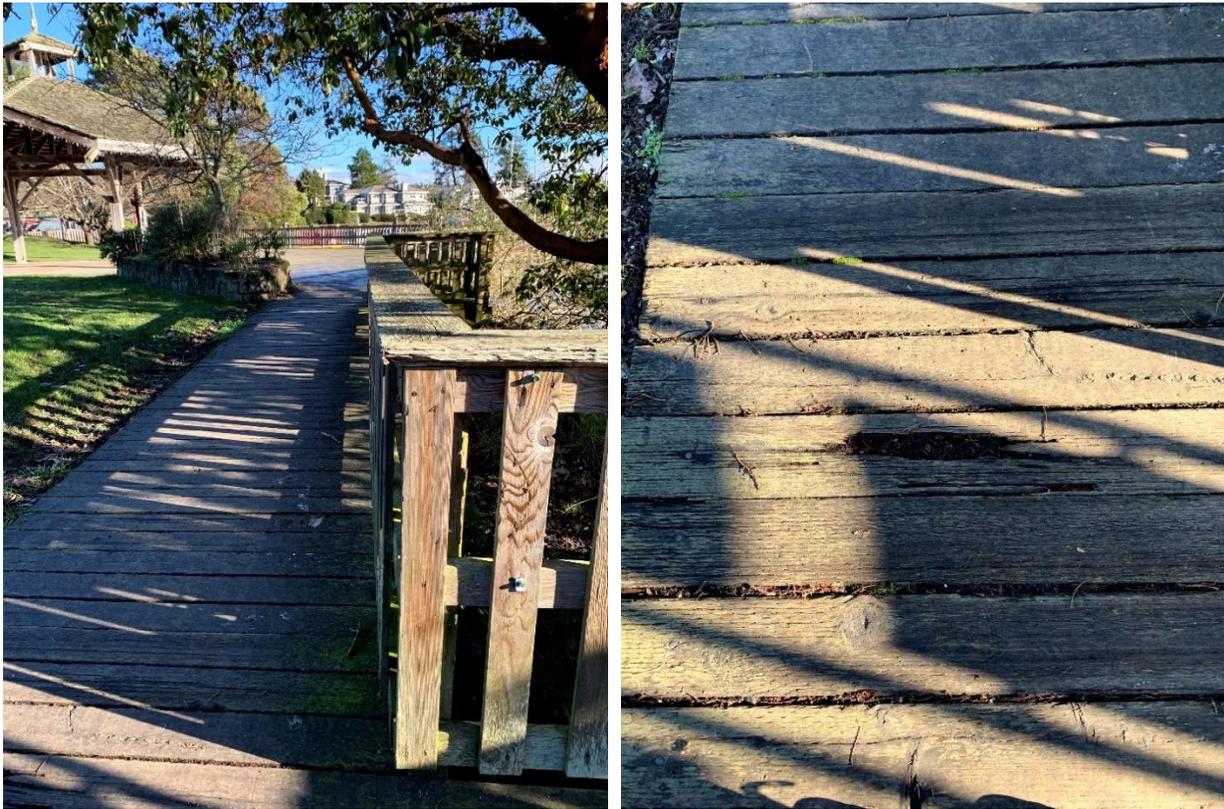
Image 14 - Section 4: (a) General view of boardwalk at grade (b) Typical condition of decking

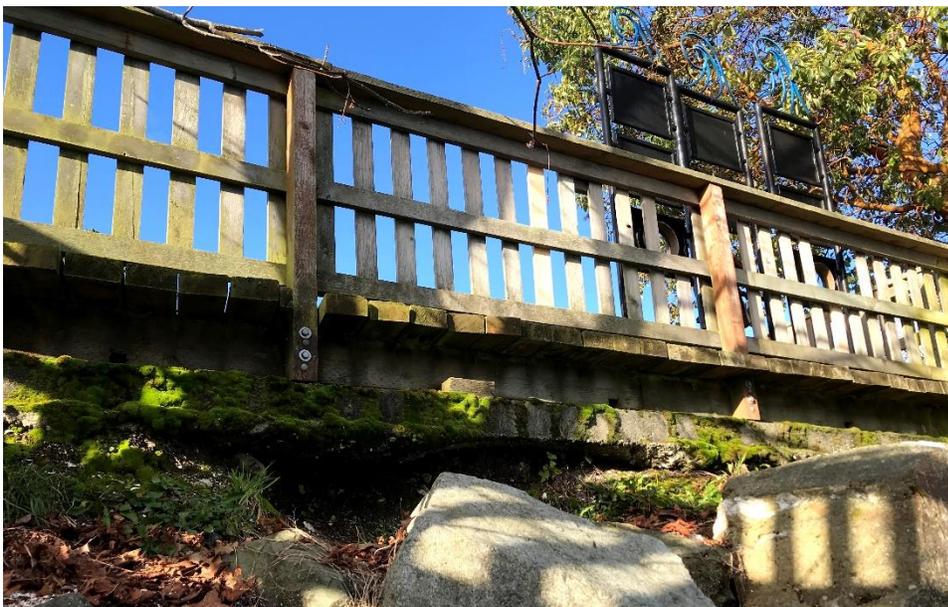
During the site review, Stantec assessed the visible portion of the east concrete strip footing. It was found that the footing is severely undermined in several locations, as shown in **Image 15** and **Image 18** of **Appendix A**. The footings have likely been undermined by erosion. It is suspected that the high tide line is below the underside of these foundations.

Image 15 - Section 4: General view of undermined foundation

Due to the current condition of the deck boards and the undermined concrete foundations, it is Stantec's opinion that a full replacement of these portions of boardwalk on grade is preferable to repair. Undermining of the foundation in these sections is very severe and the condition of the concrete looks to be poor. New reinforced, concrete foundations should be constructed at the appropriate depth to avoid undermining in the future. Where possible, these foundations should be concrete pier foundations drilled and dowelled to the existing bedrock.

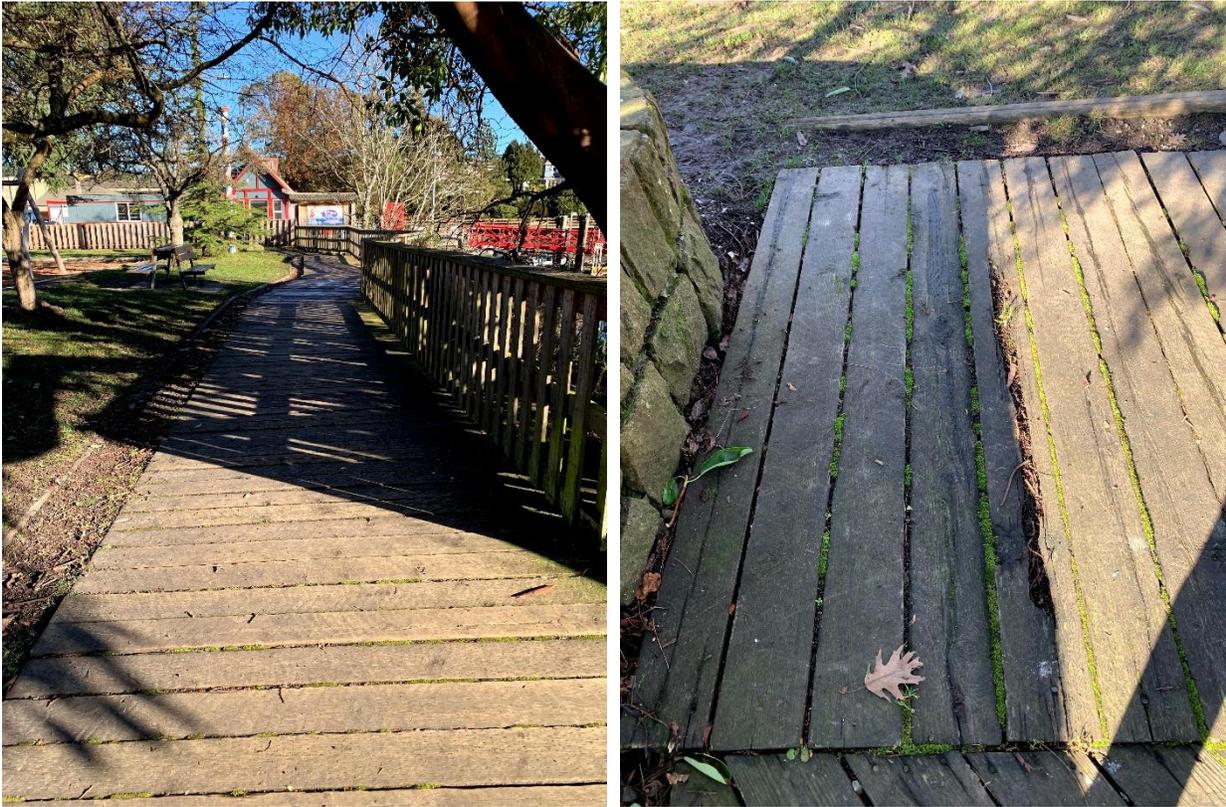
Image 16 - Section 5: (a) General view of boardwalk at grade (b) Typical condition of boardwalk decking

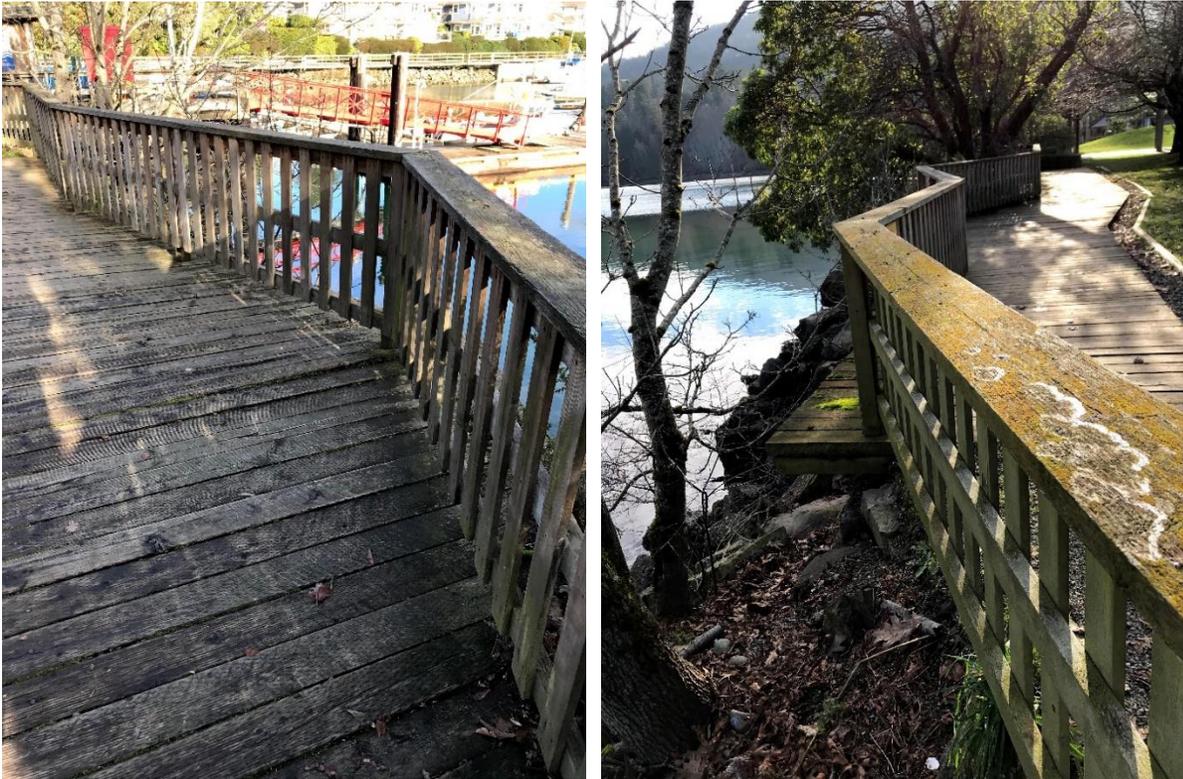
Image 17 - Section 5: (a) Uneven deck due to unstable concrete footings below (b) General view of guardrail

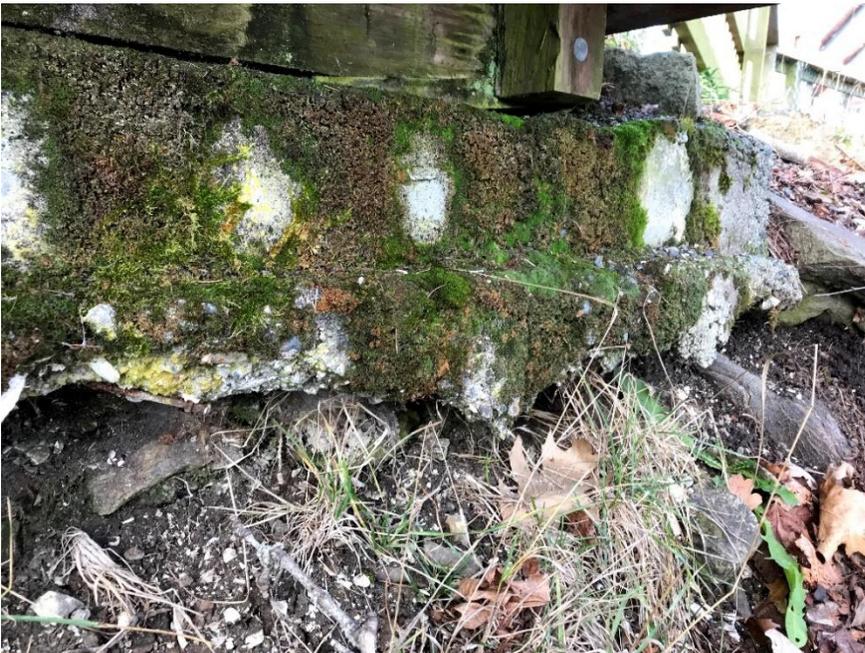
Image 18 - Section 5: Significant undermining of concrete strip footing

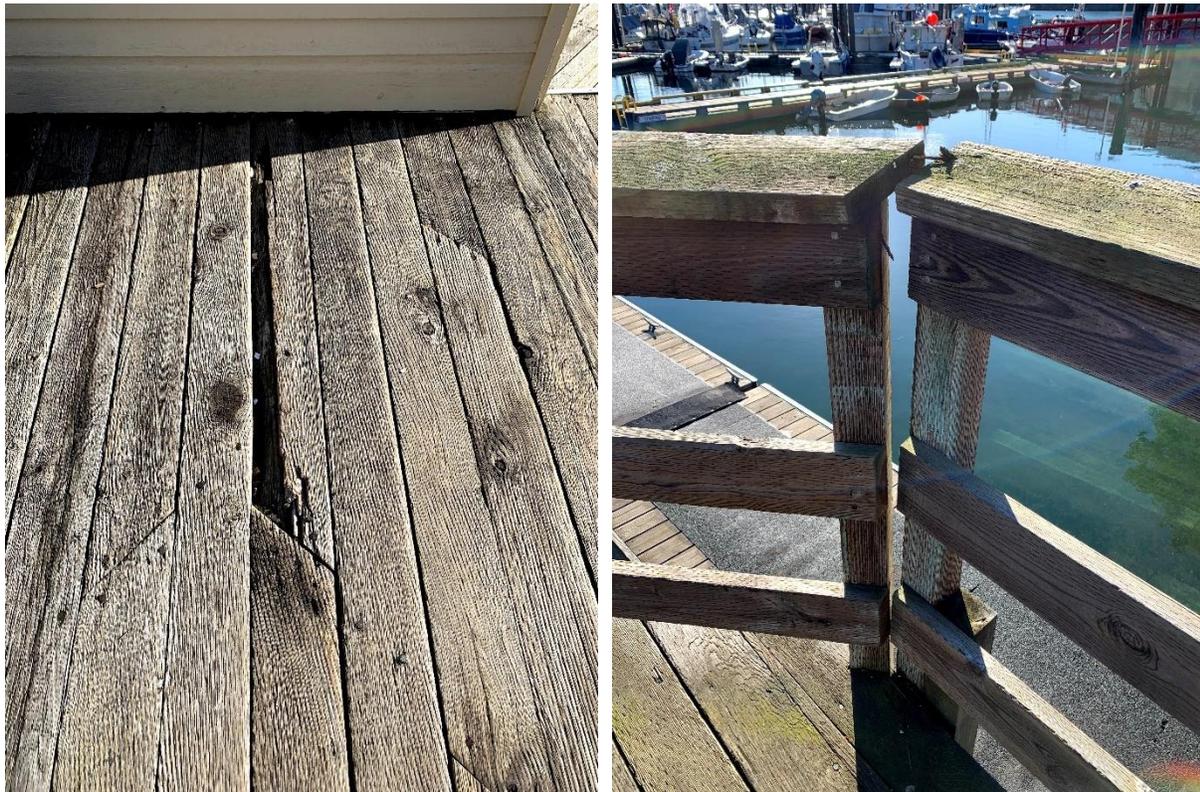
The decking was found to be in generally fair condition; however, several boards appear to be in poor condition as seen in **Image 21** of **Appendix A**. Stantec estimates that approximately 10% of the decking will need to be replaced within the next year, with the remainder recommended for replacement in the next 5 years. Due to the deck supporting the partial height walls above, the walls will likely need to be removed for the full deck replacement. The decking should be inspected annually, as part of regular maintenance, and any boards found to have major splits or rot pockets should be replaced. Nails that are found to be proud should be sunk down to reduce tripping hazards.

Image 21 - Section 6: (a) Deck board in very poor condition (b) Guardrail, typical for extent of boardwalk (note: repair required at corner)

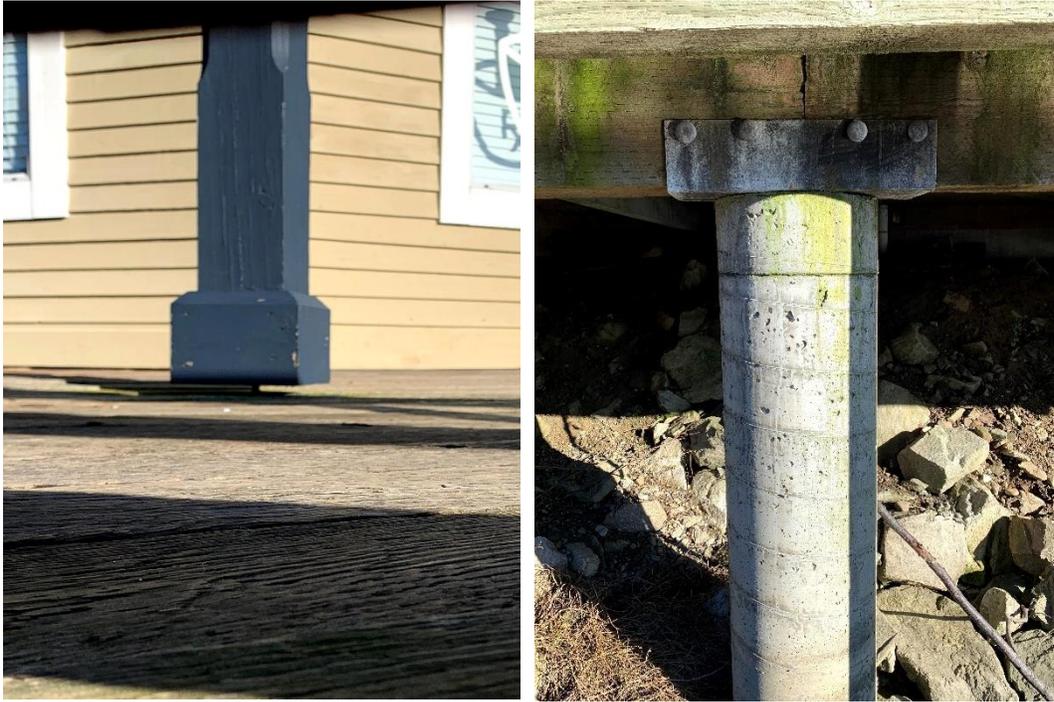
Image 22 - Section 6: Wood column, no support below deck (b) Concrete pile footing (2 total)

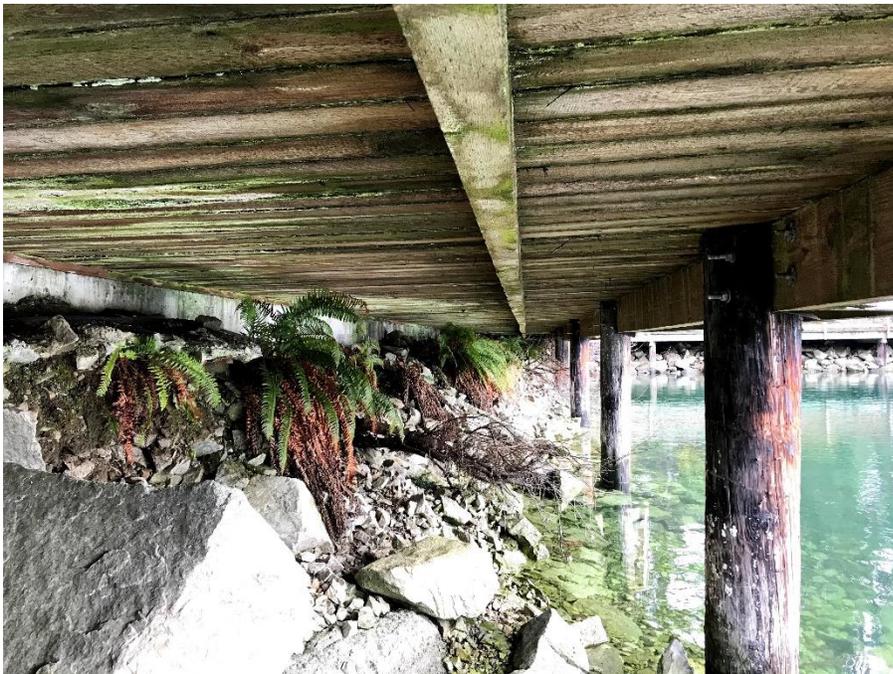
The pile caps are full dimensional pressure treated 6x12 members spanning approximately 10' between the piles, as seen in **Image 23** in **Appendix A**. The piles are notched to support the pile caps. At the west end of this portion of boardwalk, the timber stringers are supported by the pile caps with structural steel hangers. There is minor organic growth on the pile caps. At several locations the pile caps were sounded with a hammer were found to be in good condition.

Image 23 – Section 6: General view of boardwalk framing from underside

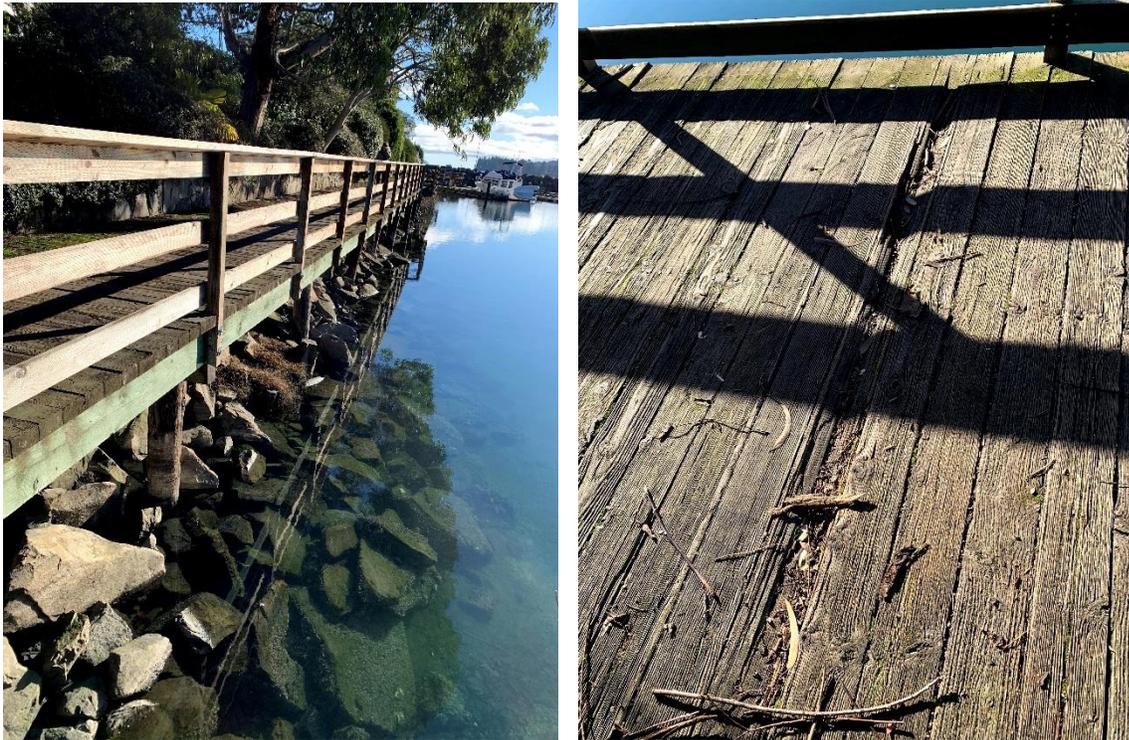
The decking appears to generally be in fair condition; however, Stantec estimates that approximately 10% of the deck boards are in very poor condition and require immediate replacement (as seen in **Image 26** of **Appendix A**). The decking should be inspected annually, as part of regular maintenance, and any boards found to have major splits or rot pockets should be replaced. Nails that are found to be proud should be sunk down to reduce tripping hazards.

Image 26 - Section 7: (a) General view of boardwalk (b) Deck boards in very poor condition

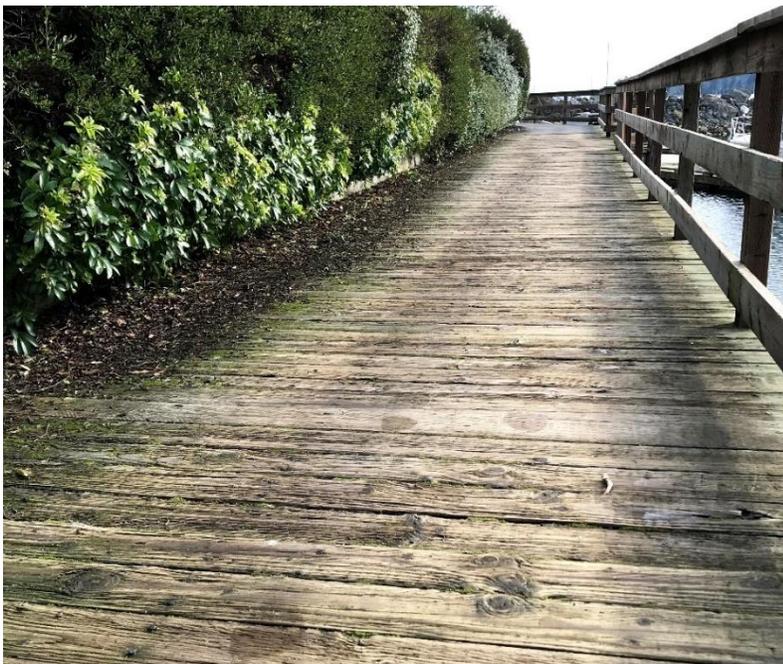
Image 27 - Section 7: Bushes overhanging deck, fallen organic matter is contributing to accelerated decay of the deck boards

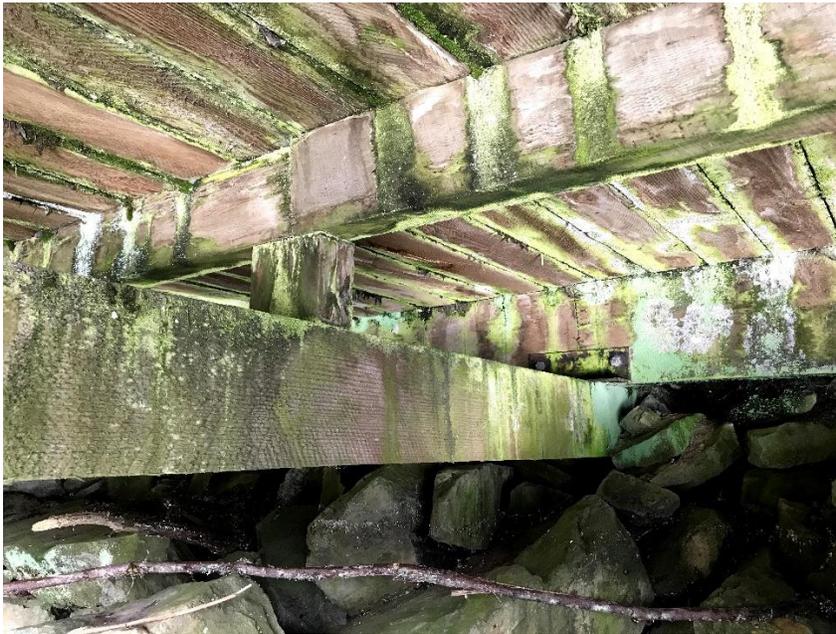
Image 30 - Section 7: View of central support, Stringer support condition unknown at north end
