March 18, 2016

Reference No. 1544314-002-L-Rev0

## ISLAND VIEW BEACH REGIONAL PARK BOAT RAMP RESTORATION ASSESSMENT

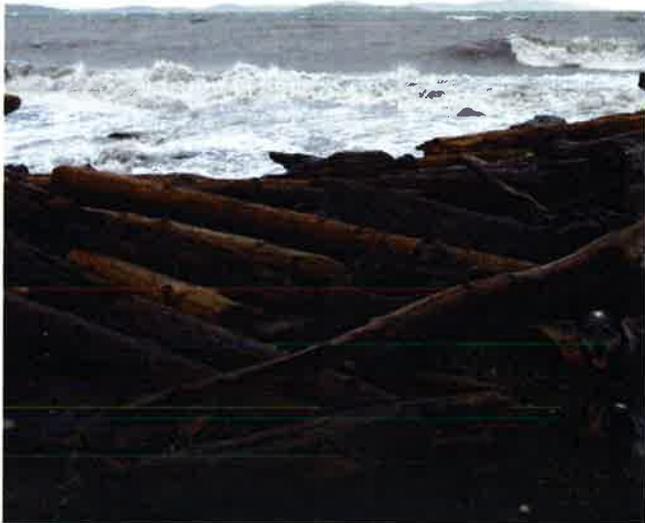
*Photograph 1: Image taken facing east along the boat ramp on December 3, 2015*

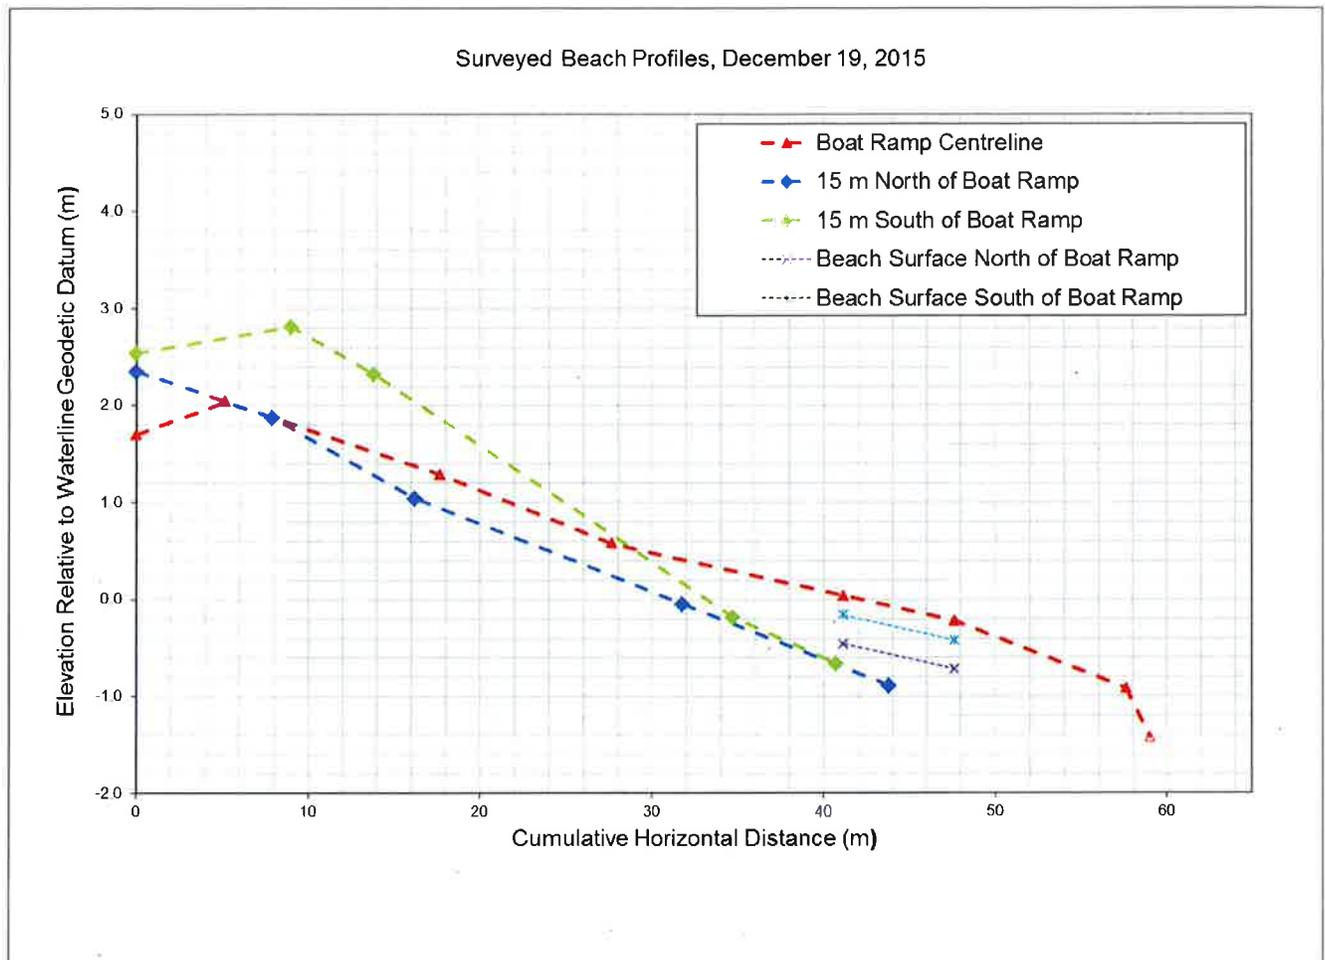
Figure 3: Surveyed beach profiles taken on December 19, 2015

The cross shore profiles indicate that the beach to the south of the boat ramp (green line, Figure 3) is higher than the beach to the north of the boat ramp (blue line, Figure 3) across the surveyed section of the shoreline. The difference in elevation varies between approximately 0.1 m and 1.1 m with an average of 0.6 m. The change in elevation is consistent with the trapping of beach sediment on the updrift side of an obstacle and erosion on the downdrift side of an obstacle. Along this shoreline updrift is to the south and downdrift is to the north. The boat ramp is lower than the beach to the south through the upper foreshore for a distance of approximately 28 m (red line, Figure 3) and higher through the intertidal zone. This appears to be related to the accumulation of woody debris south of the boat ramp. The boat ramp is higher than the beach to the north except landward of the boat ramp crest and the area of woody debris accumulation. This appears to be related to erosion of the downdrift shore. At approximately mean sea level, the boat ramp lies proud of the beach surface, approximately 0.3 m higher than the beach to the south (light blue line, Figure 3) and approximately 0.5 m to the north (light purple line, Figure 3). This implies that the boat ramp acts as an obstacle to longshore transport.

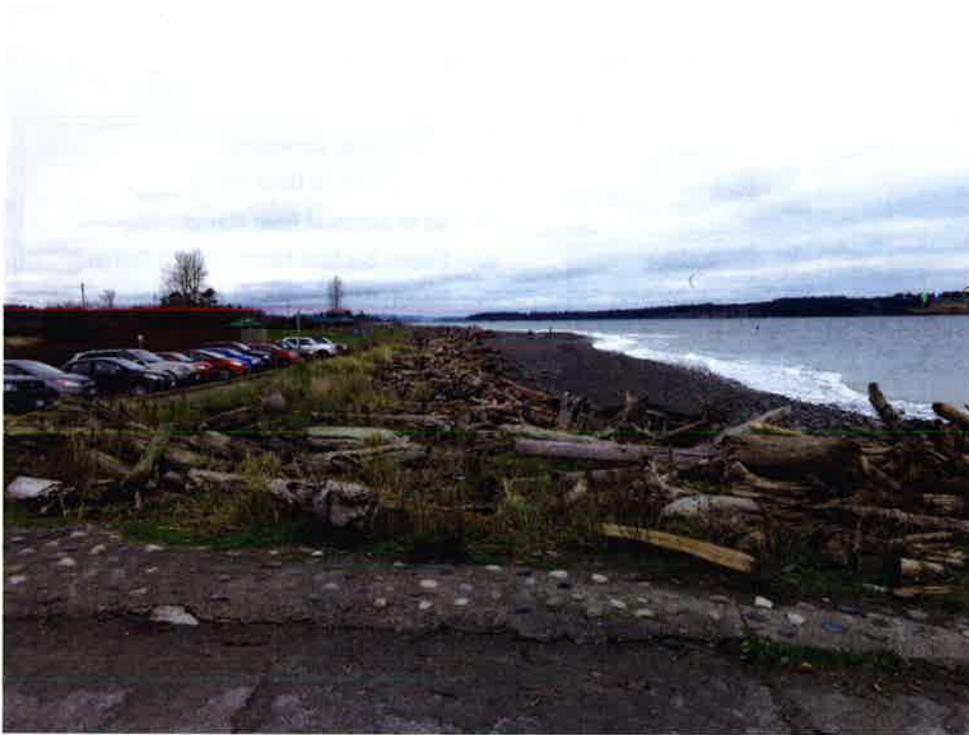
*Photograph 2: Image taken facing north from the crest of the boat ramp on December 19, 2015*

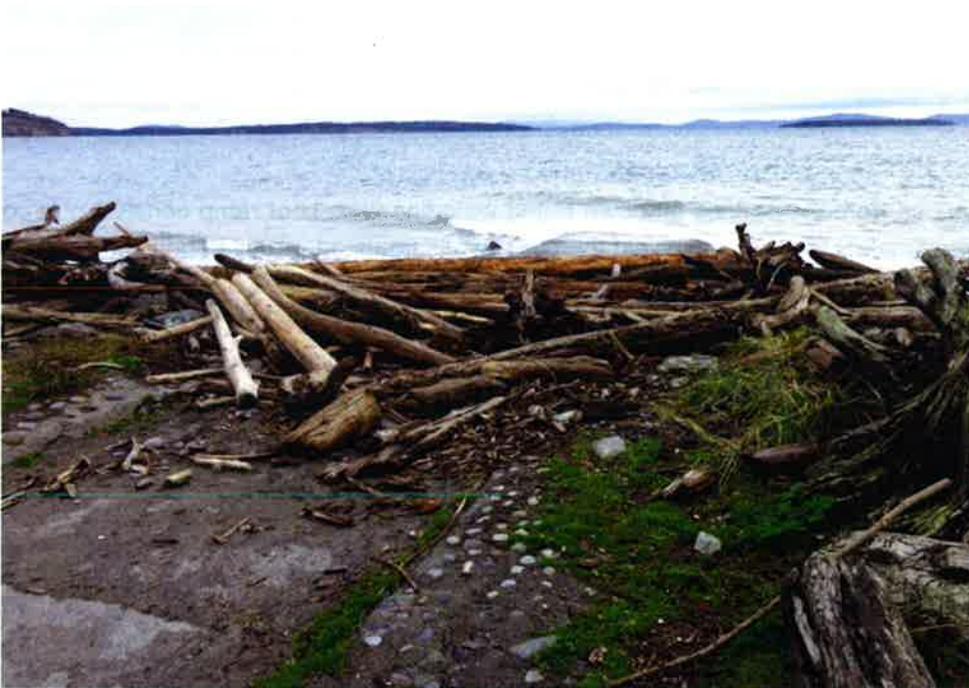
*Photograph 3: Image taken facing east on December 19, 2015*

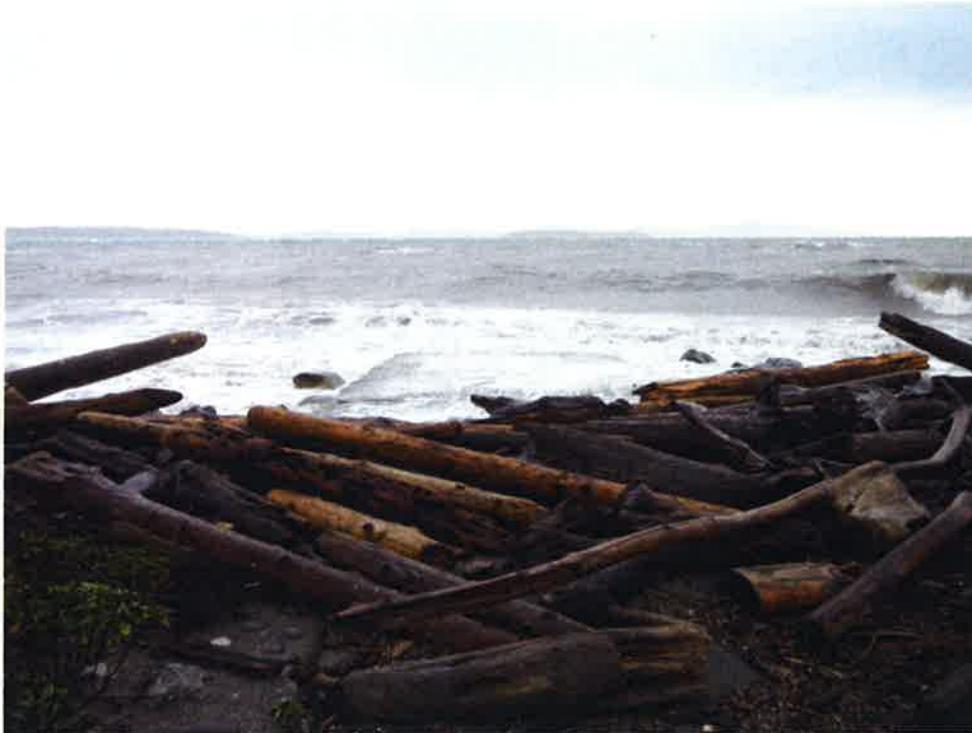
*Photograph 4: Image taken facing east on December 3, 2015.*

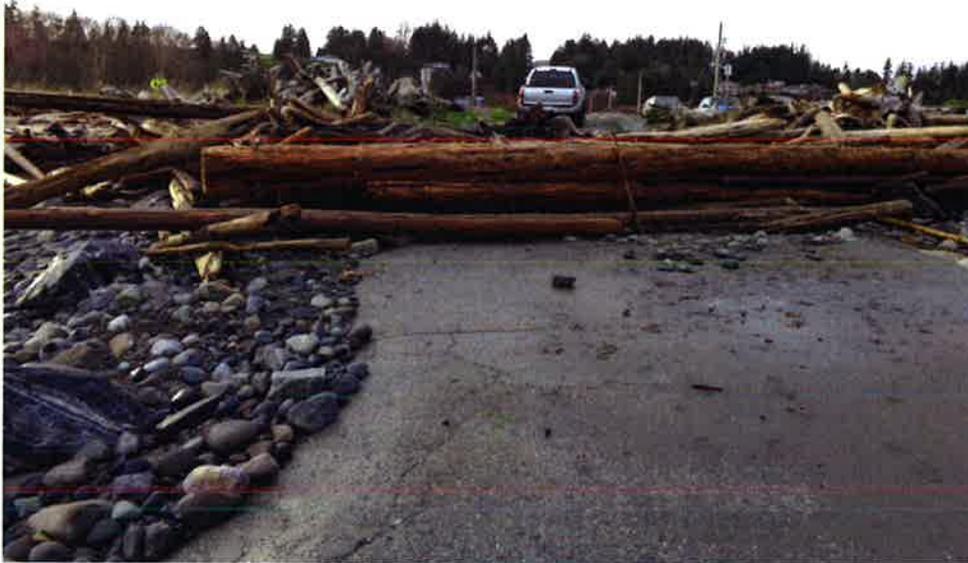
The boat ramp beyond the woody debris slopes seaward at a typical gradient of 4% to 5% (Photograph 5). The boat ramp is approximately 5 m wide and extends seawards from the area of woody debris accumulation for at least 30 m (e.g., Photograph 3). The seaward end of the boat ramp was not observed during the site visit; however, subsequent review of available satellite imagery (GoogleEarth™, image date June 7, 2015) indicates that the boat ramp extends approximately 59 m offshore of the parking lot and the survey extended approximately 58 m offshore of the parking lot. Probing with a rod beyond the furthest point surveyed indicated a drop-off of approximately 0.5 m at the end of the boat ramp to the surrounding seabed. This drop off has been included in Figure 3 as a hollow red triangle. These survey data place the seaward end of the boat ramp at an elevation of approximately -0.9 m Geodetic Datum (1.3 m Chart Datum) and the foot of the boat ramp structure 0.5 m lower at approximately -1.4 m Geodetic Datum (0.8 m Chart Datum).

*Photograph 5: Approximately the centre of the boat ramp (cross-shore) taken facing west on December 19, 2015.*

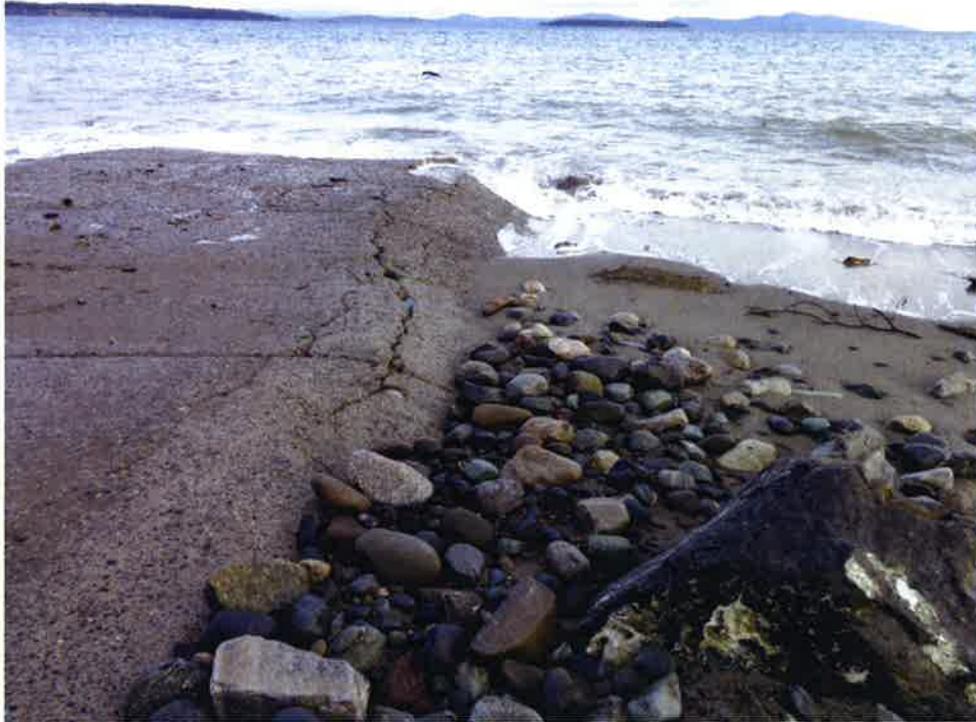
The boat ramp has a relatively intact sloped concrete edge facing south (Photograph 6). The north edge of the boat ramp has been eroded and indicates that the ramp consists of a concrete cap over a core of cobble-to-gravel-sized fill (Photograph 7). Sections of rebar were observed in the eroded surface of the boat ramp at a distance of approximately 45 m from the parking lot (Photograph 8). The hollow in the surface of the boat ramp was approximately 2 to 2.5 m wide, 1.5 to 2 m long, and 0.3 to 0.5 m deep. The hollow occupied approximately half the width of the crest of the boat ramp and appeared to limit the use of the ramp.

*Photograph 6: The southern side of the boat ramp taken facing east on December 19, 2015*

Evidence of cracking and spalling of the concrete was observed seawards of the woody debris (e.g., Photographs 6 and 7). The elevation drop that occurs immediately on either side of the ramp is shown in Figure 3 and in Photographs 9 and 10. No sediment was observed on the boat ramp surface during the site visit. The elevation drop on the south side is less pronounced than the elevation drop on the north side. This difference in beach elevation is indicative of northwards directed sediment transport. The beach surface to the south consists of a higher proportion of sand sized material relative to the beach surface to the north where more cobble-sized material was observed (e.g., Photographs 9 and 10). Typical cobble size was estimated in the field to be 150 mm minus (6" minus).

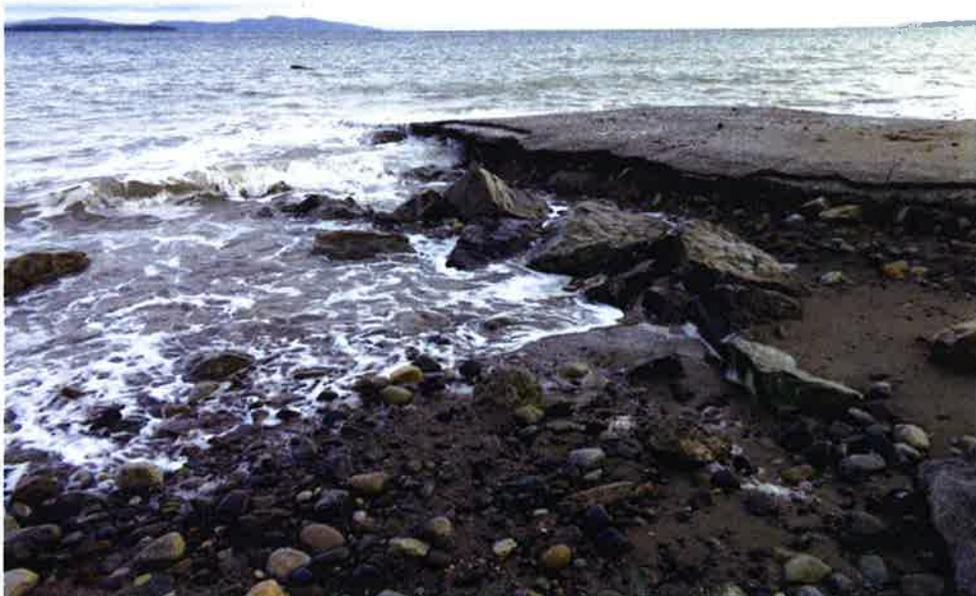
*Photograph 7: The northern side of the boat ramp taken facing southeast on December 19, 2015*

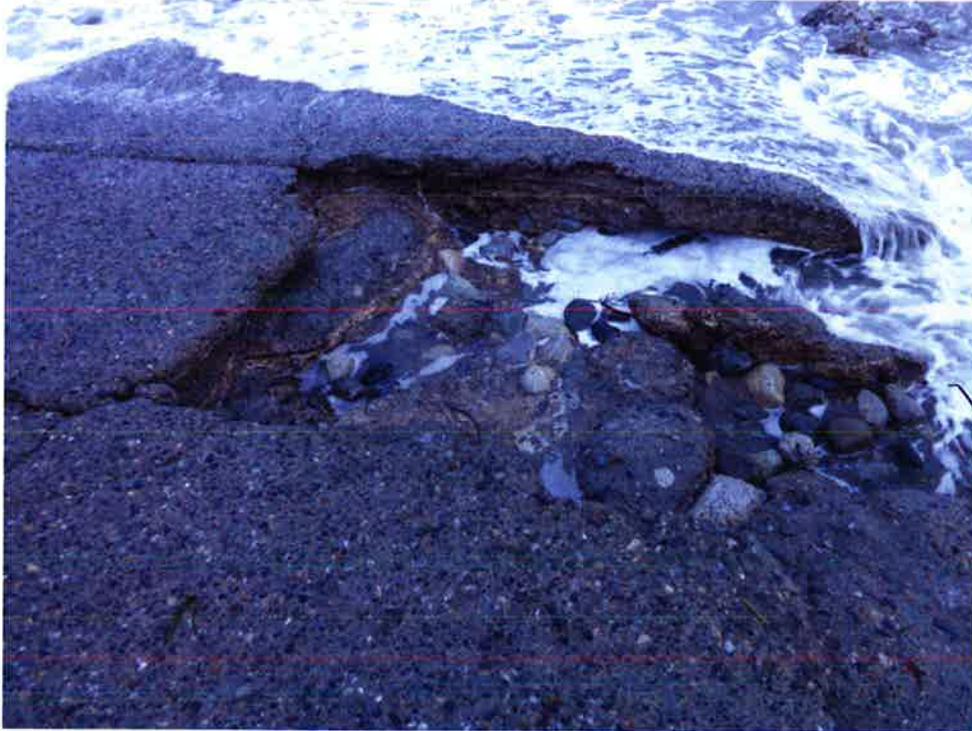
*Photograph 8: Eroded surface of the boat ramp taken facing east on December 19, 2015*

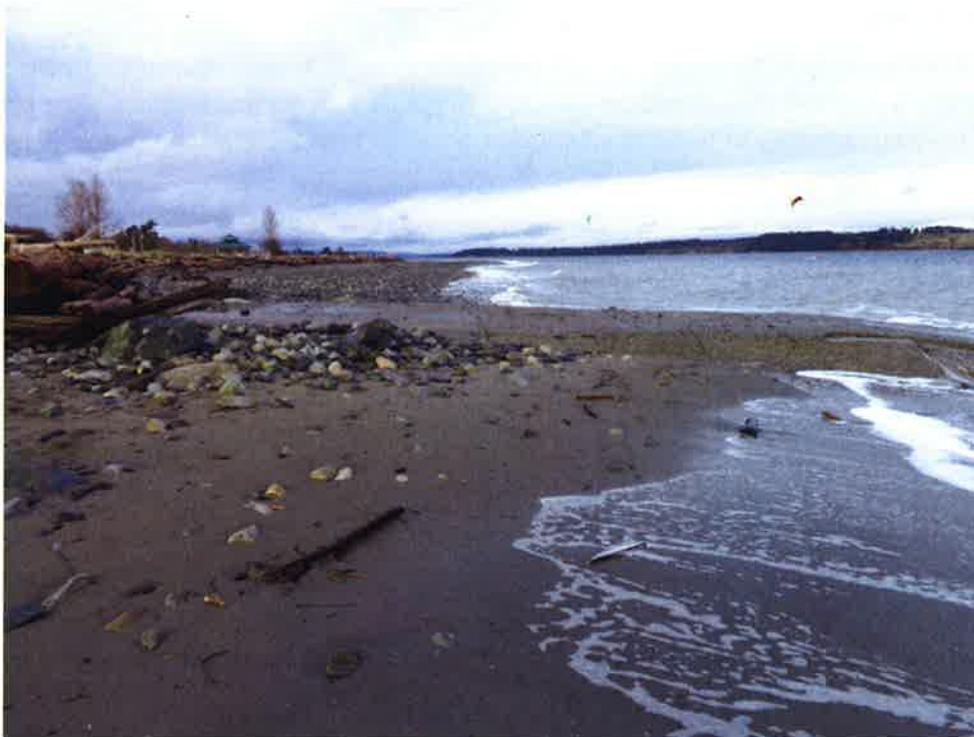
*Photograph 9: Beach to the south of the boat ramp taken facing north on December 19, 2015*

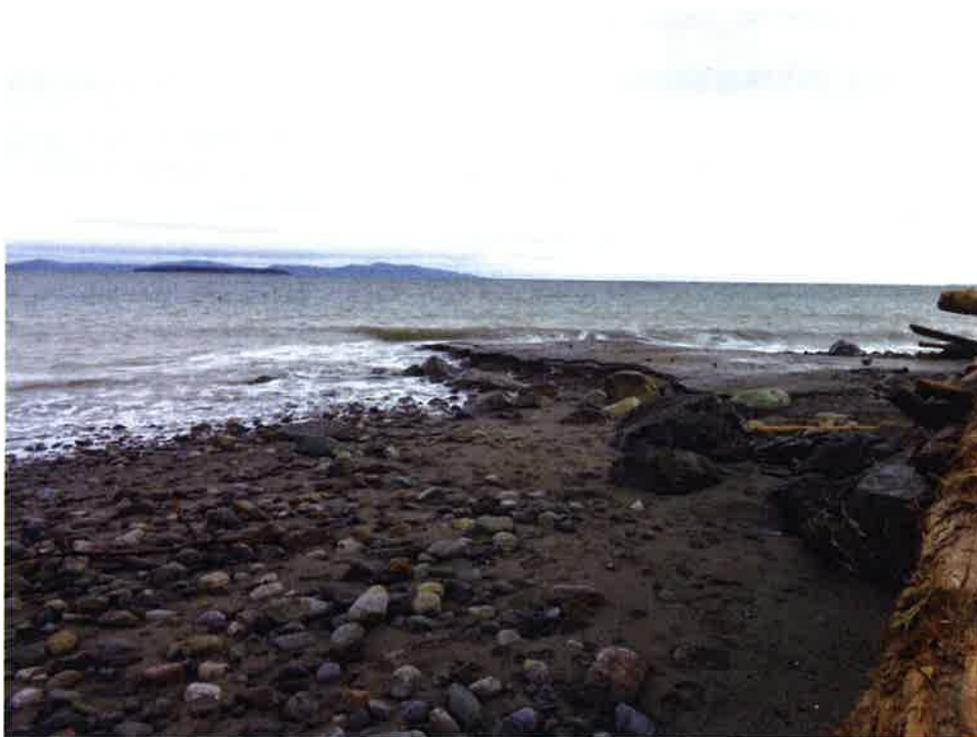
*Photograph 10: Beach to the north of the boat ramp taken facing southeast on December 19, 2015*

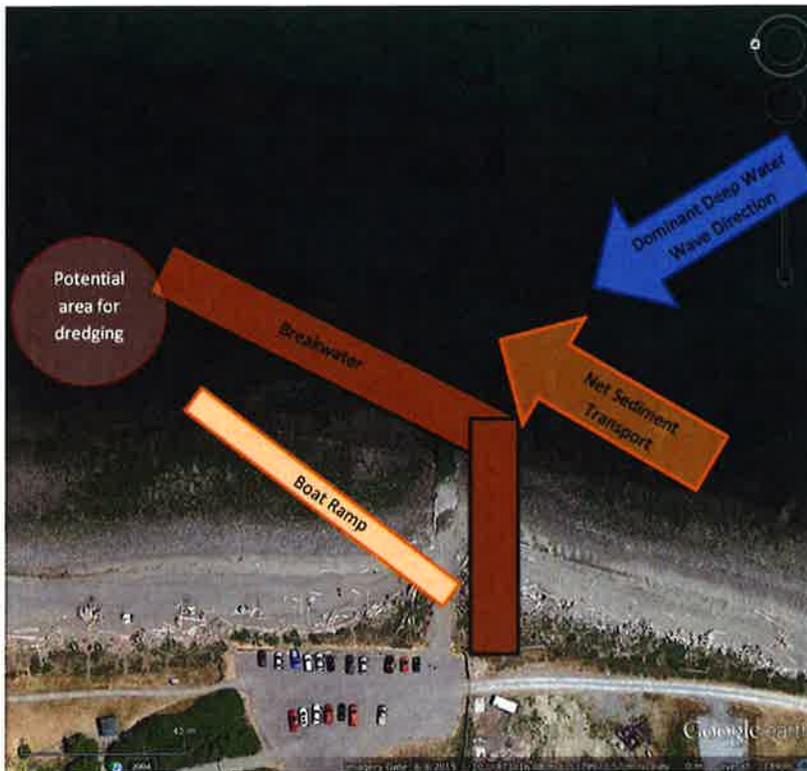
Figure 5: Potential concept for a replacement boat ramp at the present location (GoogleEarth™) that would address the principal coastal processes

In this example, the boat ramp would be extended and realigned to a water depth of -3.1 m Geodetic. A breakwater would be installed to protect the now longer boat ramp from the dominant southeasterly wind and wave direction. The breakwater would be oriented such that it would protect the boat ramp area, but this would result in offshore deflection of northwards directed sediment transport. The deflection of sediment transport would result in accumulation of sediment off the northwards tip of the breakwater and would likely result in the need for regular dredging to maintain boat access to the ramp. The deflection of sediment offshore would likely result in sediment starvation northwards along Island View Beach and increased erosion due to loss of sediment. This erosion could be partially managed by placement of the dredged material on the shore to the north of the new boat ramp, but some erosion would be expected due to offshore losses of sediment.
