Attachment 2

Photos:

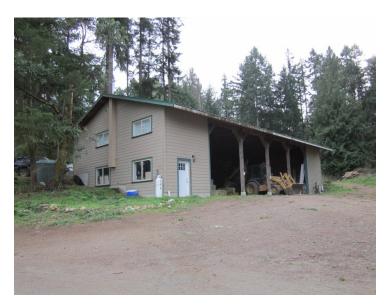
Building #1: Hay barn altered to include dwelling unit. Unknown fire separations.

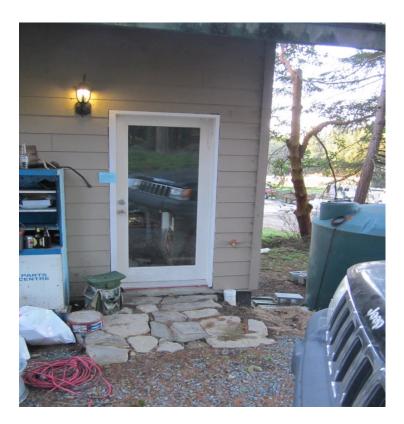
Building #1: Back entrance.

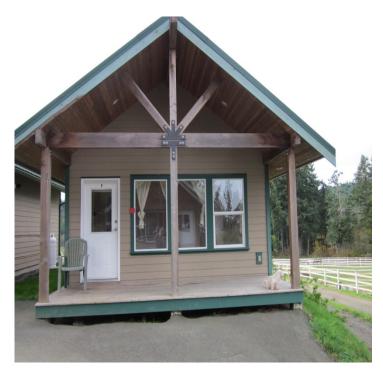
Building #2: First tack shed converted to a dwelling.

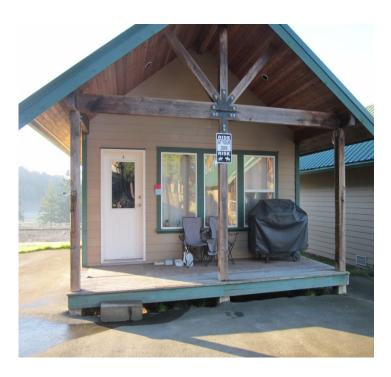
Building #3: Second tack shed converted to a dwelling.

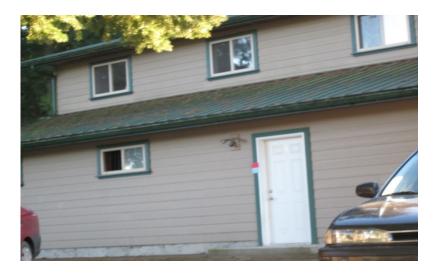
Building #4: Horse barn. Top floor converted to a dwelling with lower floor storage. Inadequate fire separations.

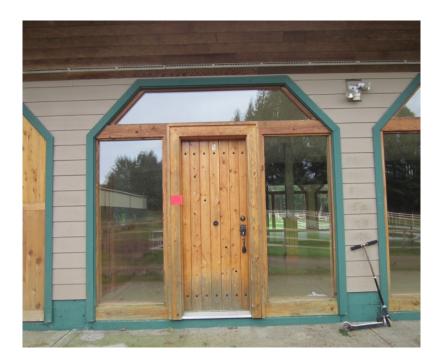
Building #5: Tractor shed. Tractor storage area eliminated. Currently vacant.

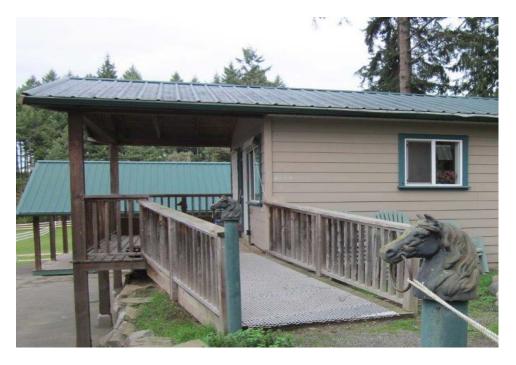
Building #6: Washroom building. Alterations to interior, converting to a dwelling.

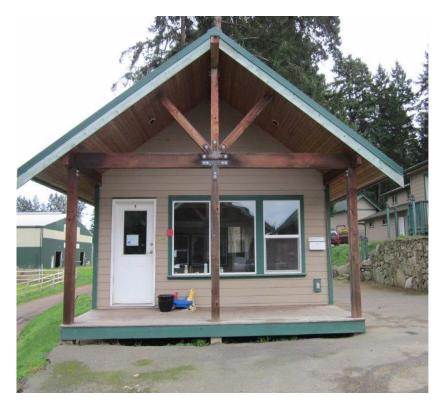
Building #7: Third tack shed converted to a dwelling.
