Environmental Assessment and Protection Plan for the Lot Subdivision of Lot 2 Anderson Road

May 2018

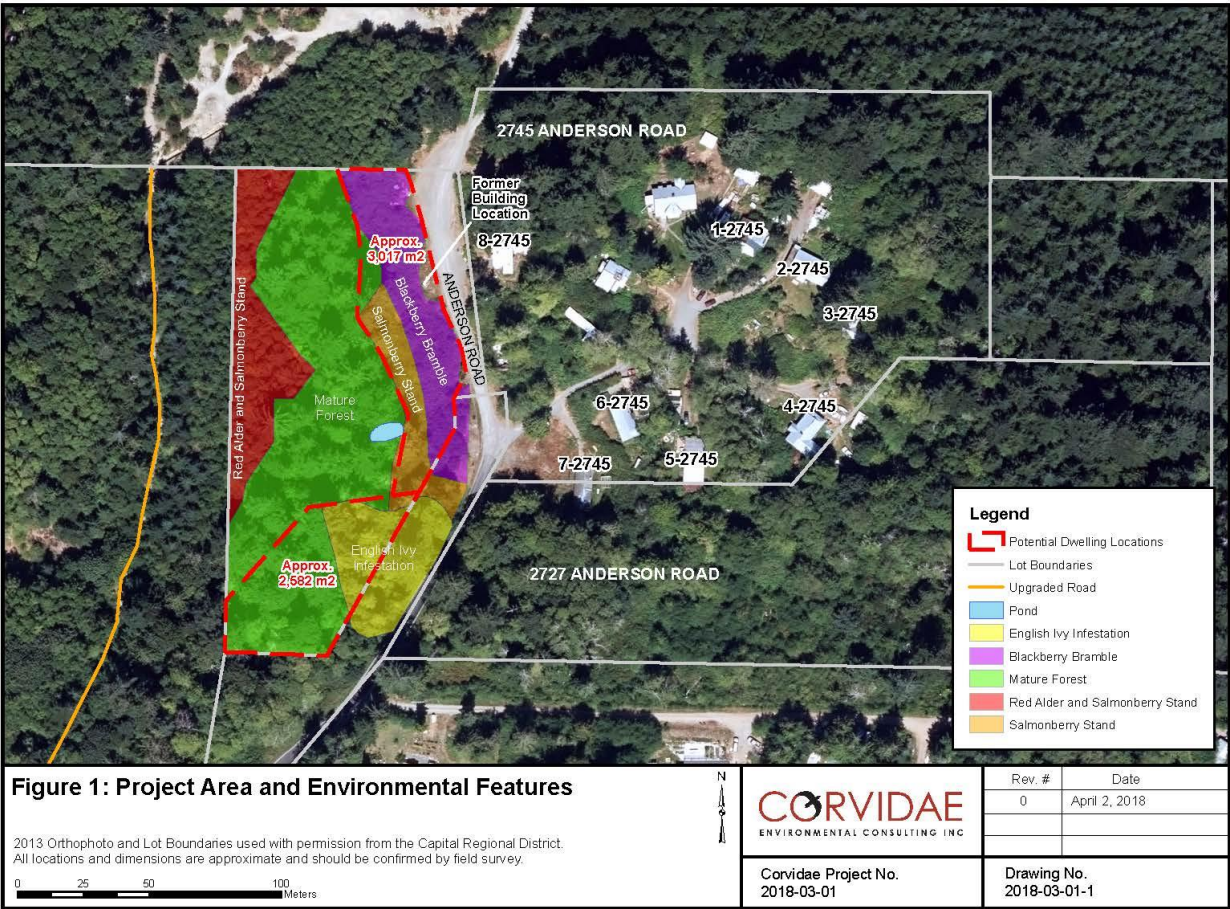
Corvidae completed a site visit on March 7th and 16th, 2018 as part of the environmental assessment. During the site assessment it was determined that there are some areas that were previously disturbed and have overgrown with invasive species (see Table 1 and Figure 1). There is a Mature Forest area to the west side of the lot (see Figure 1), which is bordered by a berm that appears to be man-made and a recently upgraded road to the west of that, on Lot 81. Appendix A shows photos of the recently upgraded road.

During the site assessment the species in Table 1 and 2 were found on the site. Figure 1 identifies the areas where the majority of the invasive species are located.

Corvidae recommends protecting the Mature Forest area that has been ground truthed and identified in Figure 1, with the exception of the 2,582 m² area. This area (southern end of the forest) and also has ivy on the trees.

It is recommended that as much of the Mature Forest remain protected as feasible. This area should be clearly marked prior to any construction, to ensure no extra clearing within this sensitive ecosystem. The large trees on site that are in good health and not a safety hazard, should be left in place. The trees in the Mature Forest range from 60 cm to 130 cm diameter at breast height (DBH). See Figure 1 for the recommended area to be protected.

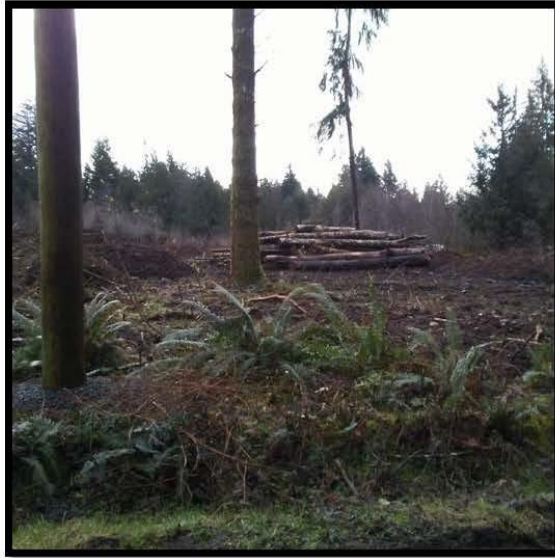
Photo 1. East side of property, vegetated ditch and logged area

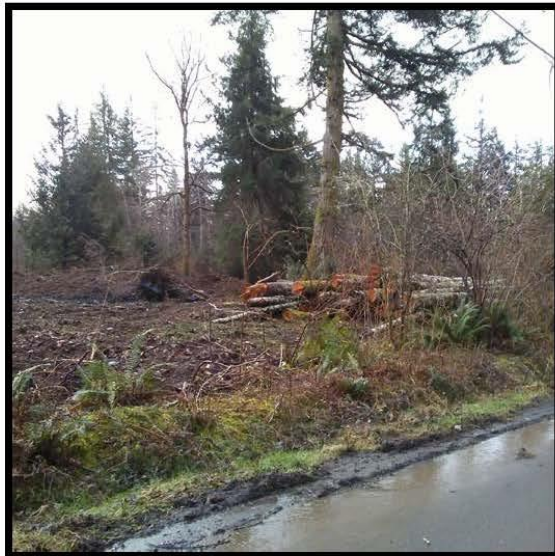
Photo 2. East side of property.

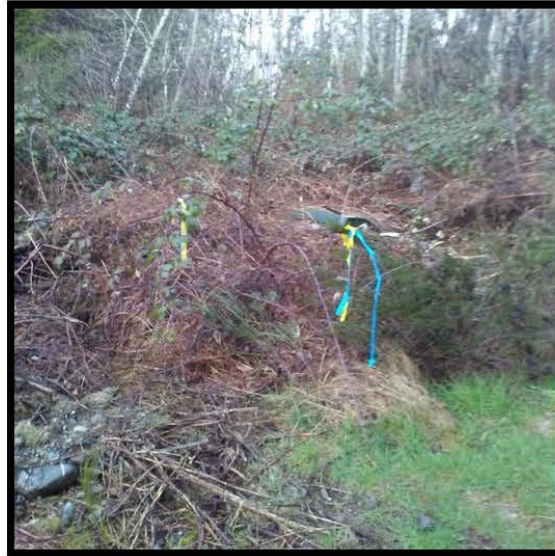
In the location of the blackberry bramble there was previously a structure used during the logging operations, which has since collapsed or been removed. (This information was anecdotal, provided by a long-time neighbour, during the site visit on March 7th, 2018.) There is a section along the border of the property on the west side that is infested with English ivy. The ivy is strangling some of the trees, and the health of the trees has been compromised. There is an area with standing water, which appears to have been man-made (due to the irregular shape, depth and dimensions). From the standing water (pond), there is a ditch running north-south. The ditch and the pond are well vegetated, but not with emergent hydrophilic vegetation. They are vegetated with the ferns and grasses typical of the understory in that forested area.

Photo 1. North edge of property, with blackberry infestation

It is recommended that the blackberry bramble be removed and planted with native species. If there are to be any dwellings built, in the location of the blackberry bramble would be the best suited due to it being the former building site and the building of the structure would facilitate blackberry removal. And/or located in the ivy infested area, and other area identified on Figure 1. Corvidae recommends ringing the ivy on the trees that are infested and completely removing the trees that are dead/dying from the ivy. Ringing the ivy from the trees consists of cutting the ivy away 6 feet (2 m) up on the tree and all the way to the ground. With the gap in the ivy, the ivy up in the tree will die. The ivy on the ground should also be removed to minimize spreading and further infestation.

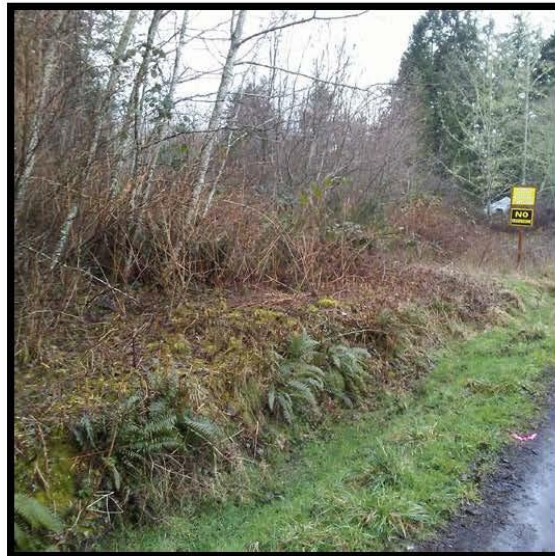
Photo 4. West side of property, salmon berry and alder stand

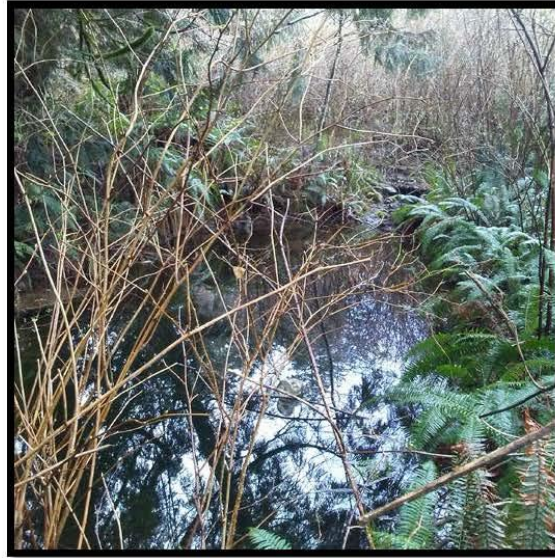
Photo 6. Pondered area from previous excavation.

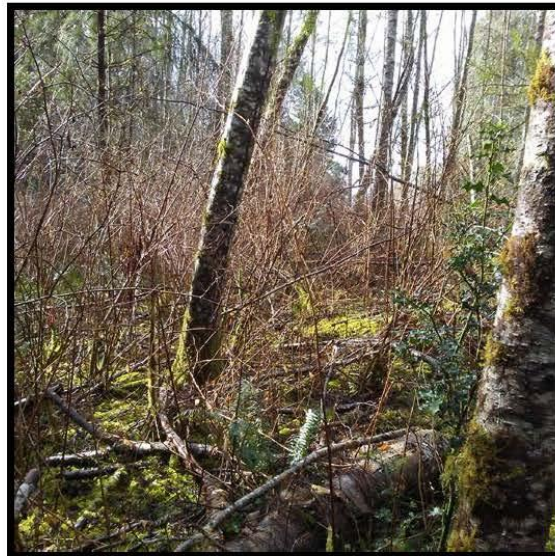
Photo 5. Red alder and salmon berry stand.

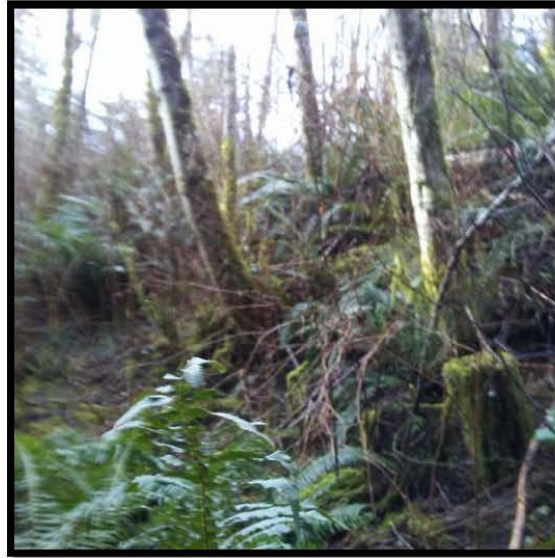
Photo 7. Steep berm at western edge of west side of property, directly beside the new road (Lot 81).

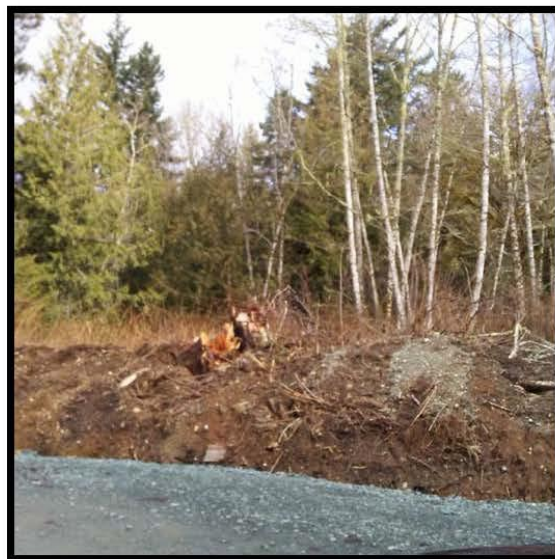
Photo 8. Newly upgraded road (Lot 81).

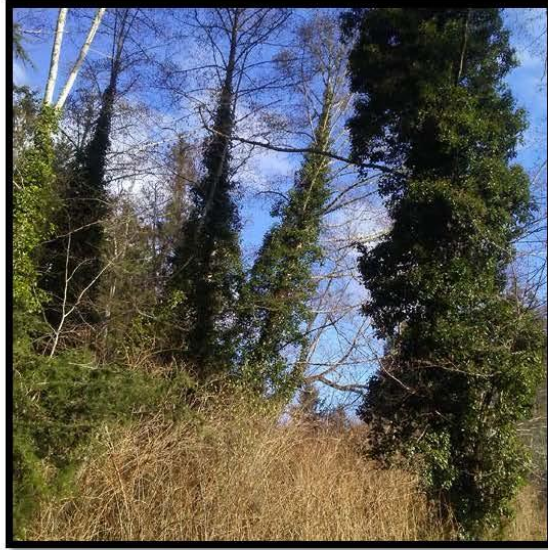
Photo 9. Trees being strangled by English ivy.

On the west side, Corvidae recommends removing the invasive species, specifically the blackberry bramble and English ivy; and removing the trees that are a hazard from the ivy damage.

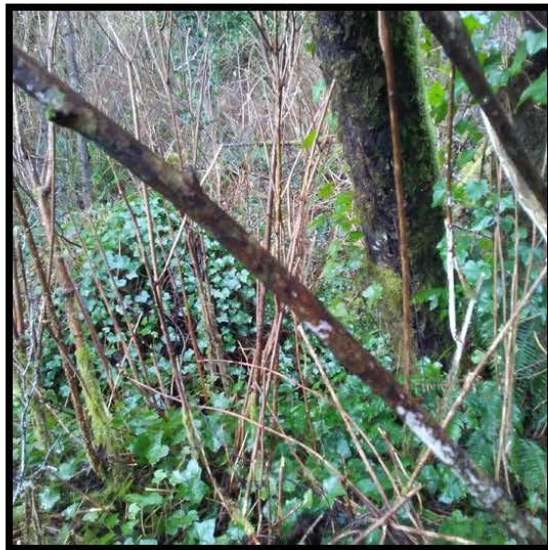
Photo 10. English ivy infestation.
