DEVELOPMENT PERMIT WITH VARIANCE NO. DV000071

*Environmental Assessment and Protection Plan for the Lot
Subdivision of Lot 2 Anderson Road*

Environmental Assessment and Protection Plan for the Lot Subdivision of Lot 2 Anderson Road

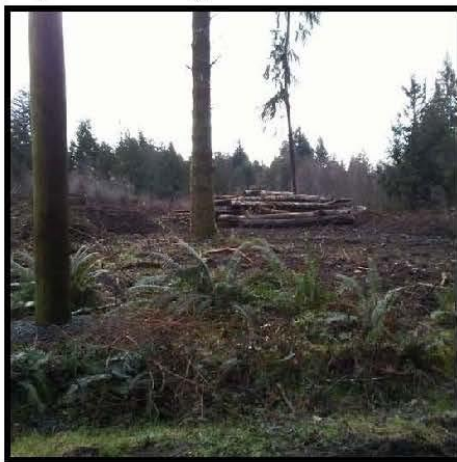
The section of the lot on the right side (east) of Anderson Road has been recently logged (Appendix A – Photos).

Photo 1. East side of property, vegetated ditch and logged area

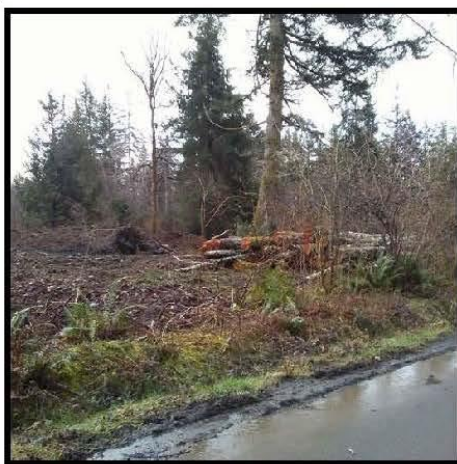
Photo 2. East side of property.

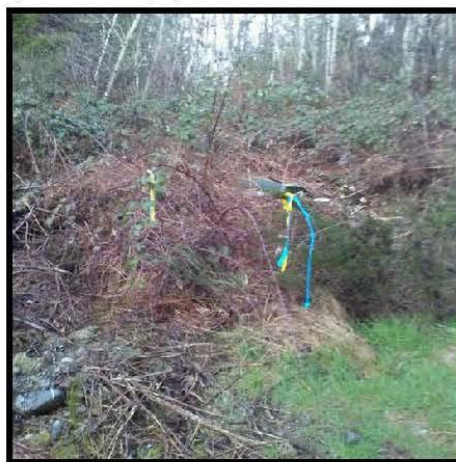
In the location of the blackberry bramble there was previously a structure used during the logging operations, which has since collapsed or been removed. (This information was anecdotal, provided by a long-time neighbour, during the site visit on March 7th, 2018.) There is a section along the border of the property on the west side that is infested with English ivy. The ivy is strangling some of the trees, and the health of the trees has been compromised. There is an area with standing water, which appears to have been man-made (due to the irregular shape, depth and dimensions). From the standing water (pond), there is a ditch running north-south. The ditch and the pond are well vegetated, but not with emergent hydrophilic vegetation. They are vegetated with the ferns and grasses typical of the understory in that forested area.

Photo 1. North edge of property, with blackberry infestation

It is recommended that the blackberry bramble be removed and planted with native species. If there are to be any dwellings built, in the location of the blackberry bramble would be the best suited due to it being the former building site and the building of the structure would facilitate blackberry removal. And/or located in the ivy infested area, and other area identified on Figure 1. Corvidae recommends ringing the ivy on the trees that are infested and completely removing the trees that are dead/dying from the ivy. Ringing the ivy from the trees consists of cutting the ivy away 6 feet (2 m) up on the tree and all the way to the ground. With the gap in the ivy, the ivy up in the tree will die. The ivy on the ground should also be removed to minimize spreading and further infestation.

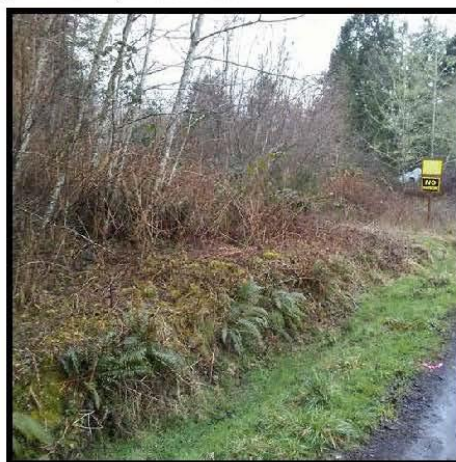
Photo 4. West side of property, salmon berry and alder stand

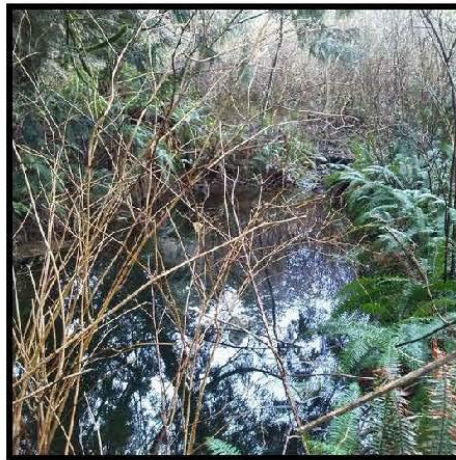
Soils in the Biogeoclimatic zone are typically moderately deep Orthic Humo-Ferric Podzols with Hemimor humus forms (Pojar et al. 1991). The soils on the site were a sandy clay loam. They were light-brown in colour. The clay properties are evident in the standing water in the ponded area. From the vegetation types it was evident that the standing water is seasonal and the site is typically dry in the summer/fall (depending on rainfall). There were other low areas with some water pooling on site. Due to the east side of the lot being completely logged and cleared of understory vegetation, it was difficult to tell what the surface landscape used to be there. On the west side there were signs of an altered landscape including the long berm (see photos in Appendix A) and signs of ditch and pond excavations; as well as the personal communication regarding the previous building on site where the blackberries are currently. The area of the building location was not accessible due to the blackberries.

Photo 6. Pondered area from previous excavation.

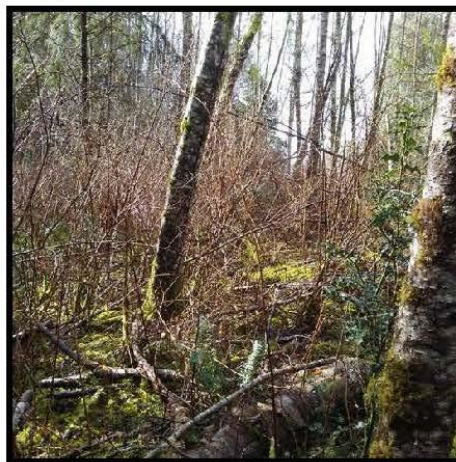
Photo 5. Red alder and salmon berry stand.

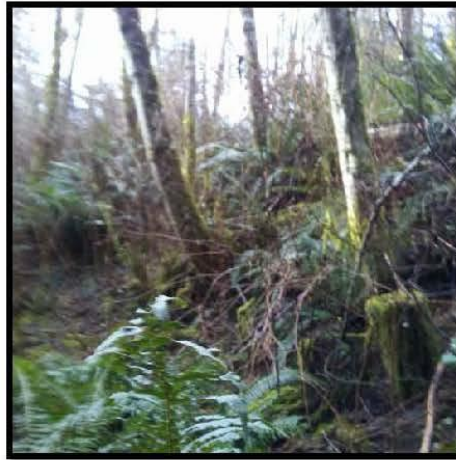
Photo 7. Steep berm at western edge of west side of property, directly beside the new road (Lot 81).

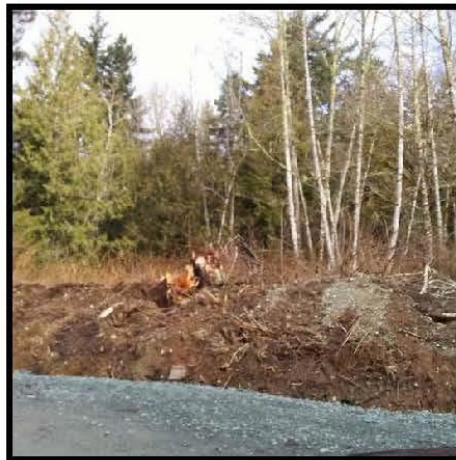
Photo 8. Newly upgraded road (Lot 81).

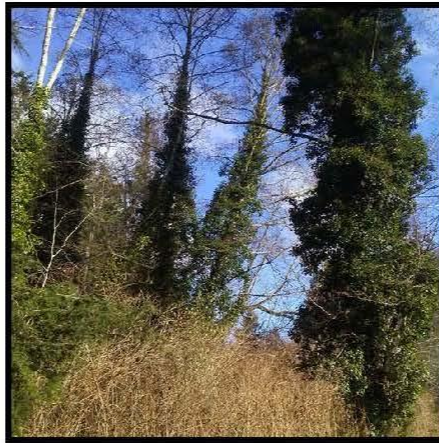
Photo 9. Trees being strangled by English ivy.

On the west side, Corvidae recommends removing the invasive species, specifically the blackberry bramble and English ivy; and removing the trees that are a hazard from the ivy damage.

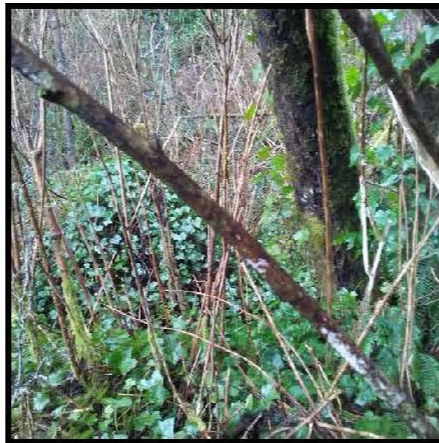
Photo 10. English ivy infestation.
