**CAPITAL REGIONAL DISTRICT**  
**DEVELOPMENT PERMIT WITH VARIANCE DV000079**

## ENVIRONMENTAL ASSESSMENT FOR 6402 CERANTES ROAD DEVELOPMENT

CORVIDAE PROJECT #2021-036  
MAY 2021

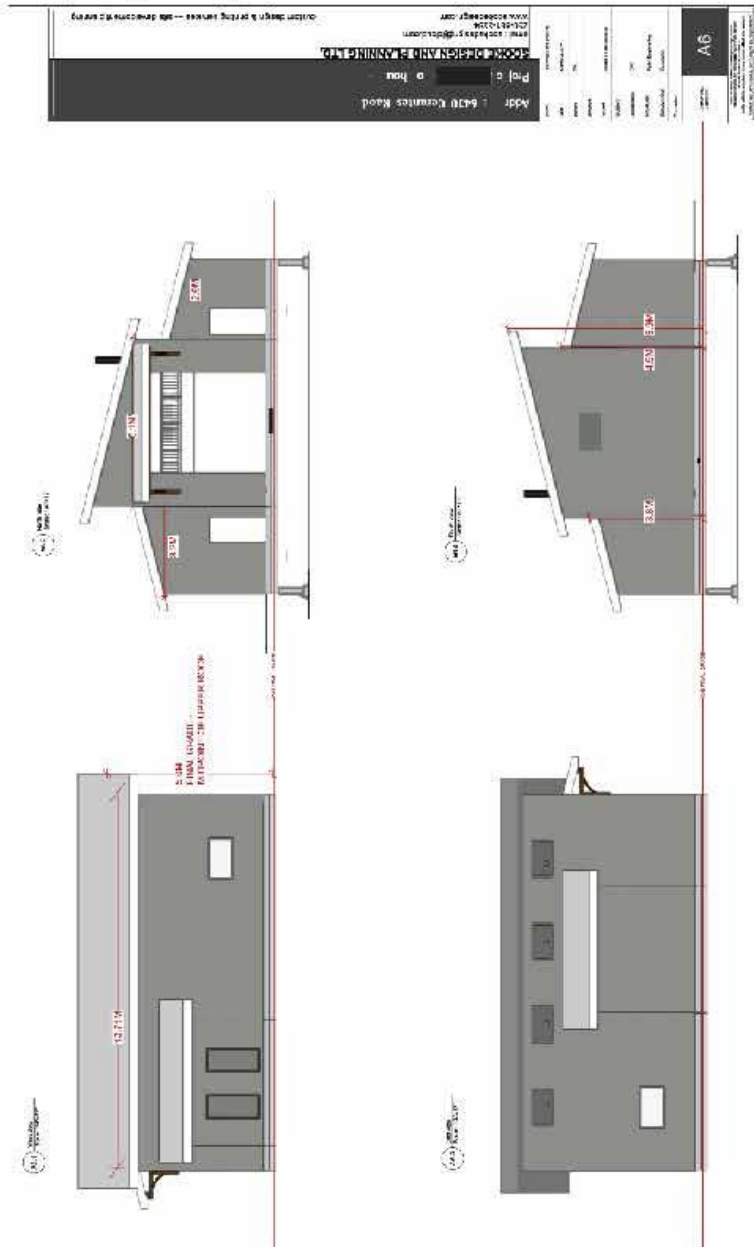
Appendix B: Garage Design Drawings

5. The Capital Regional District's **Bylaw No. 3109** is varied under Section 498 of the *Local Government Act* as follows:
  - a. Part IV, Section 22(2)(f) be varied by increasing the maximum height for an accessory building from 4.8 m to 5.6 m in accordance with the Garage Design Drawings; and

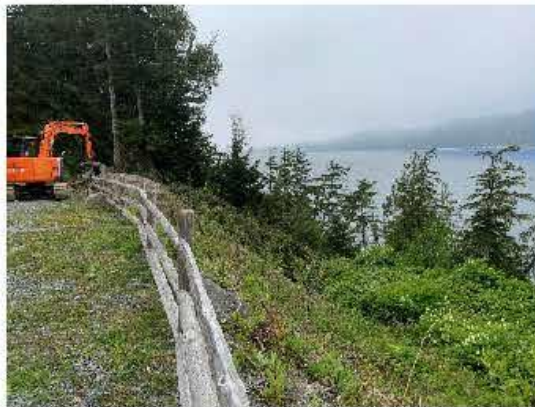
The shoreline consists of rocky steep rocky outcrops leading up to a steeply sloped forested foreshore area along the eastern portion of the property. Sections of the foreshore in this area are steep rocky cliffs of approximately 20-50m. The proposed garage development is adjacent to one of the cliffs and is 11.3m south of the present natural boundary at its closest extent (Figure 2). The landowner has discussed the encroachment of the development into the Shoreline Protection Development Permit Area of 15m from the natural present boundary with the CRD and they may approve it with the findings of this report.

Photo 2. View looking west at the foreshore just north of the residential buildings on the east portion of the property. May 14, 2021.

We recommend the removal of the blackberries from the foreshore to reduce further spreading. Replanting of vegetation at the top of the bank, and any other resulting bare areas from the removal (that are not bedrock), will have to occur within that growing season (prior to wet weather) to decrease the risk of erosion and recolonization of invasive species. The area should be replanted with native species, including the recommended revegetation species provided in Table 3. If any additional work to the shoreline is needed the Green Shore methods and shoreline stewardship are recommended (<https://stewardshipcentrebc.ca/green-shores-home/>).

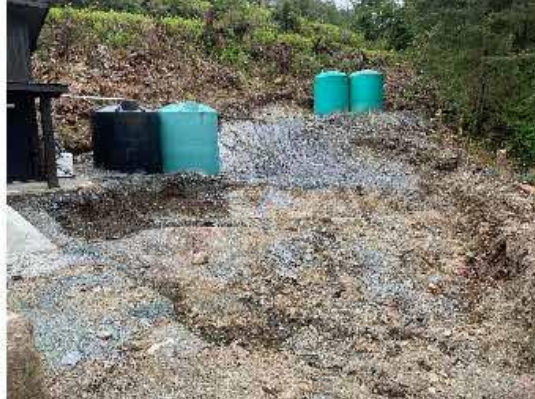
Photo 3. View looking south at the purposed garage location. May 14, 2021.

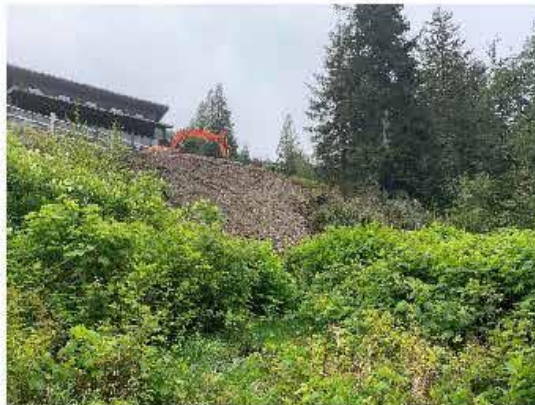
The property slopes sharply to the north with rocky cliffs occupying portions of the shoreline. Approximately 5m North of the proposed development, there are cliffs of ~15m which lead to an inlet off of the northern shore. Soil from the development area has recently been excavated and placed along the northern boundary of the previously developed area onsite outside of the 15m Shoreline Protection DPA.

Photo 4. View looking south at the excavated soil being placed along the northern development boundary outside of the 15m Shoreline Protection DPA. May 14, 2021.

- Install sediment fences downslope from the construction areas and at the top of bank of the foreshore slope.
- Regularly inspect and maintain the erosion and sediment control measures during all phases of the project.
- Keep the erosion and sediment control measures in place until all disturbed ground has been permanently stabilized.
- Heed weather advisories and scheduling work to avoid wet, windy and rainy periods that may result in high flow volumes and/or increase erosion and sedimentation.
- Any loose soil storage should be in flat areas, covered and protected with a sediment fence below.
- Minimize amount of time soils are exposed by seeding and planting as soon as disturbance or construction is complete. Cover exposed soil areas with tarps if for a prolonged period or during rainfall events (specifically adjacent to waterbodies and foreshore areas).

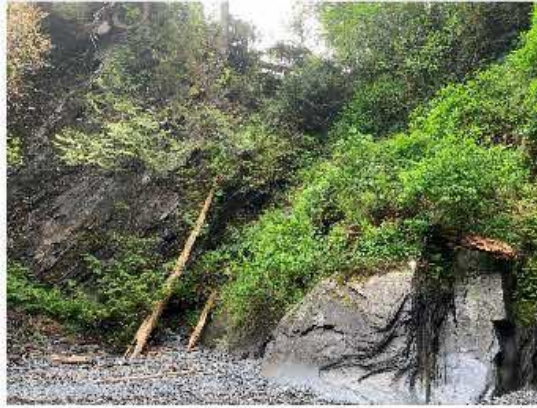
Photo 5. View looking south at the inlet and rocky cliffs adjacent to the proposed garage development area. May 14, 2021.

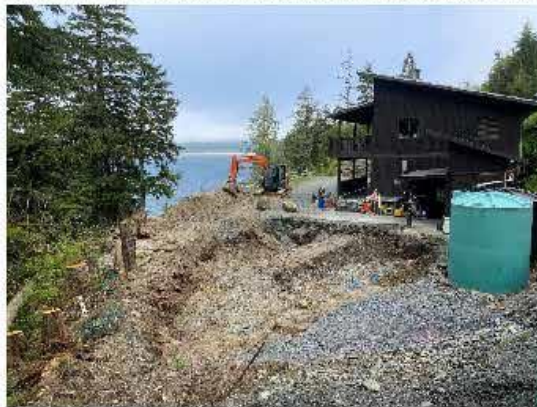
Mature cedar trees and understory vegetation have recently been cut on the northern edge of the proposed development area.

Photo 6. View looking east at the proposed garage development area. May 14, 2021.

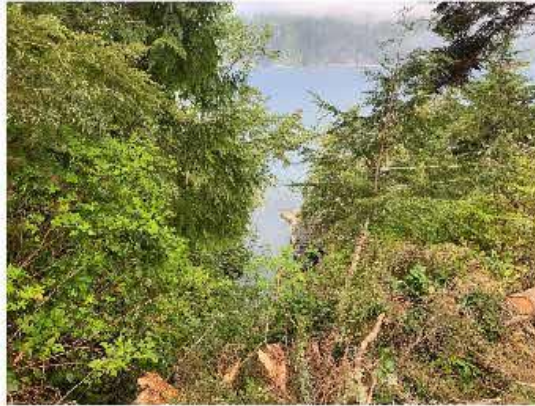
Photo 7. View looking north from the northern edge of the proposed garage development to the adjacent inlet. May 14, 2021.

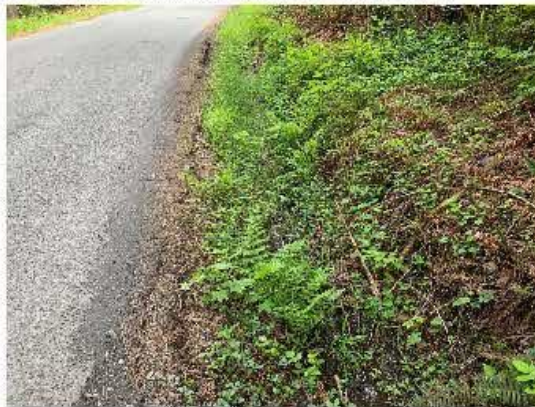
Two unnamed streams were identified on the central portion of the property (Figure 1). These streams are fed from a ditch along the south of Cerantes Road and two tributaries flowing north from a southern forested area. The wetted area of the ditch did not extend east into the 30m RAA due to the topography of the area. Water in that portion of the ditch flows west from the highpoint at the eastern edge of the ditch (Figure 1). Both of the streams flow into the San Juan Port via rocky cliffs along the northern boundary acting as a barrier to fish passage. Additionally, both of these streams do not require a RAPR due to them being outside of the 30m RAA for the garage development and are not identified on the Riparian Development Permit Areas in the Port Renfrew OCP.

Photo 8. View of the wet ditch along the south side of Cerantes Road.

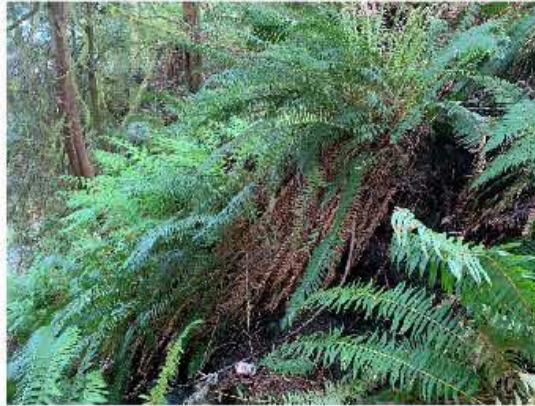
**Photo 9. View looking east of the most eastern unnamed stream identified in the central portion of the property. May 14, 2021.**

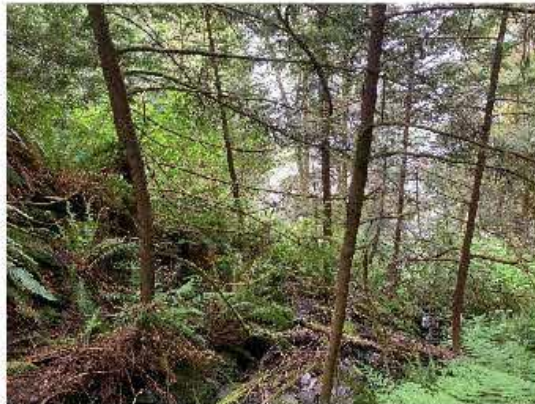
**Photo 10. View looking north at the most western unnamed stream identified in the central portion of the property. May 14, 2021.**

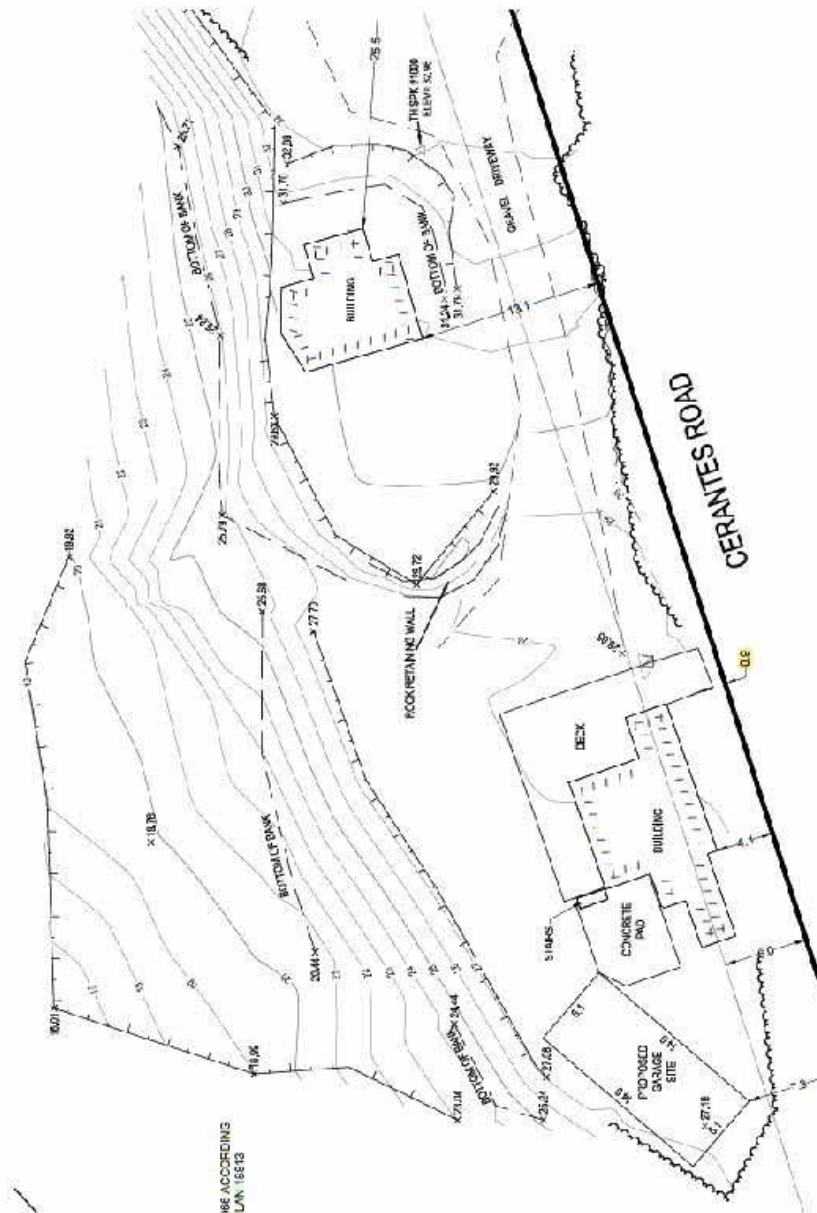
Appendix E: Dwelling and Deck Site Plan

- b. Part IV, Section 22(2)(g)(iii) be varied by reducing the exterior side setback requirement from 4.6 m (4.1 m) to 0.9 m for the siting of an existing deck in accordance with the Dwelling and Deck Site Plan.
