CRD Regional Parks
2022 Island View Beach Regional Park Drainage Ditch Maintenance
Status as of July 13, 2022

Status of IVBRP Drainage Ditch Maintenance Activities as of July 13, 2022

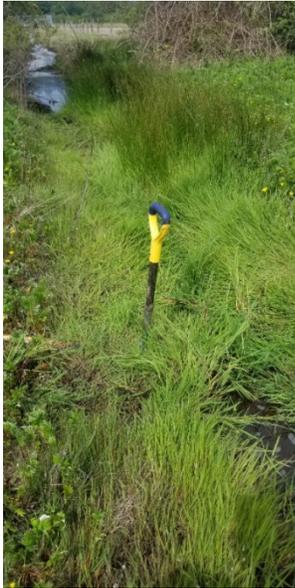
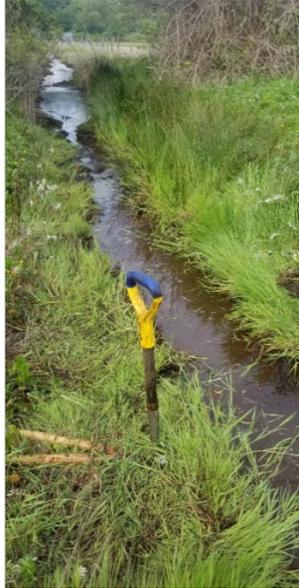
Example 1

- Ditch maintenance activities at Island View Beach Regional Park (IVBRP) began on June 7, 2022.
- As of July 13, 2022, 168 hours has been spent hand clearing ditches in sections not accessible by heavy equipment due to soft soils (see photos next page). The work being completed includes:

- the removal of logs placed by park users to cross the ditches
 - the removal of clumps of grass and horsetail that are slowing the movement of the water through the ditches

Before and After Photos of Ditch Clearing

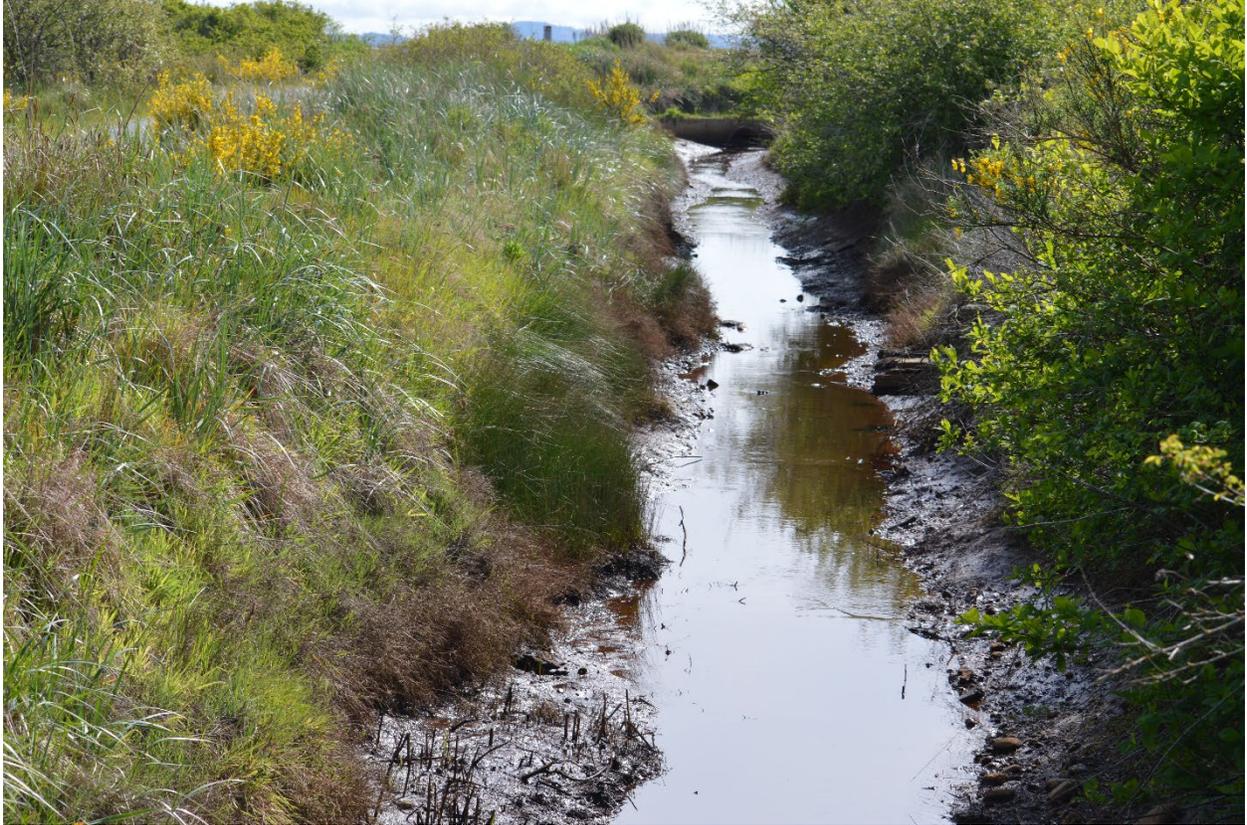
Typical view of unimpeded IVBRP drainage ditch

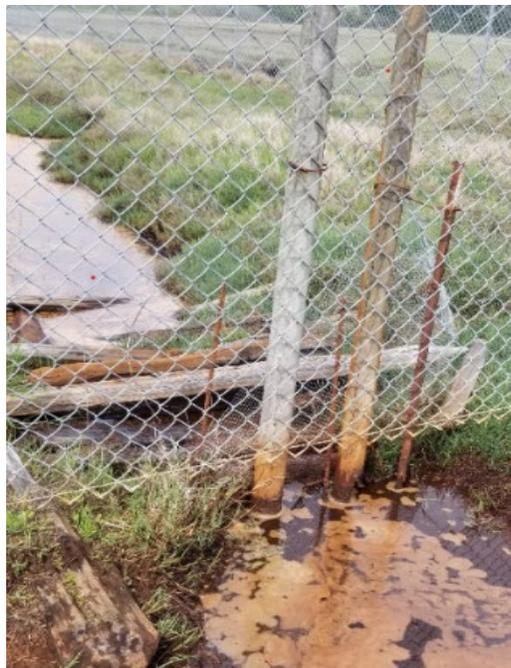
- The ditch system starts on CRD land but one section of the ditch extends under a fence to private land. The photo to the right shows debris in the ditch on the private property (see also map on next page – black line indicates the location of this private property).
- Staff have observed what are believed to be stickleback fry in the ditches. This hinders further work being done in the ditches until a Section 11 permit from the Ministry of Environment and a permit from the Department of Fisheries and Oceans is obtained.

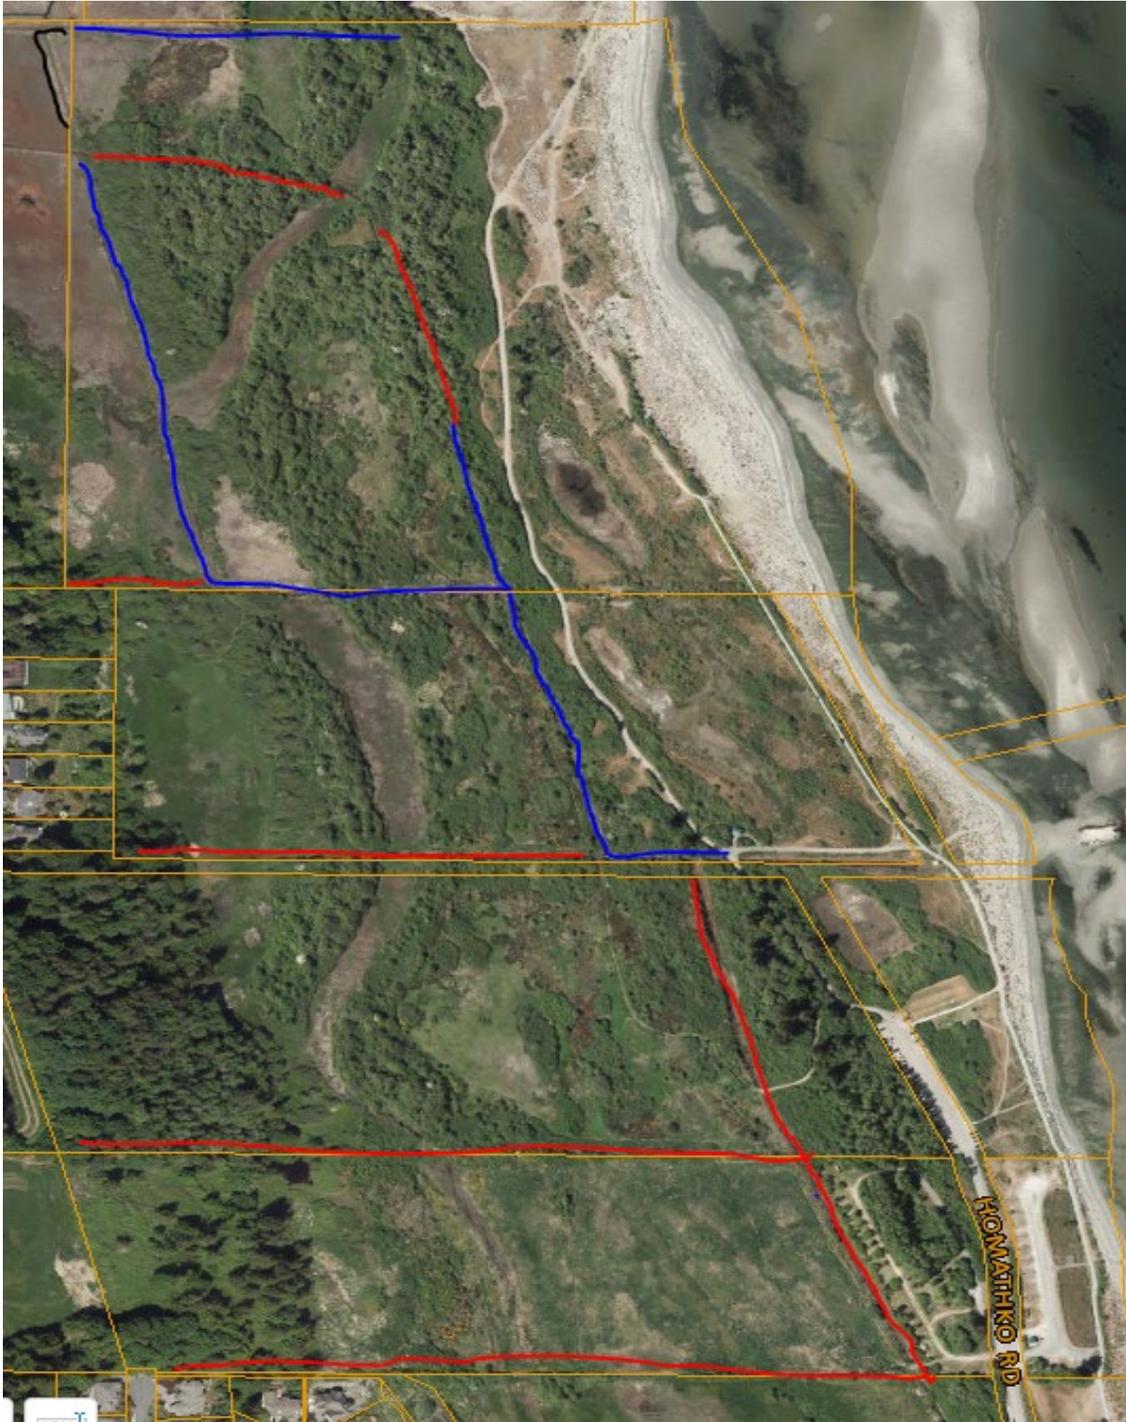
Ditch Colour

- Blue – completed
- Black – located on private property
- Red – not completed
