CAPITAL REGIONAL DISTRICT

DEVELOPMENT PERMIT WITH VARIANCE NO. DV000088

Re: 2193 Otter Ridge Drive – Environmental Review – DPAs

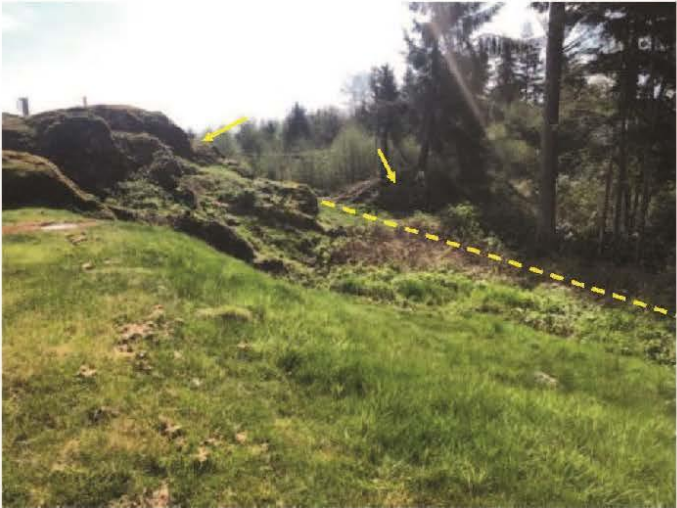
Photo 1. Looking south at the bed rock mounds adjacent to the proposed daughter Lot driveway (dashed yellow line). The large bed rock outcrop on the left would remain as part of the parent Lot. The small outcrop on the right would remain undisturbed as part of the daughter Lot.

Our site assessment was unable to determine whether this species occurs on the bed rock outcrop at the entrance to the proposed panhandle driveway (Figure 3) (Photo 1, Photo 2, Photo 4 – Photo 7). Given that the literature indicates that this species is almost always observed on coastal bluff areas, in close approximation to the exposed shoreline, it strongly suggests that the subject property's bed rock outcrop habitat, as a possible location for this species to thrive, is too far from the ocean.

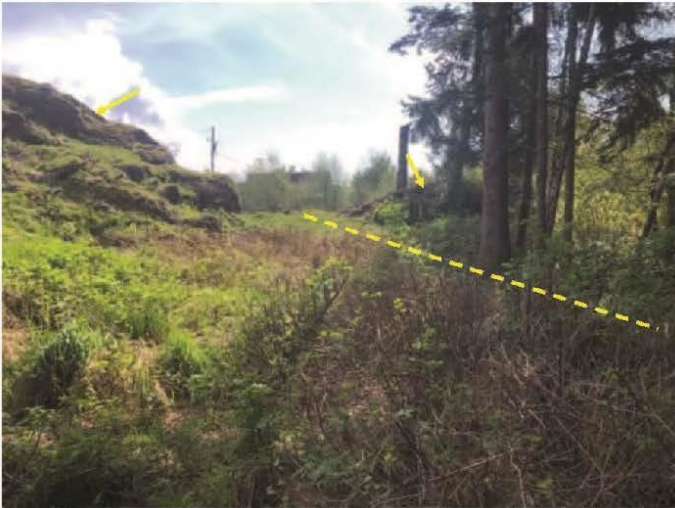
Photo 2. Looking southeast at the proposed daughter Lot driveway (dashed yellow line). The large bed rock outcrop on the left would remain as part of the parent Lot.

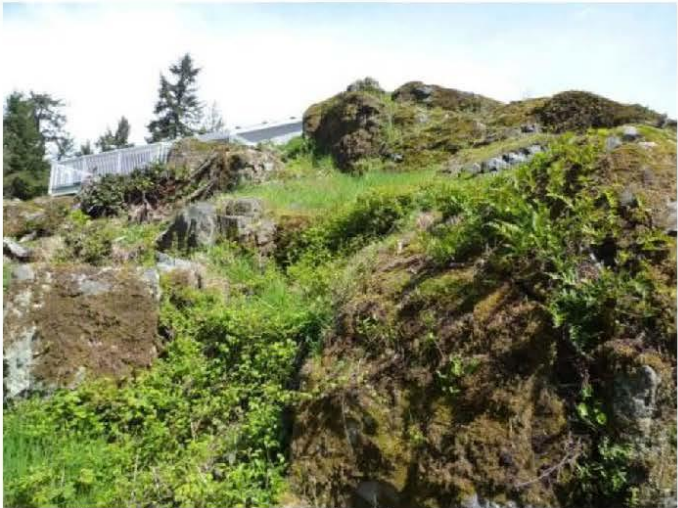
Photo 4. The large bed rock outcrop has a thin soil layer in which an herb, fern, and forb plant community exists. This outcrop is south facing and subject to extreme dry conditions during the late spring to early autumn months.

The Herbaceous category is a true Sensitive Ecosystem category. The only example of this habitat category we observed was the bed rock outcrop at the entrance to the proposed daughter Lot (Photo 4 – Photo 7).

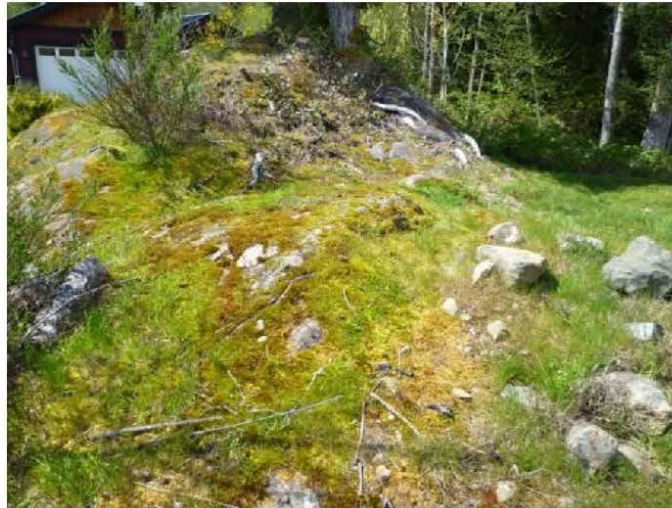
Photo 6. The small bed rock outcrop at the edge of the parent Lot property boundary has a thin, dry, soil layer in which mosses, lichens, grasses are growing. There is a single, drought stressed conifer growing at the peak of the outcrop, with a conifer trunk that was topped and left as a wildlife tree. The Scotch broom plant shall be removed.

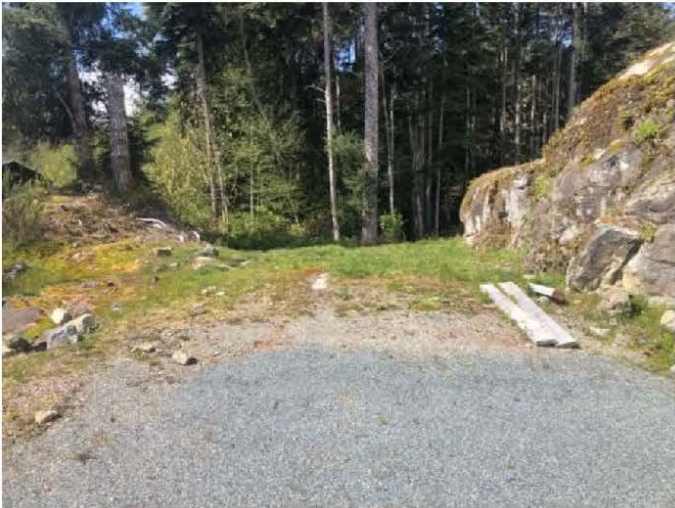
Photo 7. Looking across the proposed panhandle daughter Lot access driveway. A narrow (5 m wide) road can be constructed that would leave the two bed rock outcrops undisturbed. The conservation of the bed rock outcrop plant communities would be a prescribed environmental management objective.

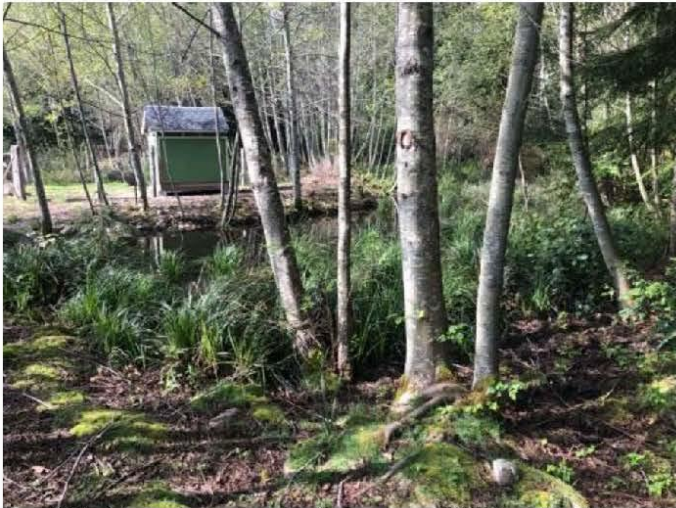
Photo 10. Looking southwest across the adjacent property (2195 Otter Ridge Drive) at the man made, isolated pond/wetland (Figure 2).

17. An isolated pond was observed on the adjacent property to the south (2195 Otter Ridge Drive) (Figure 2).
18. The isolated pond is not connected by surface stream channel to any fisheries habitat, therefore the pond is not subject to the Riparian Areas Protection Regulation (RAPR), nor to the Federal *Fisheries Act*.

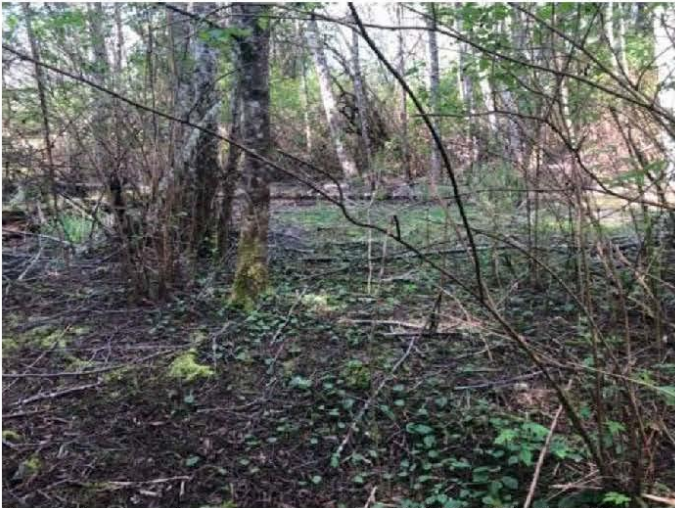
Photo 14. Looking southwest across the west edge of 2195 Otter Ridge Drive. There are no discharge channels emanating from the wetland / pond on this property.

An assessment of discharge channels leading from the wetland / pond was made (Photo 14 and Photo 15) and **no surface channels (i.e., streams) were observed** – the feature is isolated. Therefore, the feature is not subject to the RAPR nor to the Federal *Fisheries*

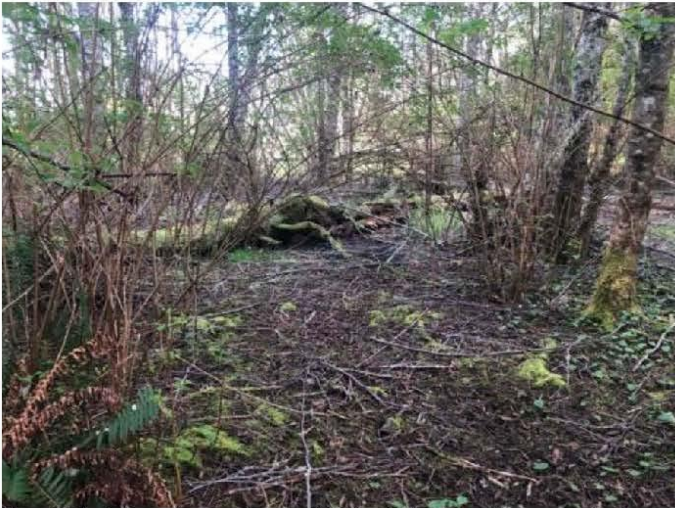
Photo 15. Looking south across the rear 2195 Otter Ridge Drive. There are no discharge channels emanating from the wetland / pond on 2195 Otter Ridge Drive.

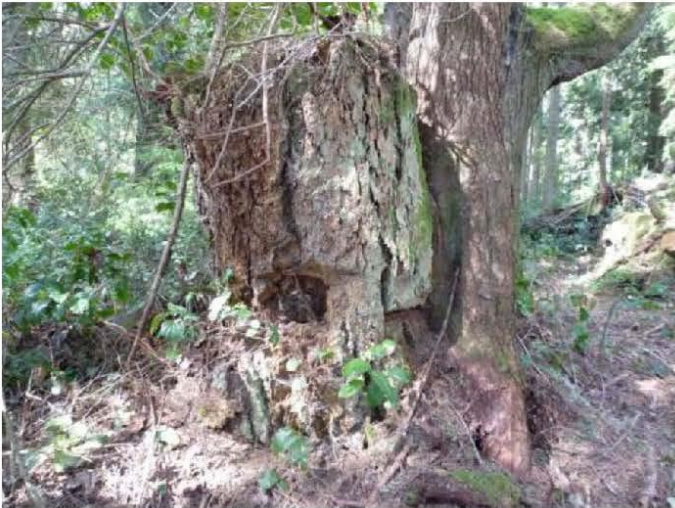
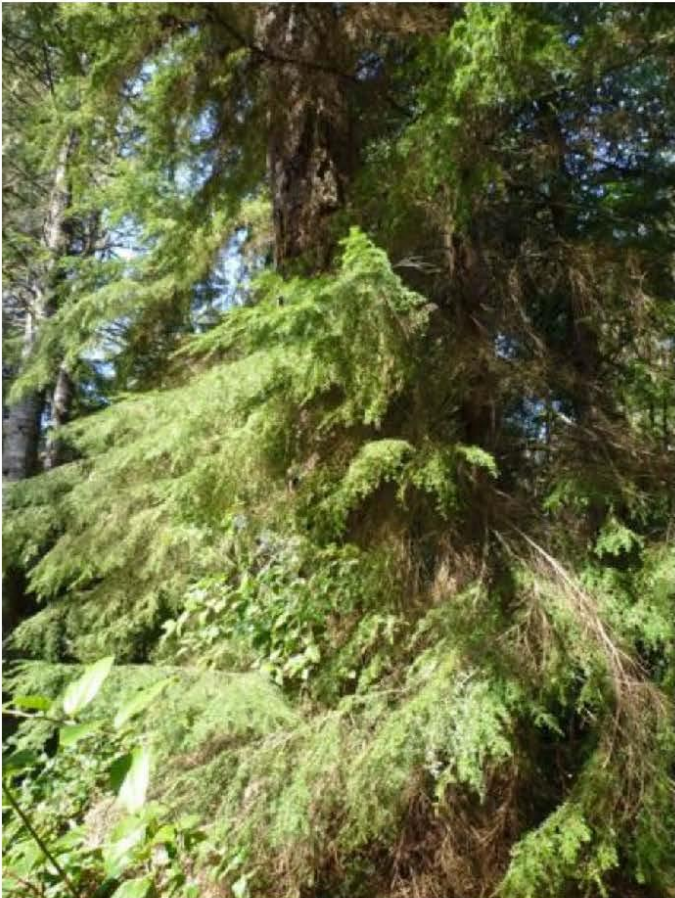
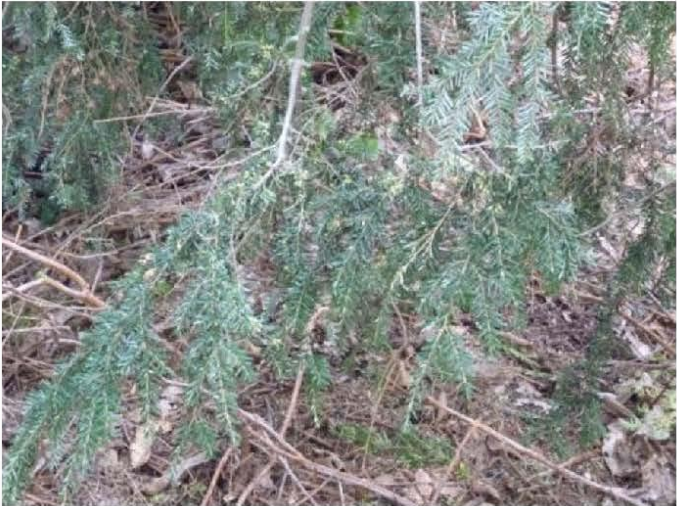
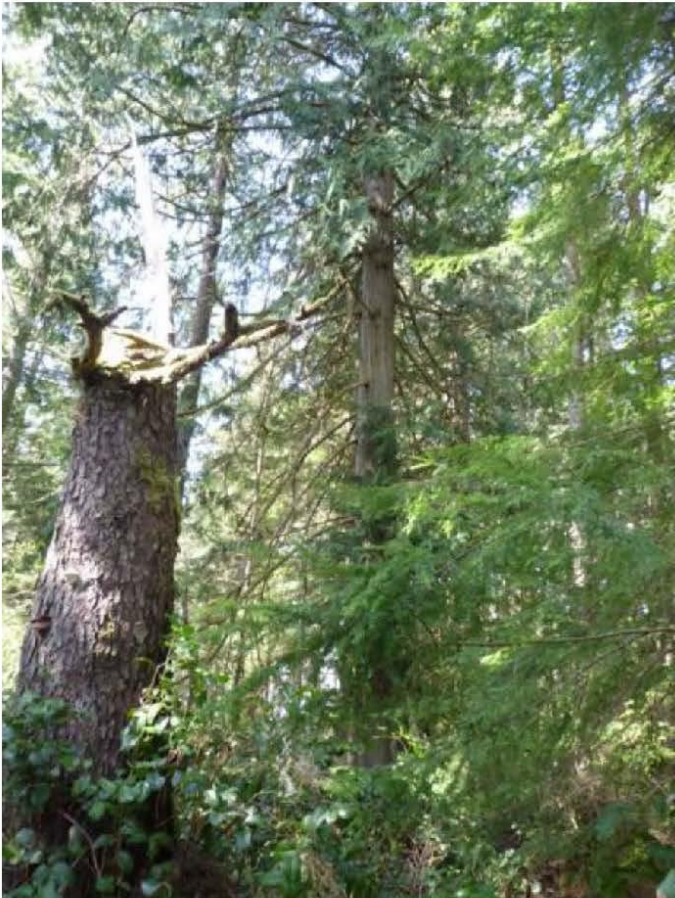
Photo 17. Potential habitat for Seaside Bone Lichen was checked for the presence of this species. None was observed.

Photo 18. Potential habitat for Seaside Bone Lichen was checked for the presence of this species. None was observed. No Shore Pines were observed on the subject property, nor on adjacent properties.

Photo 19. Potential habitat for Seaside Bone Lichen was checked for the presence of this species. None was observed.

Photo 20. Potential habitat for Seaside Bone Lichen was checked for the presence of this species. None was observed.

assessed for this species, but the species was not seen (Photo 17 – Photo 20). Additional information can be found at: https://www.crd.bc.ca/docs/default-source/jdf-pdf/otter-point-otp/otter-point-sensitive-ecosystem-inventory.pdf?sfvrsn=11e289e9_0

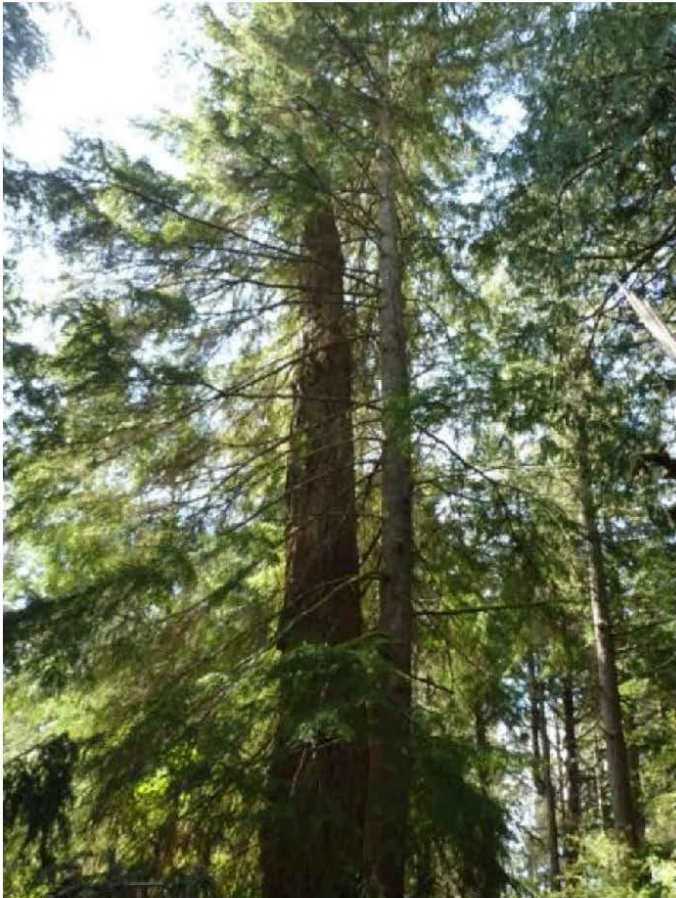
Photo 21. Mature conifer that has been topped during severe winter wind storms. This was one of a few remnant mature trees in the area.
