CONDITIONS AND IMPACT REPORT FOR 3542 OTTER POINT ROAD

CORVIDAE PROJECT #2019-010
FEBRUARY 2020

CORVIDAE
ENVIRONMENTAL CONSULTING INC
6526 WATER STREET, SOOKE, BC

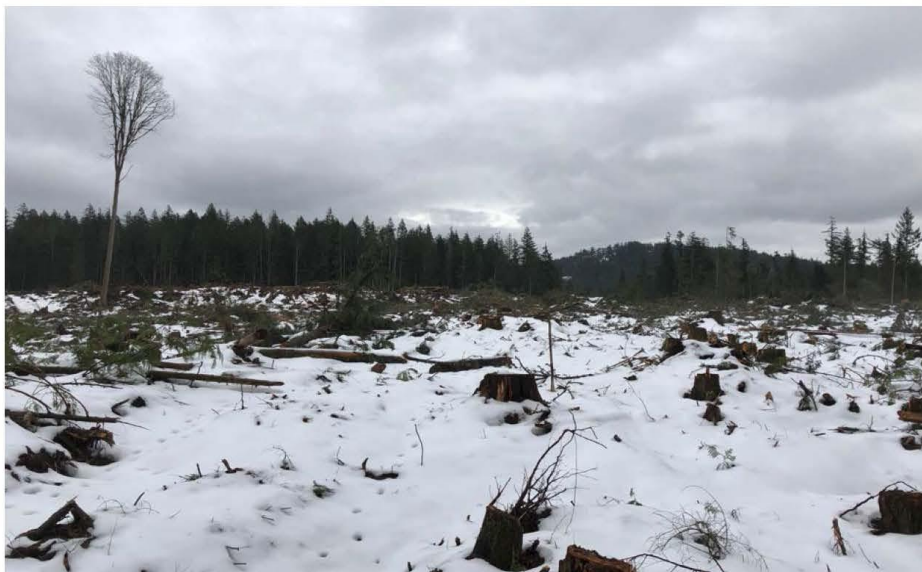
Photo 2. Lot 2 area

The landowner () are subdividing the property at 3542 Otter Point Road, which is approximately 37 acres (15 ha). Currently, an access road and a residence are located near the mid-point of the northwestern property line (see Figure 1). Further along the access road, the property owner operates a sawmill and logging operation (Photo 1). With the exception of the trees immediately adjacent to the watercourse and wetland, the property has been logged (Photo 2).

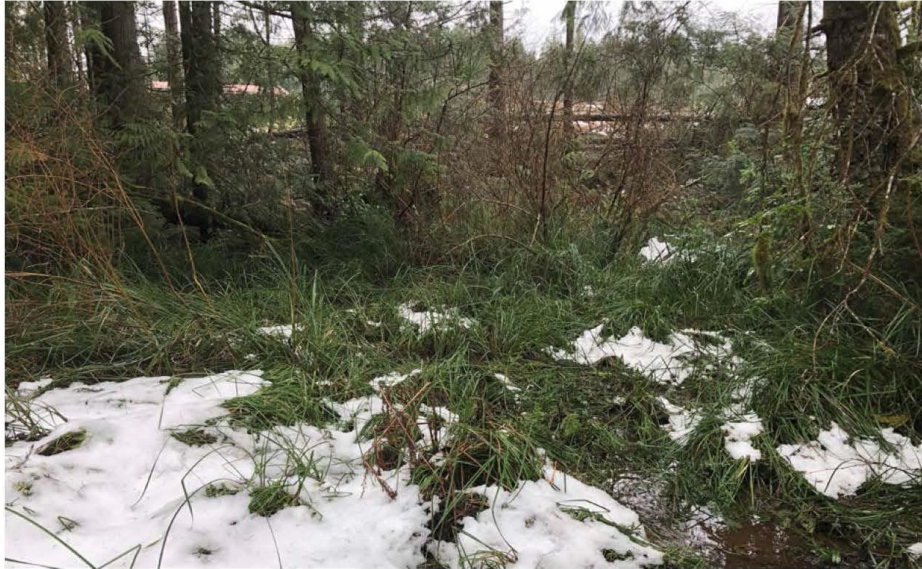
Photo 5. Sedge dominated wetland area with mature forest adjacent. Uncleared.

The wetland is fed by an unmapped watercourse (drainage/creek) running from the northeastern most corner of the property, between the existing residential and sawmill areas. The watercourse passes under the sawmill access road through a culvert. On the downstream side of the culvert, the watercourse opens into a marshy wetland area. This continues through the riparian forest (Photo 7) to the large wetland in the property's southwest. A small portion of the watercourse is channelized (Photo 8), however, the majority is wide and marshy (Photo 5).

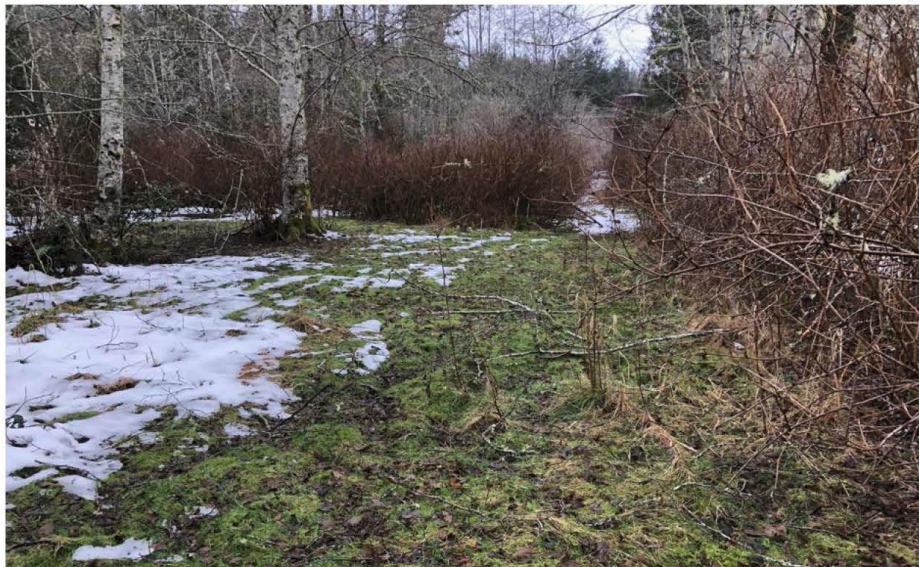
Photo 9. Filled area on adjacent property to the west of 3542 Otter Point Road (view north).

Along the property's southwestern boundary, the wetland and riparian areas are constrained by historical addition of fill to the neighbouring property (Photo 9). Approximately 500 m downstream, the drainage is dammed and used as a water supply for agriculture (ALM Farm).

The unmapped watercourse has been modified historically for the installation of the sawmill access road and culvert. Existing extensive modification and addition of fill has also occurred on the adjacent property to the west. Implementation of mitigation measures will serve to restore and maintain the drainage of water to the southwest.
