**DEVELOPMENT PERMIT WITH VARIANCE NO. DV000083**

Re: Proposed Lot Subdivision  
590 Seedtree Road – East Sooke, BC

ENVIRONMENTAL OVERVIEW ASSESSMENT REPORT (FINAL REV 0)  
590 SEEDTREE ROAD, EAST SOOKE, BC

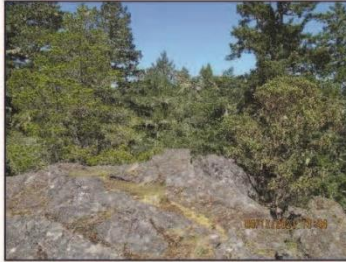
Photo 3 Typical rock outcropping (C. Barlow).

The property is predominated by exposed bedrock faces, escarpments and outcroppings (Photos 3 & 4). Based on the prevalence of bedrock, it is anticipated that the topsoil horizon throughout most of the property is extremely shallow.

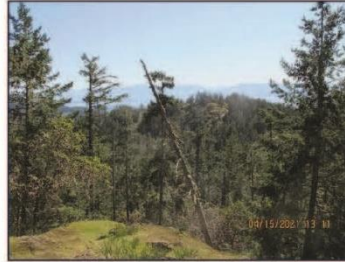
Photo 4 Typical rock outcropping (C. Barlow).

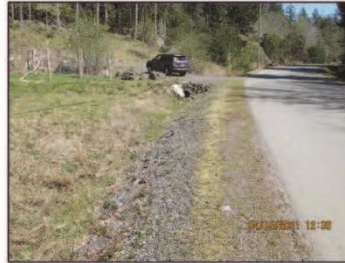
Photo 5 Road frontage ditch at subject property (C. Barlow).

The road frontage ditch drains to Seedtree Creek, originating from runoff areas along the north side of Seedtree Road for a distance of approximately 140 m (Photo 5). This point demarcates the topographic transition such that drainage flows to the east.

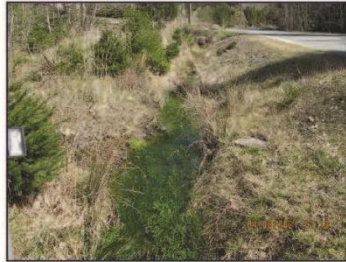
**Photo 6** Spring-fed flows to headwaters of Seedtree Creek at 630 Seedtree Road (C. Barlow).

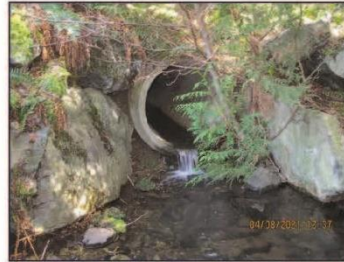
**Photo 7** Seedtree Road concrete culvert conveying Seedtree Creek (C. Barlow).

The stream alignment generally follows the Seedtree Road alignment, crossing by way of road culverts (Photo 7). Near the intersection with East Sooke Road, Seedtree Creek ultimately flows to two large (upper and lower) wetland complexes (~3 ha and ~4 ha, respectively), oriented parallel to East Sooke Road (Appendix 1: Figure 1).

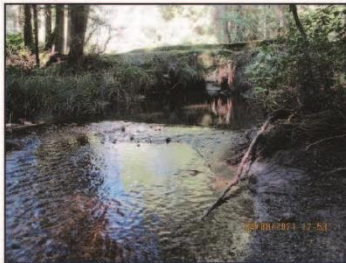
Photo 8 Seedtree Creek looking upstream to East Sooke Road elliptical culvert (C. Barlow).

At East Sooke Road, the stream passes under East Sooke Road by way of a low gradient, elliptical pipe arch culvert approximately 2 m in diameter (Photo 8). Downstream of the road culvert, the low-gradient channel is generally unaltered. It exhibits natural stream development characteristics such as pool-riffle sequencing, sinuosity, bank development, large woody debris complexes, gravel aggradation, well-established riparian community, etc. (Photo 9). Seedtree Creek discharges to the marine environment at Murder Bay. However, private properties prevented access to the stream outlet to confirm if there are any hydraulic (vertical) barriers that could constrain access by anadromous fish species.

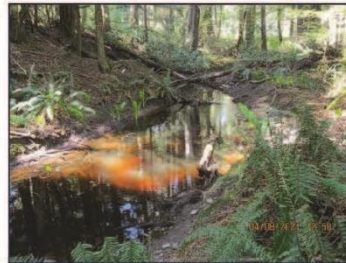
Photo 9 Seedtree Creek typical low gradient channel conditions downstream of East Sooke Road (C. Barlow).

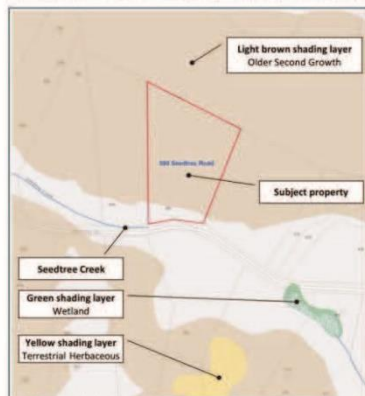
**Figure A** Sensitive Ecosystem polygons at and near the subject property<sup>7</sup>.

The Sensitive Ecosystem DPA occurs throughout the subject property, covering approximately 3.7 ha (90%) of the total area (Figure A; light brown shading).

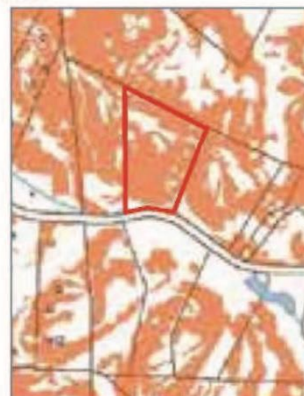
**Figure B** Steep Slope DPA<sup>7</sup>.

The Steep Slopes DPA occurs throughout the property (Figure B; orange shading). Field review confirms that steep slope terrain commonly occurs.

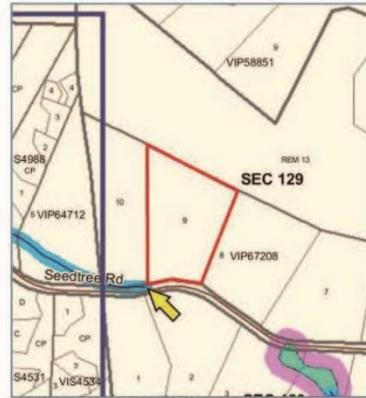
Figure C Riparian DPA and the mapped upstream terminus end of Seedtree Creek<sup>8</sup>.

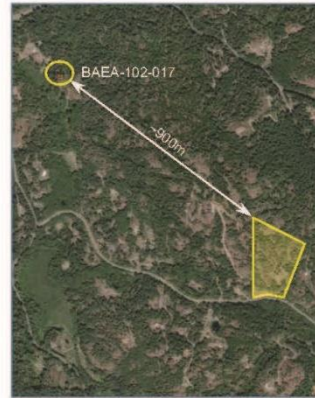
Figure D Location of the nearest Bald Eagle nest to the subject property<sup>8</sup>.

The Wildlife Tree Stewardship Atlas<sup>8</sup> provides a database of known Bald Eagle and Osprey nests throughout BC. The nearest identified occurrence of a Bald Eagle nest (BAEA-102-017) is approximately 900 m northwest of the subject property (Figure D). A second Bald Eagle nest (BAEA-102-004) exists on an island near Beecher Bay Marina, approximately 2.5 km southeast of the subject property.
