Appendix D: Permit DV000077

DEVELOPMENT PERMIT WITH VARIANCE DV000077

- 3. This development permit authorizes construction of an accessory building (the "development") on the Land, located within the development permit areas established under the Comprehensive Community Plan for Willis Point, Bylaw No. 3027, 2003, Section 4.10.3 (Steep Slopes), in accordance with the plans submitted to the CRD and subject to the conditions set out in this Permit.

Appendix C: Geotechnical Report

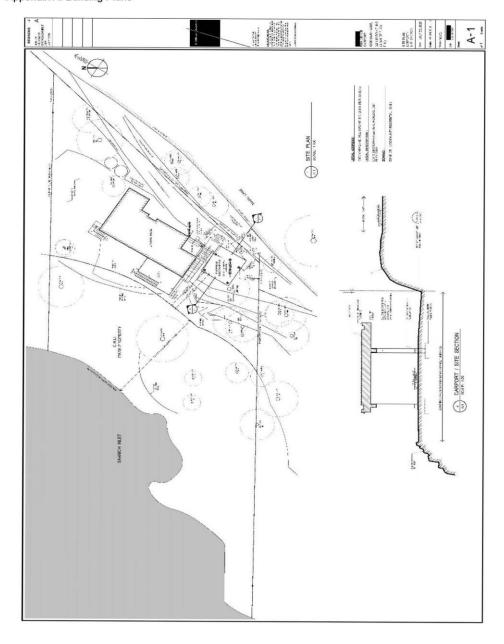
Appendix A: Building Plans

- 4. The conditions under which the development referred to in section 3 may be carried out are as follows:
 - a. That the proposed development comply with the Building Plans;

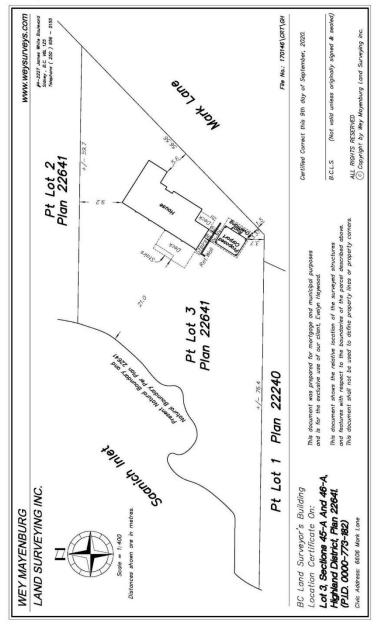
Appendix B: Building Location Certificate

- That the proposed development of the property comply with the Building Location Certificate prepared by Wes Mayenburg Land Surveying Ltd., dated September 9, 2020;
