Appendix G: Hydrogeology Report

File: 2012191

Re: Preliminary Groundwater Assessment, Section 42, Otter Point Estates

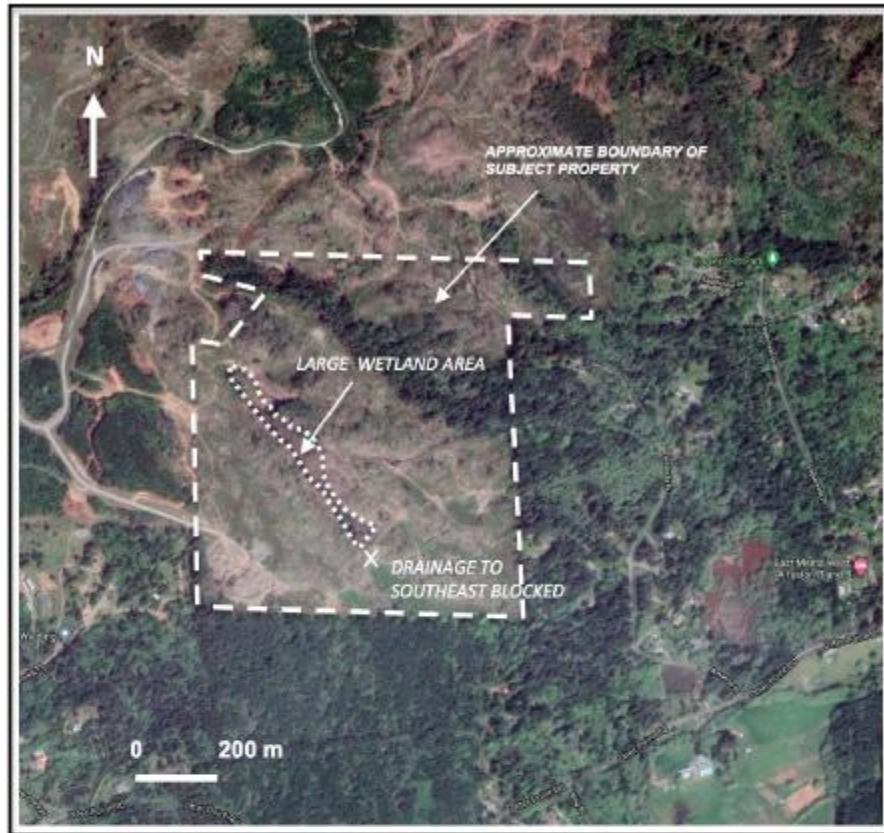
Figure 3. Area of proposed subdivision and location of major wetland. Basemap from Google Maps (2021).

There is a relatively large wetland in the south-western quarter of the property that is shown on existing CRD (2021) mapping, draining south-easterly (Figure 3). The drainage from the south end of the wetland, however, is blocked by an abandoned logging road grade from draining towards the southeast. It likely drains north-easterly towards tributaries of King Creek.

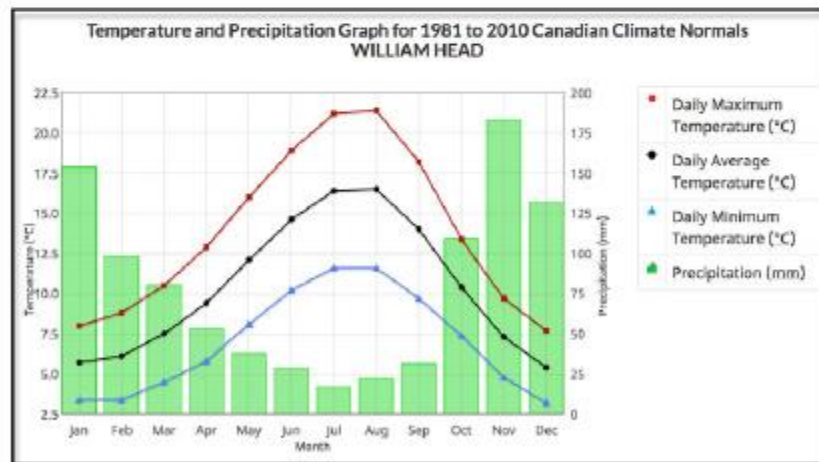
Figure 4. Graph of monthly normal precipitation for William Head station (Climate ID: 1018935). Graph from Government of Canada (2021).

The region is situated in a cool Mediterranean climatic zone with mild wet winters and dry summers. Monthly normal precipitation for the nearby William Head weather station for the 1981-2010 period has been reported by the Government of Canada (2021) for climate station 1018935 as shown in Figure 4. The area receives about 994 mm of precipitation on an annual basis (Government of Canada, 2021). Precipitation normally follows a seasonal cycle, with highest rainfall during the fall, winter and early spring months while the summer months are subject to drought conditions.

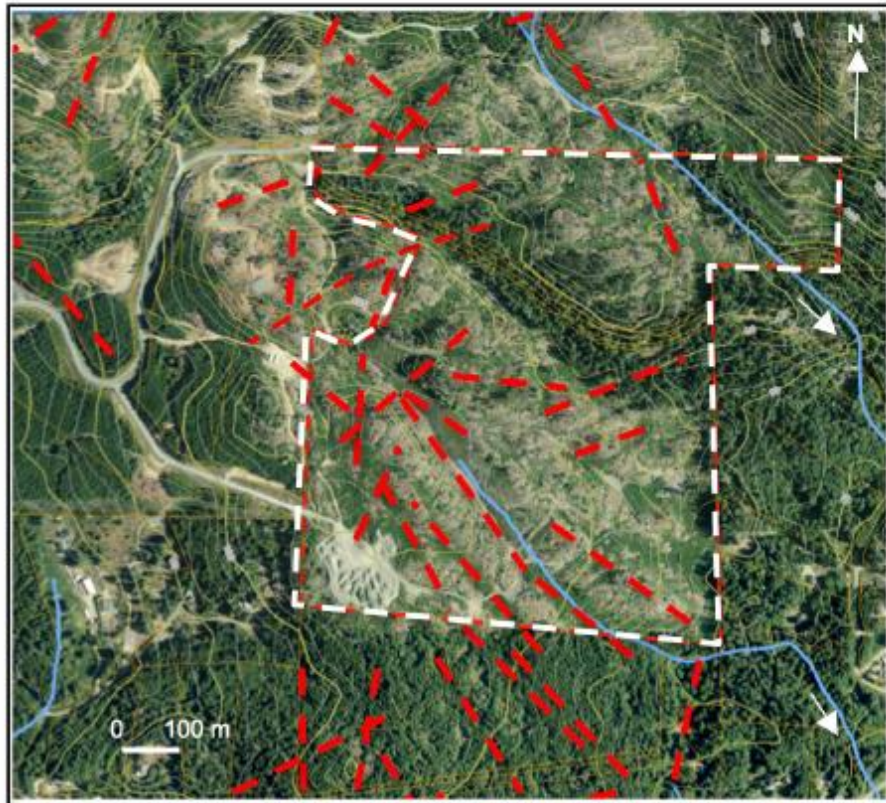
Figure 5. Interpreted major bedrock lineaments in region. Basemap from CRD (2021).

Figure 5 shows some of the major bedrock lineaments present in the region that likely represent large fracture zones and joint systems. These lineaments trend in two dominant directions, namely northwest to southeast and southwest to northeast. Larger capacity wells are often situated along or close to these fracture trends and where lineaments intersect.

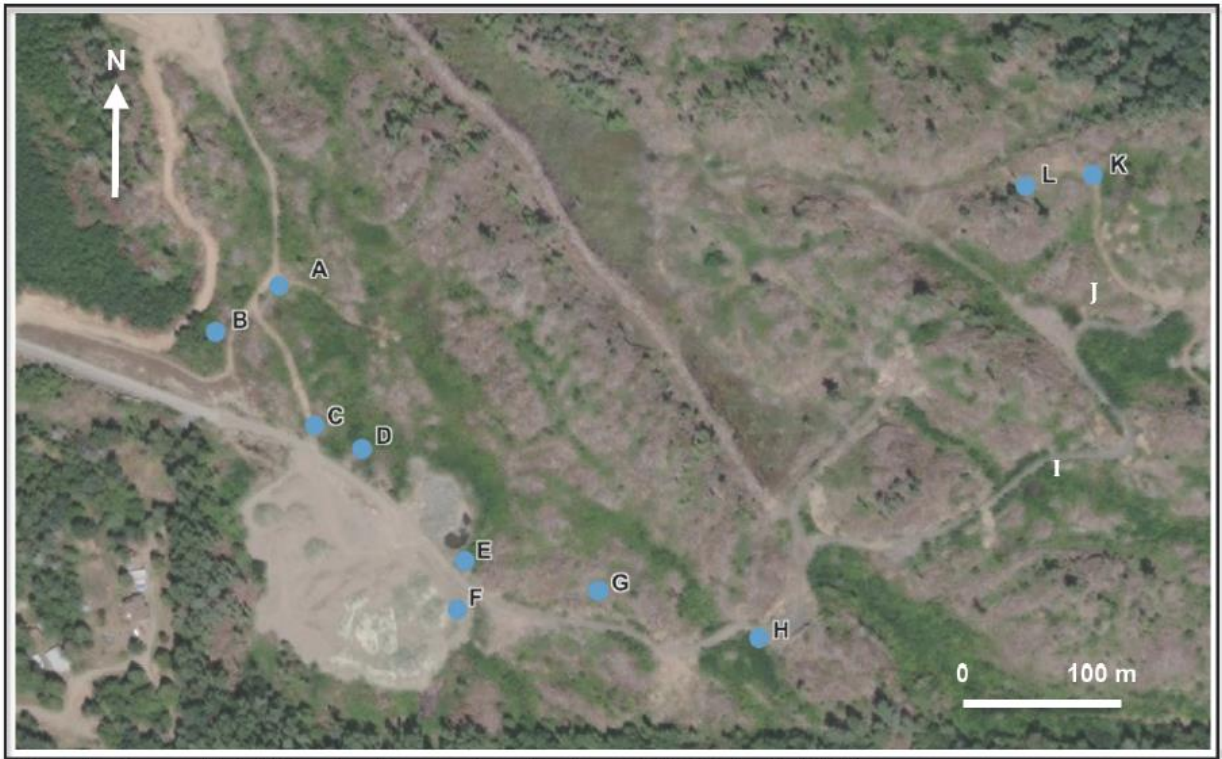
Figure 7. Proposed test drilling sites. Basemap from Province of British Columbia (2021).

Based on the current proposed subdivision layout and geologic conditions observed in the field a number of recommended potential drilling sites are shown in Figure 7. It may not be necessary to drill at all of these locations.

Site A: 48° 22.863' N, 123° 49.583'W Lot 7

Site B: 48° 22.846' N, 123° 49.613'W Lot 7

Site C: 48° 22.814' N, 123° 49.562'W Lot 6

Site D:	48° 22.806' N,	123° 49.537'W	Lot 5
Site E:	48° 22.768 N,	123° 49.484'W	Lot 4
Site F:	48° 22.751 N,	123° 49.488'W	Lot 1
Site G:	48° 22.757 N,	123° 49.415'W	Lot 3
Site H:	48° 22.741 N,	123° 49.332'W	Lot 1
Site I:	48° 22.778 N,	123° 49.295'W	Lot 2
Site J:	48° 22.858 N,	123° 49.192'W	Lot 2
Site K:	48° 22.900 N,	123° 49.159'W	Lot 2
Site L:	48° 22.896 N,	123° 49.194'W	Lot 3

Each of the sites except Site J has been marked in the field with blue tapes. Currently most sites should be relatively accessible for a drilling rig with minimal road fill, grading and/or culvert installations. Access to site L would require some road work due to steepness of the slope. The sites should be inspected by the drilling contractor prior to mobilizing the drilling rig.

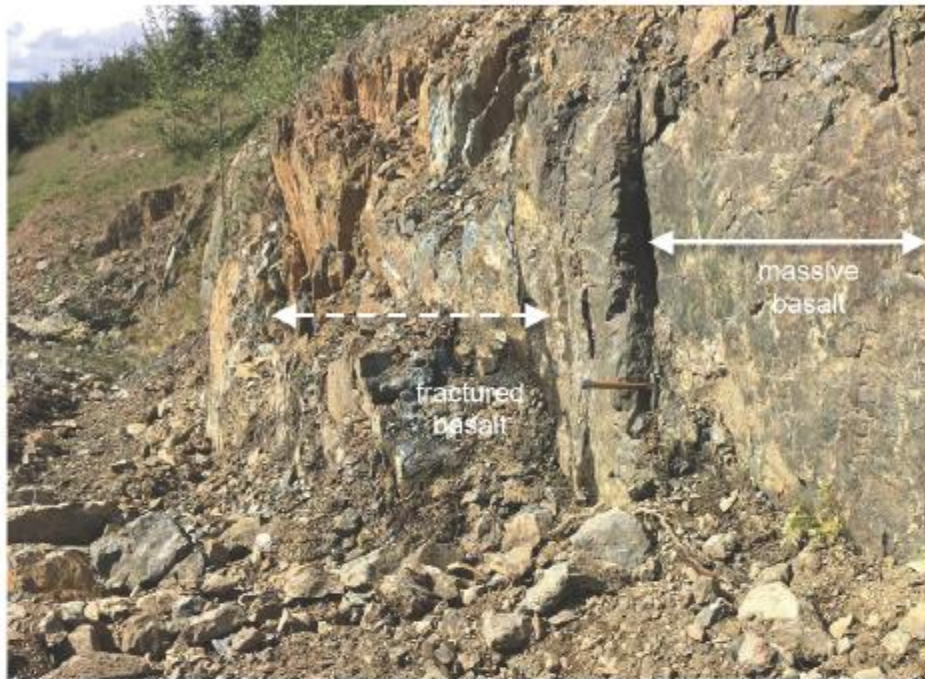
Photo 1. Outcrop of fractured basalt looking northwesterly along north side of Aythree Way extension near entrance to Otter Point Estates, April 25, 2021.

Groundwater is found primarily in open fractures in the bedrock as they are encountered during drilling of water wells. These fractures constitute the major zones for groundwater storage and movement. Exposures of the volcanic rock in the region generally show relatively massive blocks of tightly fractured rocks with discrete zones of more intense fracturing in some places. See photos 1 to 4 in Appendix A.

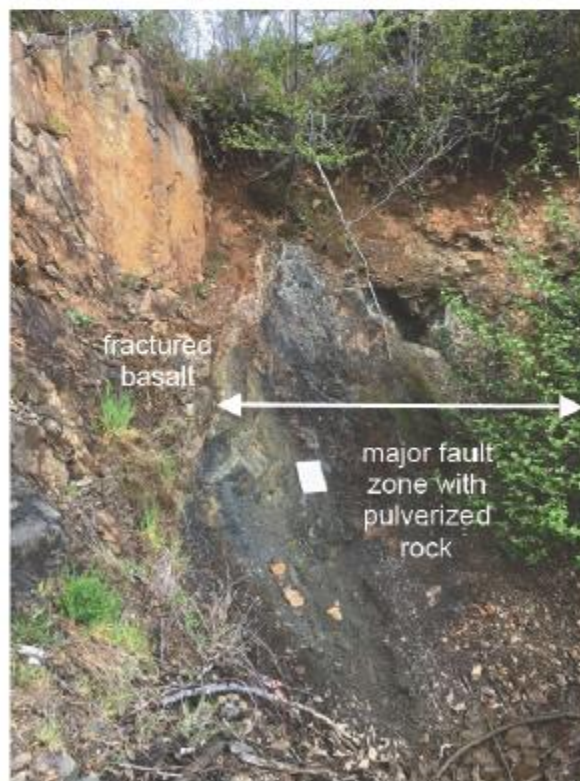
Photo 2. West side of large near vertical fault zone with soft pulverized rock looking northerly near western boundary of proposed Lot 2, April 25, 2021.

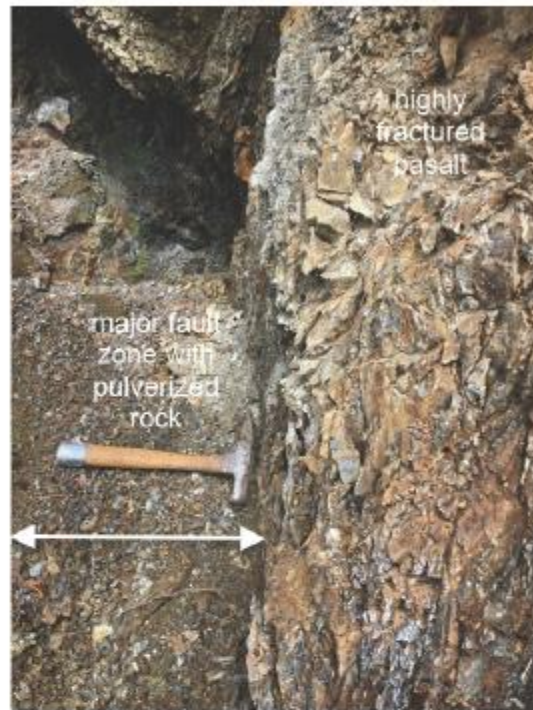
Photo 3. East side of large near vertical fault zone with soft pulverized rock looking northerly near western boundary of proposed Lot 2, April 25, 2021.

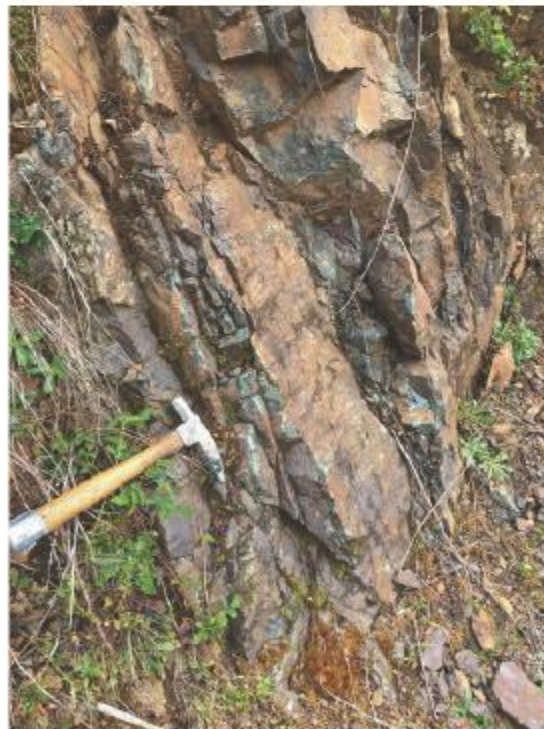
Photo 4. Fractured basalt in central portion of proposed Lot 2, April 25, 2021.
