2021 INVENTORY OF BOATS AND PRIVATE MOORING BUOYS IN TSEHUM HARBOUR AND BRENTWOOD BAY

January 2024

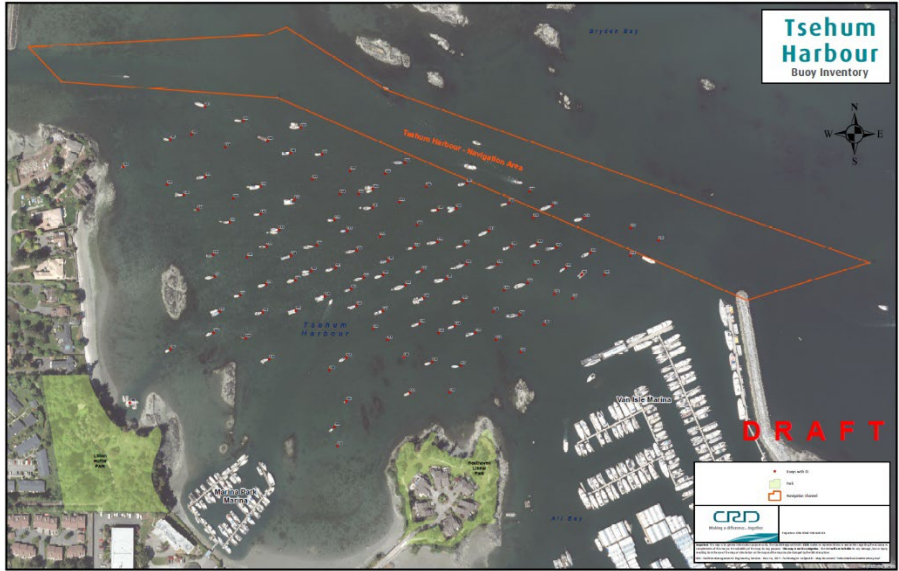
Figure 1: Ortho image of boats and private mooring buoys (red dots) in Tsehum Harbour including placement in navigation channels

Further violations included several PMBs and boats located within the defined navigation channels (Figures 1 and 2).

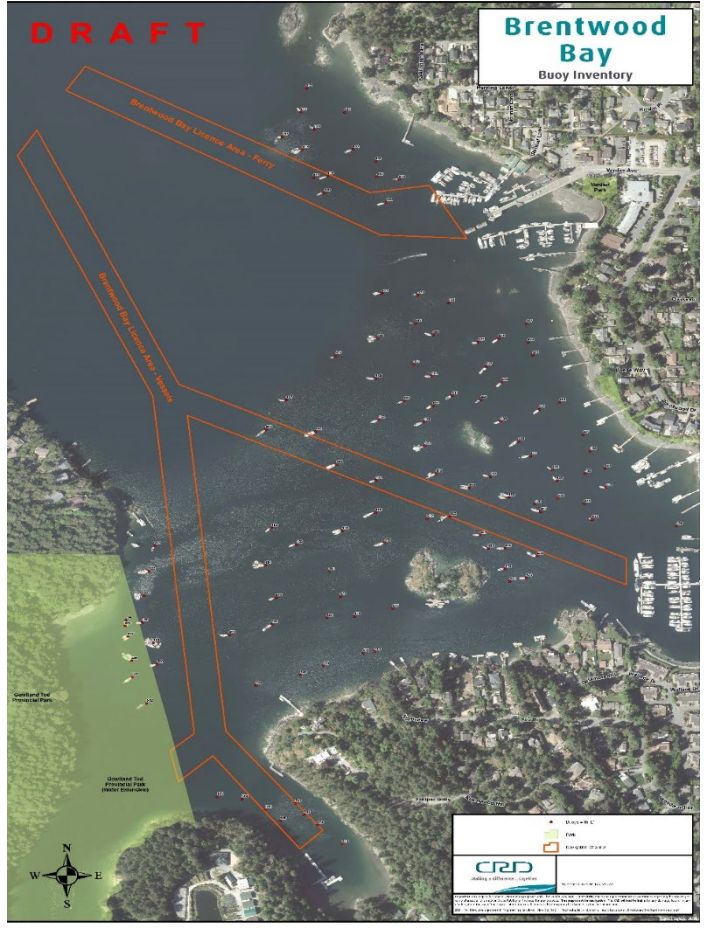
Figure 2: Ortho image of boats and private mooring buoys (red dots) in Brentwood Bay including placement in navigation channels
